COMPLAINT INVESTIGATION REPORT

Project Name:	Mountain Valley Pipeline	Inspector:	Marshall Willis
Inspection Date:	Thursday, August 12, 2021	Project Contact:	Brian Clauto, Cory Chalmers
Spread H: Franklin County	STA 12915+20 – 12924+12 MVP-RO-286	Weather:	Dry

Background: This investigation was conducted in response to a complaint of possible work in wetlands (IR#: 300539) received on August 10, 2021 for the MVP ROW at MP 244.5.

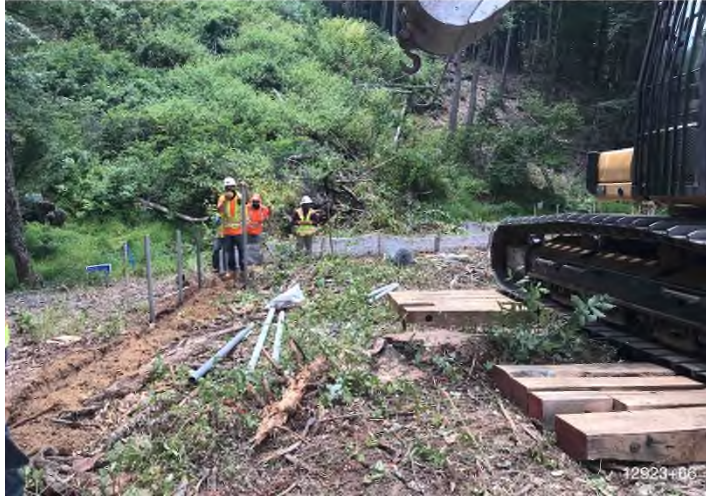
Figure 1: STA 12923+66 – PPL crews installing ECDs and establishing buffer for stream S-EF44 and wetland W-EF44.

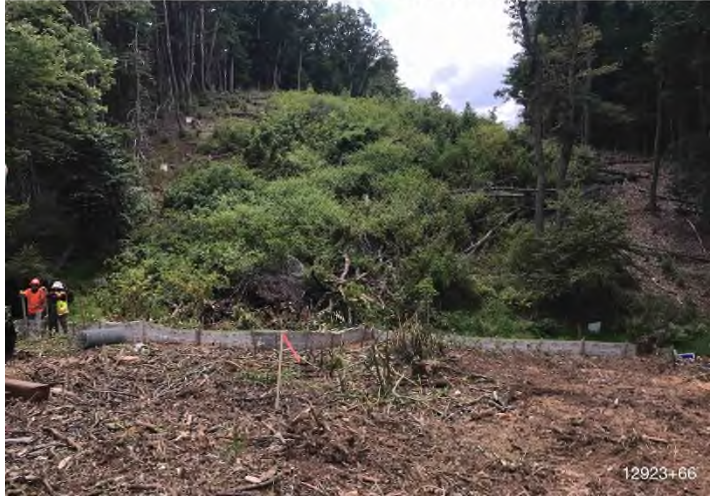
Figure 2: STA 12923+66 – Looking south towards stream S-EF44 and wetland W-EF44.

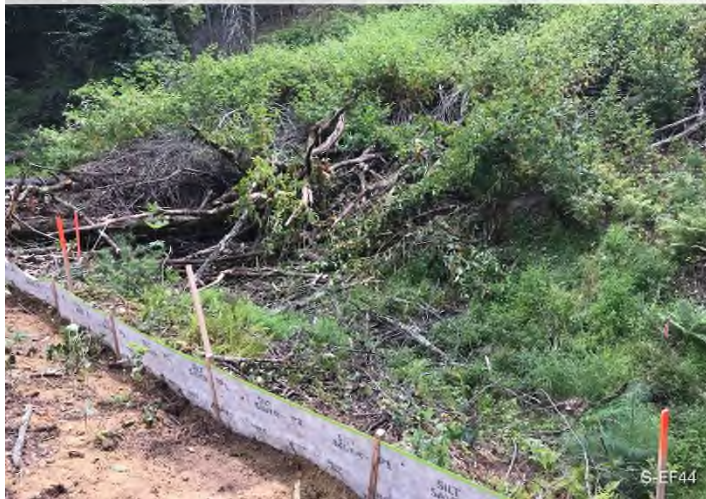
Figure 3: Stream S-EF44/Wetland W-EF44 – PPL crews installing ECDs and establishing buffer for resources.

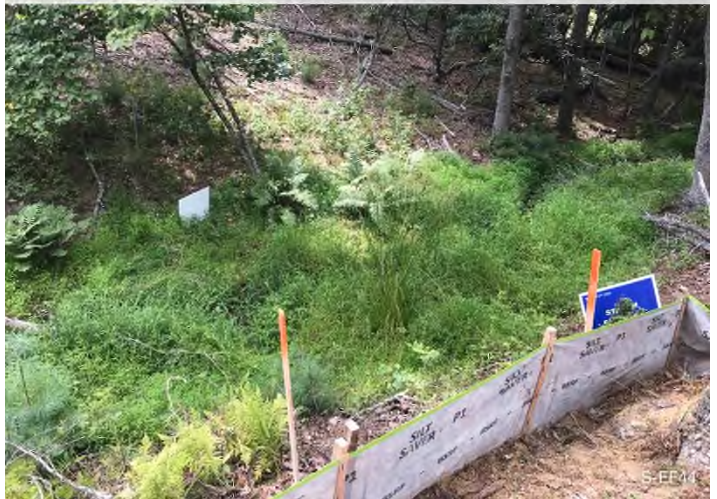
Figure 4: Stream S-EF44/Wetland W-EF44 – PPL crews installing ECDs and establishing buffer for resources.

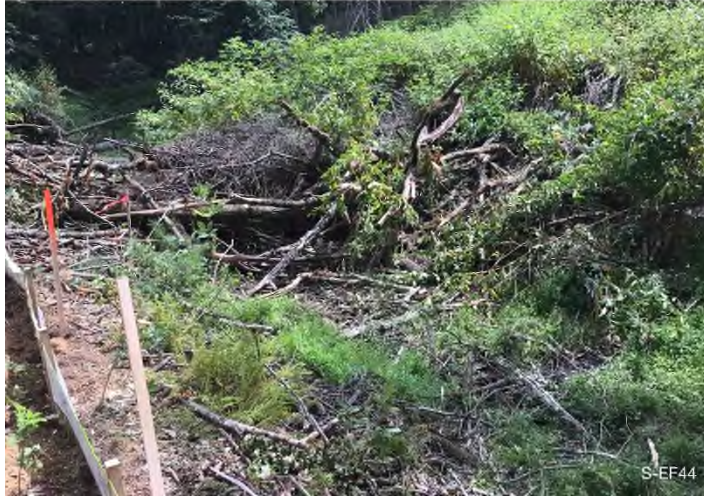
Figure 5: Stream S-EF44/Wetland W-EF44 – PPL crews installing ECDs and establishing buffer for resources.

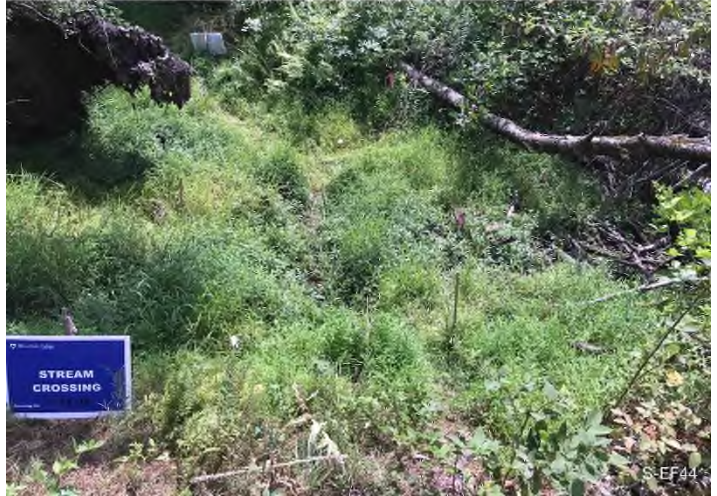
Figure 6: Stream S-EF44/Wetland W-EF44 – PPL crews installing ECDs and establishing buffer for resources.

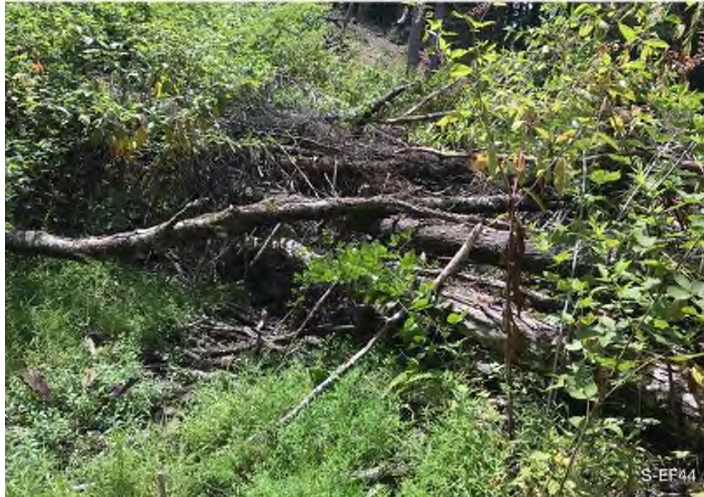
Figure 7: Stream S-EF44/Wetland W-EF44 – PPL crews installing ECDs and establishing buffer for resources.

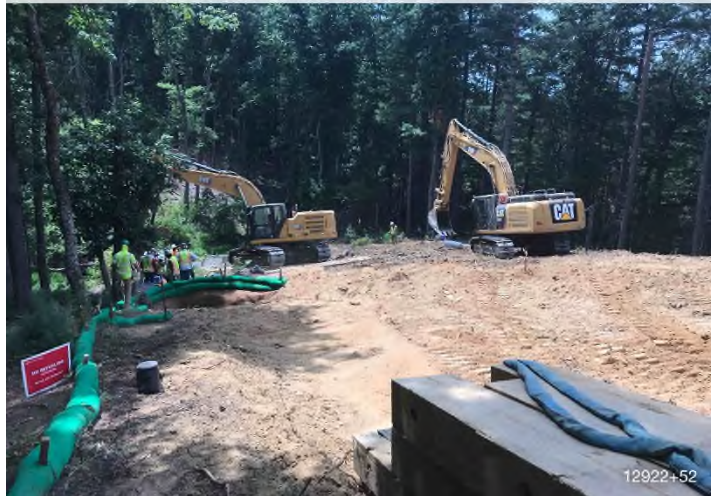
Figure 8: STA 12922+52 – Controls in place and functioning properly above stream S-EF44. PPL crews actively installing ECDs and establishing buffer area.
