COMPLAINT INVESTIGATION REPORT

Project Name:	Mountain Valley Pipeline	Inspector:	Marshall Willis
Inspection Date:	Tuesday, August 10, 2021	Project Contact:	Brian Clauto, Cory Chalmers
Spread H: Roanoke County	STA 12776+93 – 12796+50 MVP-RO-282	Weather:	Dry

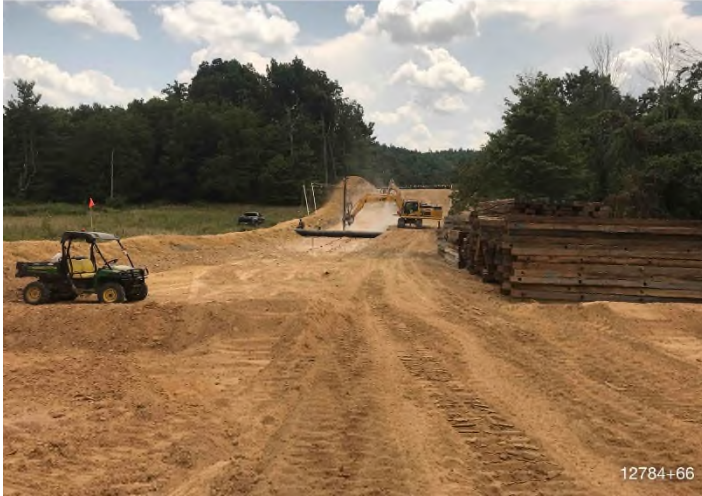
Figure 1: STA 12784+66 – Controls in place and functioning properly.

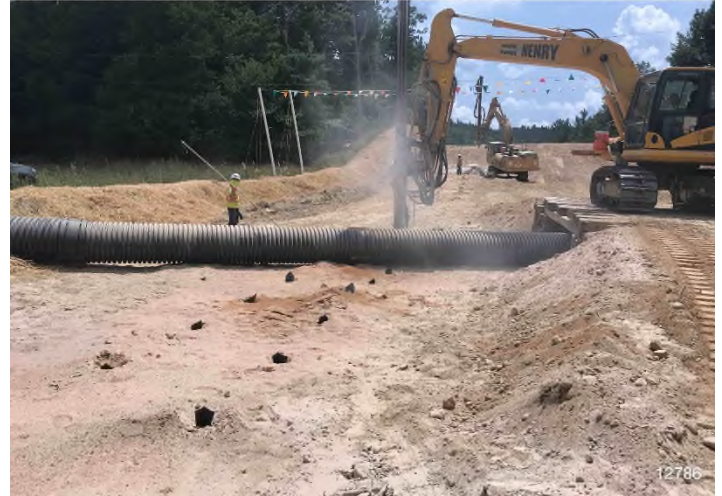
12786

Figure 2: STA 12786+00 – Controls in place and functioning properly. PPL drilling in preparation for blasting trench line.

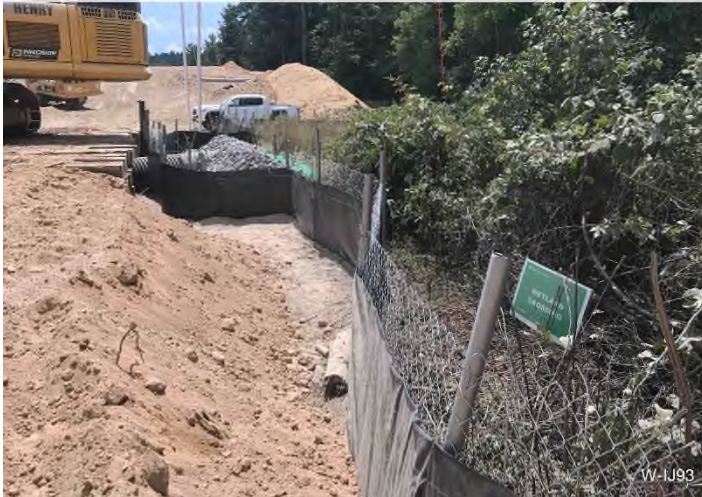
Figure 3: Wetland W-IJ93 – Controls in place and functioning properly.

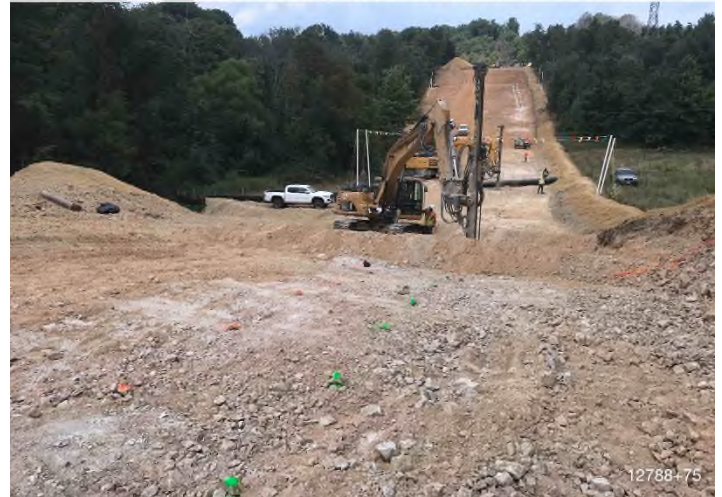
12788-75

Figure 4: STA 12788+00 – Controls in place and functioning properly.

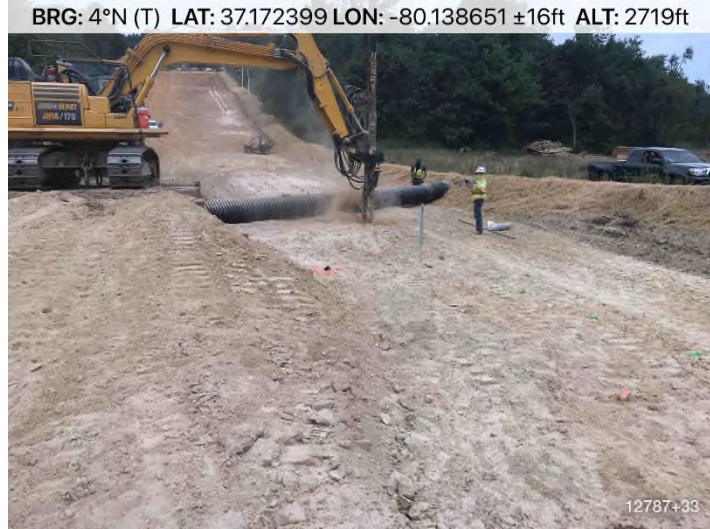
Figure 5: STA 12787+33 – Controls in place and functioning properly. PPL drilling in preparation for blasting trench line.

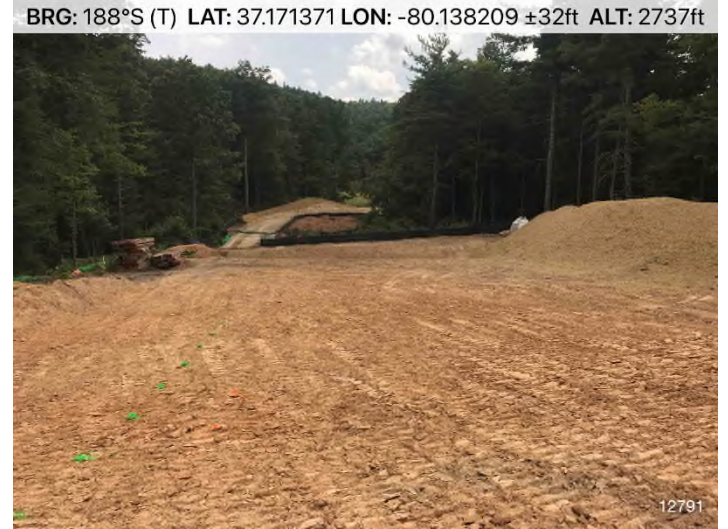
Figure 6: STA 12791+00 – Controls in place and functioning properly.

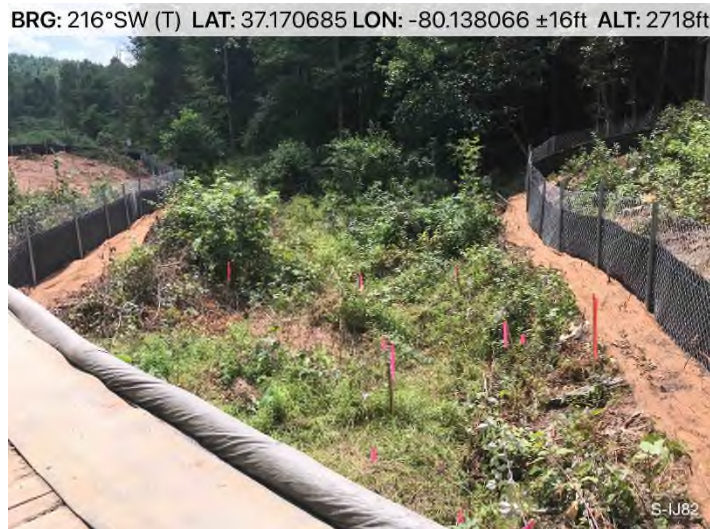
Figure 7: Stream S-IJ82 – Controls in place and functioning properly along stream S-IJ82 crossing.

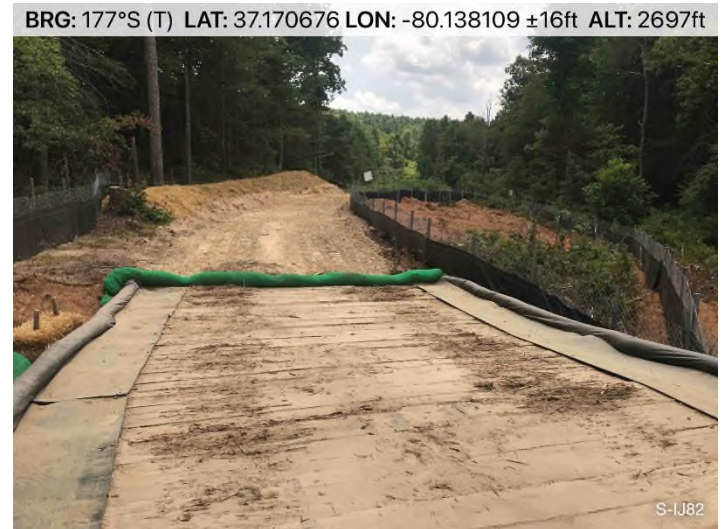
Figure 8: Stream S-IJ82 – Controls in place and functioning properly along stream S-IJ82 crossing.
