## FIELD INSPECTION REPORT

<b>Project Name:</b>	Mountain Valley Pipeline	<b>Inspector:</b>	Marshall Willis
<b>Inspection Date:</b>	Friday, August 6, 2021	<b>Project Contact:</b>	Brian Clauto, Cory Chalmers
<b>Spread G: Giles County</b>	STA 11298+08 – 11356+18 MVP-GI-253.02 MVP-GI-256	<b>Weather:</b>	Dry

## FIELD INSPECTION PHOTO LOG

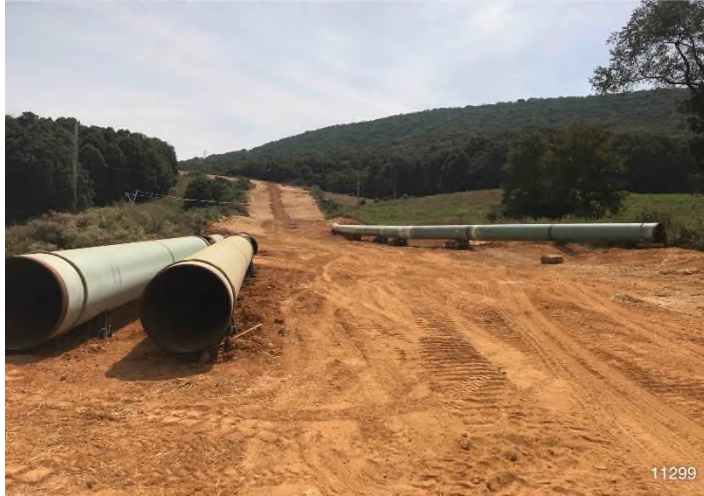
**Figure 1: STA 11299+00** – Controls in place and functioning properly.  
 BRG: 100°E (T) LAT: 37.296728 LON: -80.478602 ±32ft ALT: 2287ft

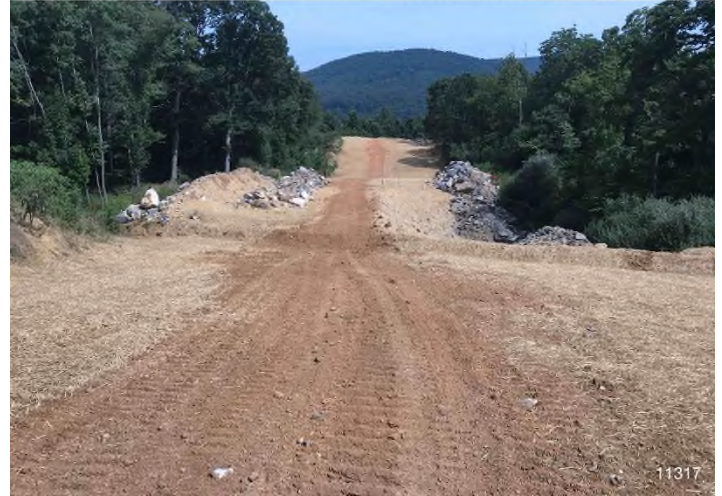
**Figure 2: STA 11317+00** – Controls in place and functioning properly.  
 BRG: 37°NE (T) LAT: 37.295694 LON: -80.476087 ±7237ft ALT: 2312ft

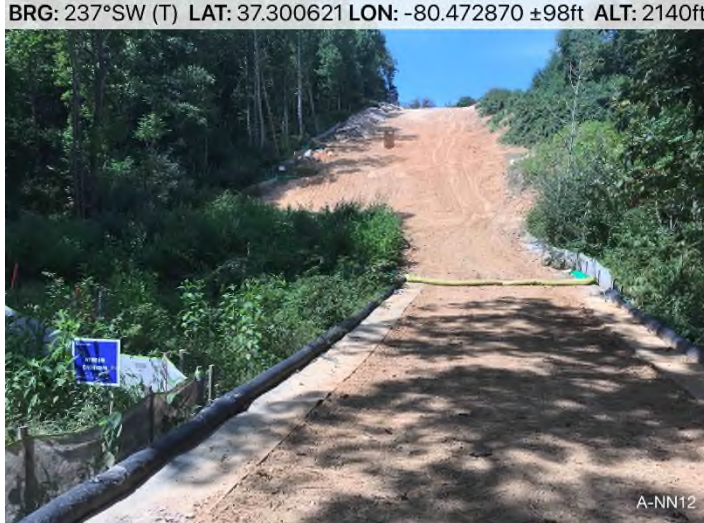
**Figure 3: Stream S-NN12** – Controls in place and functioning properly along stream S-NN12.  
 BRG: 237°SW (T) LAT: 37.300621 LON: -80.472870 ±98ft ALT: 2140ft

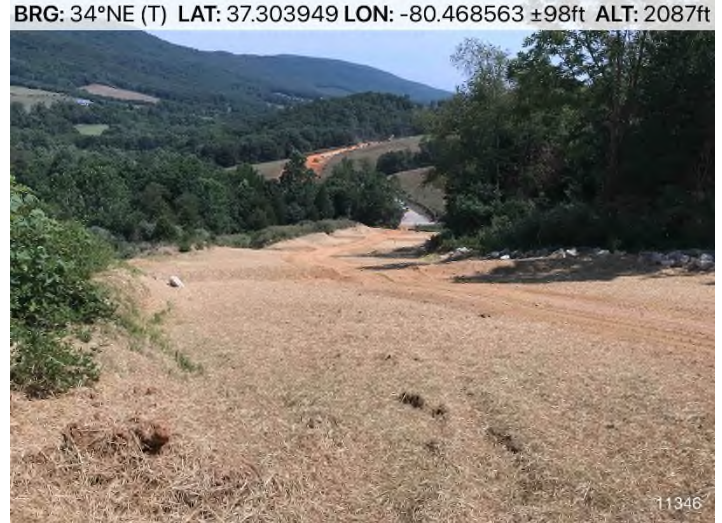
**Figure 4: STA 11346+00** – Controls in place and functioning properly.  
 BRG: 34°NE (T) LAT: 37.303949 LON: -80.468563 ±98ft ALT: 2087ft
