FIELD INSPECTION REPORT

Project Name:	Mountain Valley Pipeline	Inspector:	Marshall Willis
Inspection Date:	Tuesday, July 27, 2021	Project Contact:	Brian Clauto, Cory Chalmers
Spread G: Giles County	STA 11158+12 – 11252+17 STA 10802+00 – 10820+00 MVP-GI-249.03 MVP-MLV-AR-25	Weather:	Dry

FIELD INSPECTION PHOTO LOG

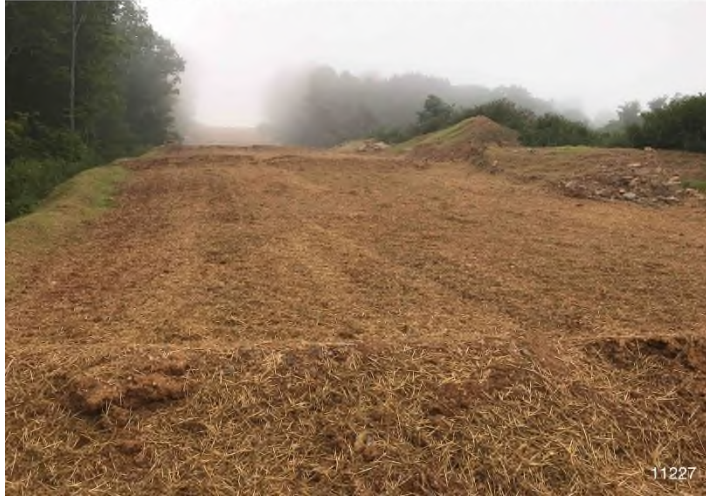
Figure 1: STA 11227+00 – Controls in place and functioning properly.
 BRG: 142°SE (T) LAT: 37.329366 LON: -80.421533 ±16420ft ALT: 2010ft

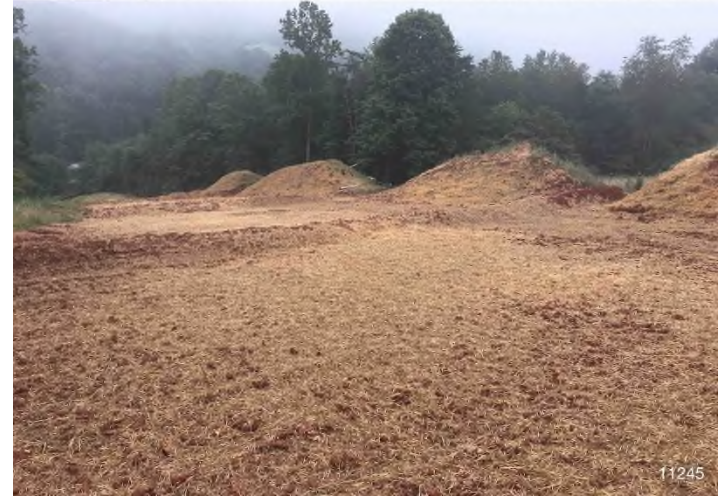
Figure 2: STA 11245+00 – Controls in place and functioning properly.
 BRG: 151°SE (T) LAT: 37.310473 LON: -80.506968 ±12326ft ALT: 2127ft

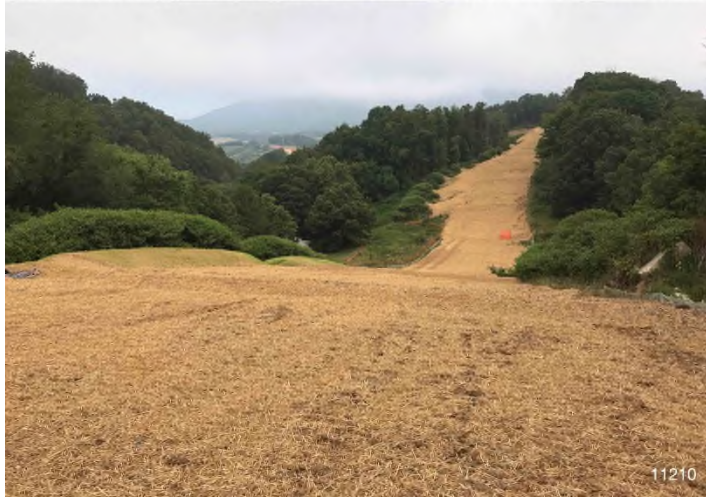
Figure 3: STA 11210+00 – Controls in place and functioning properly.
 BRG: 305°NW (T) LAT: 37.302960 LON: -80.505797 ±32ft ALT: 2013ft

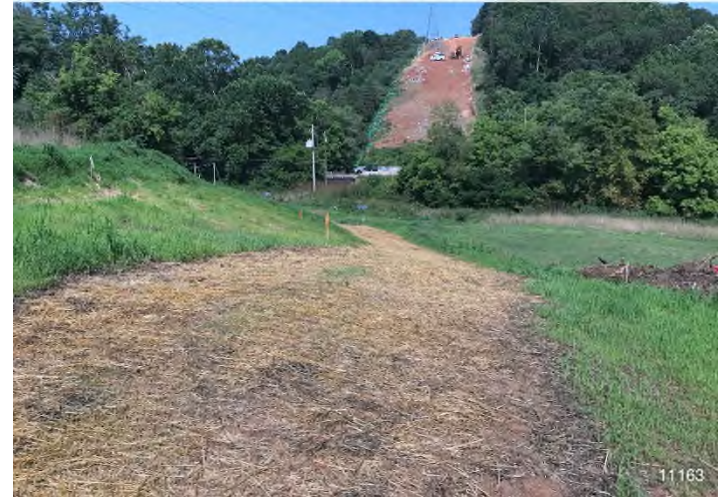
Figure 4: STA 11163+00 – Controls in place and functioning properly.
 BRG: 288°W (T) LAT: 37.311321 LON: -80.514494 ±16ft ALT: 1829ft
