# FIELD INSPECTION REPORT

<b>Project Name:</b>	Mountain Valley Pipeline	<b>Inspector:</b>	Matthew Grant
<b>Inspection Date:</b>	Tuesday, July 27, 2021	<b>Project Contact:</b>	Brian Clauto
<b>Spread G: Giles</b>	AR 241.02, 241.03 St 10815-10802 ATWS 464	<b>Weather:</b>	Dry

# FIELD INSPECTION PHOTO LOG

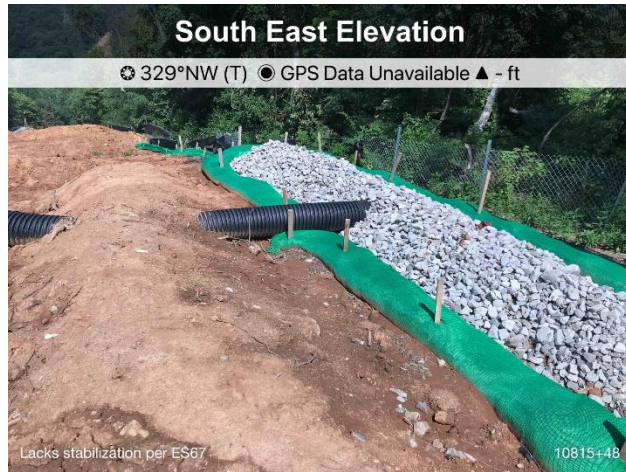
Figure 1: St10815+45 lacks stabilization per ES 67

**Recommended Corrective Action:** Maintain and install all controls per the approved PSS&S.

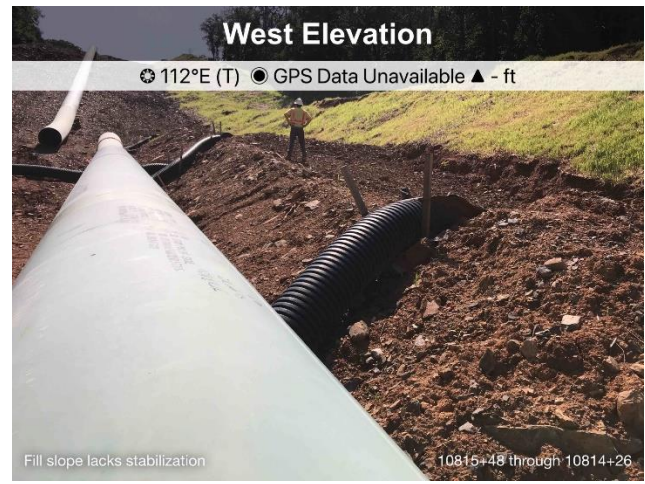
Figure 2: Two tone area lacks stabilization from 10815+45-10814+26

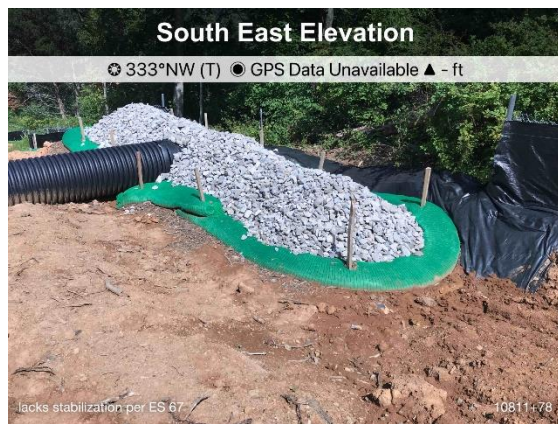
Figure 3: St10811+78 lacks stabilization per ES 67

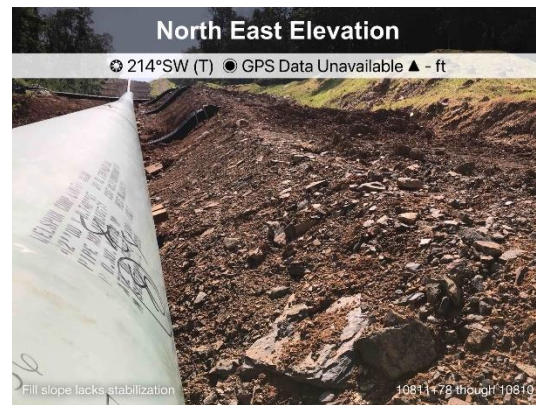
Figure 3: St10811+78 to10810 two tone area lacks stabilization

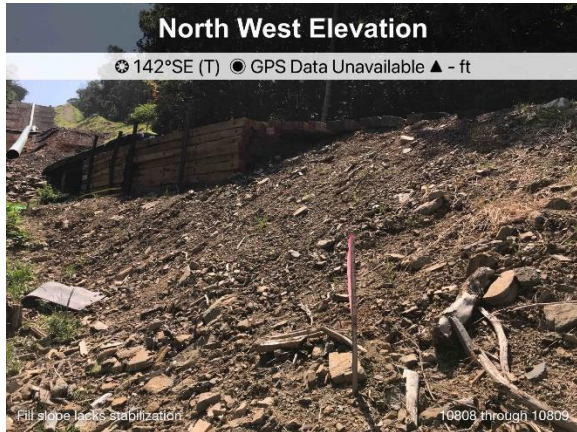
- **Figure 5:** From St10808 to 10809 two tone area lacks stabilization.
