FIELD INSPECTION REPORT

Project Name:	Mountain Valley Pipeline	Inspector:	Marshall Willis
Inspection Date:	Monday, July 26, 2021	Project Contact:	Brian Clauto, Cory Chalmers
Spread G: Giles County Craig County	STA 11524+16 – 11528+00 STA 10971+74 – 10929+71 MVP-CR-258.02 MVP-GI-242.01	Weather:	Dry

FIELD INSPECTION PHOTO LOG

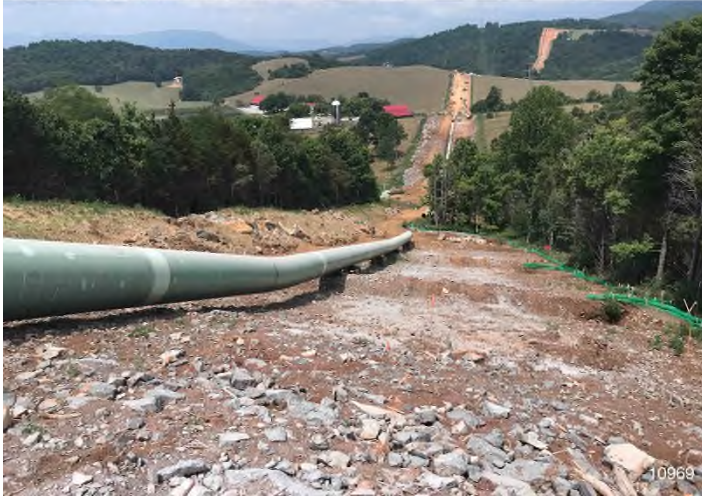
Figure 1: STA 10969+00 – Controls in place and functioning properly.
 BRG: 266°W (T) LAT: 37.327408 LON: -80.569155 ±164ft ALT: 2452ft

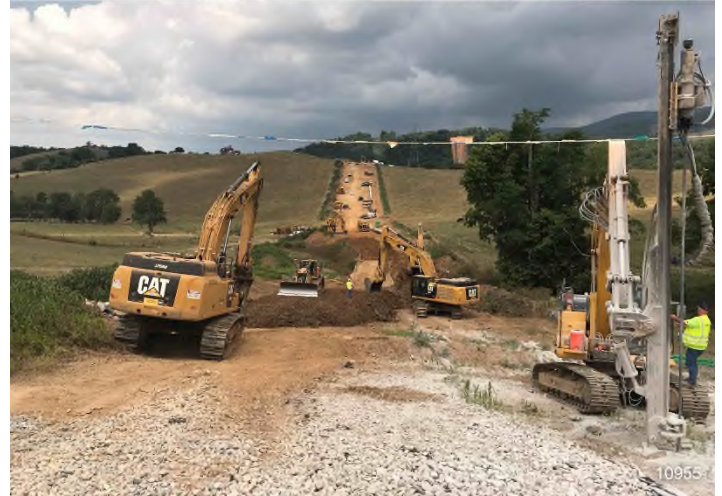
Figure 2: STA 10955+00 – Controls in place and functioning properly.
 BRG: 295°NW (T) LAT: 37.324559 LON: -80.588027 ±18789ft ALT: 2247ft

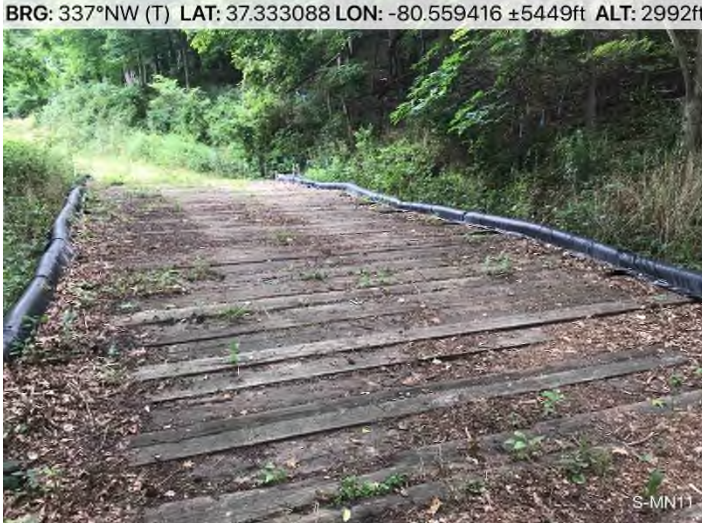
Figure 3: Stream S-MN11 – Controls in place and functioning properly.
 BRG: 337°NW (T) LAT: 37.333088 LON: -80.559416 ±5449ft ALT: 2992ft

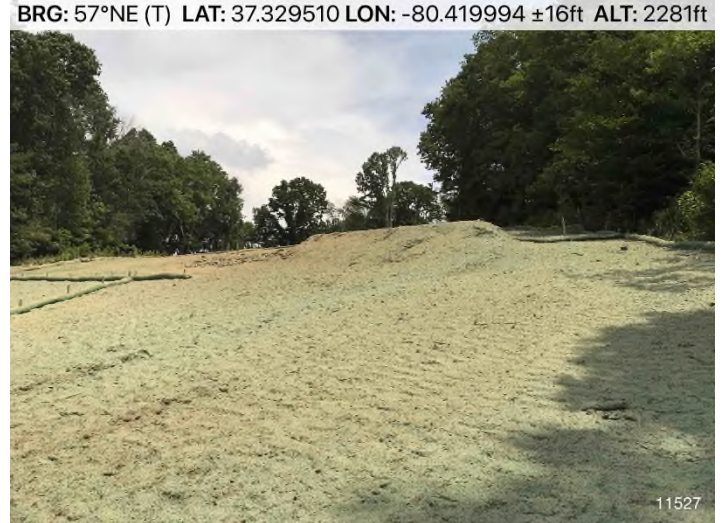
Figure 4: STA 11527+00 – Controls in place and functioning properly.
 BRG: 57°NE (T) LAT: 37.329510 LON: -80.419994 ±16ft ALT: 2281ft
