FIELD INSPECTION REPORT

Project Name:	Mountain Valley Pipeline	Inspector:	Matthew Grant
Inspection Date:	Monday, July 26, 2021	Project Contact:	Brian Clauto
Spread G: Giles	AR GI 242.01 St 11970-10990 ATWS 467, 1331	Weather:	Dry

FIELD INSPECTION PHOTO LOG

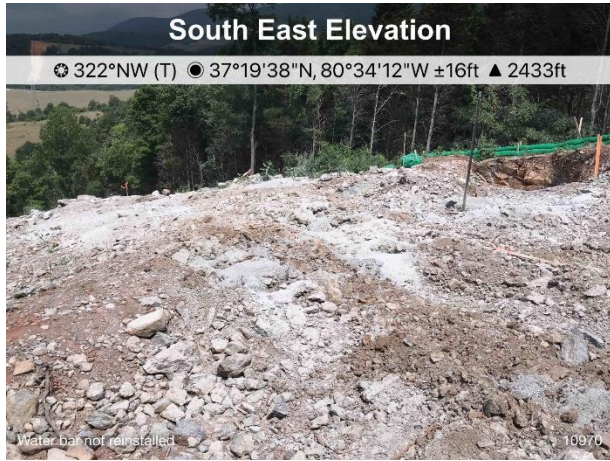
- Figure 1: St 10970 waterbar does not extend to the sump and will require reinstall

Recommended Corrective Action: Maintain and install all controls per the approved PSS&S.

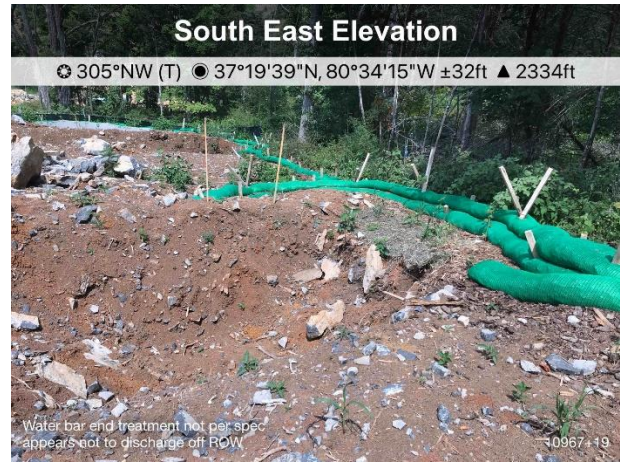
- Figure 2: St10967+19 waterbar end treatment appears not to allow water off ROW

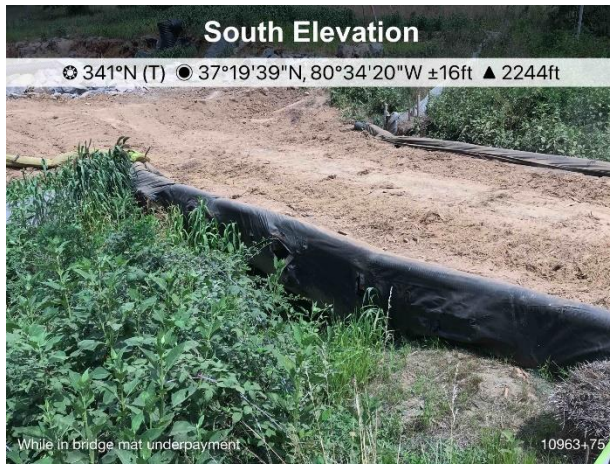
- Figure 3: St 10967+75 hole in bridge mat underpayment

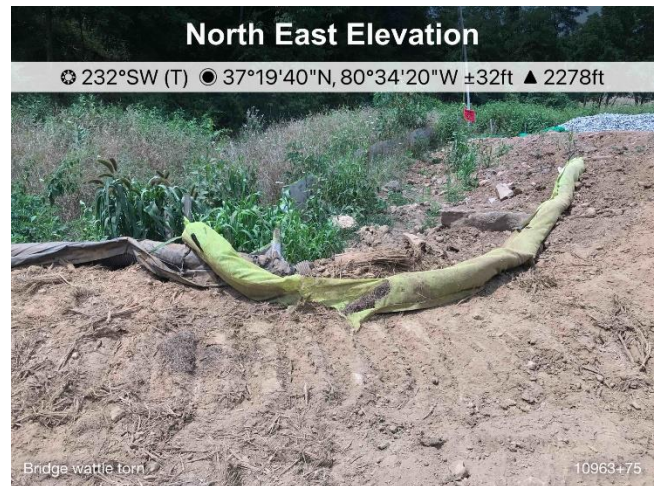
- Figure 4: St 10967+75 torn bridge wattle

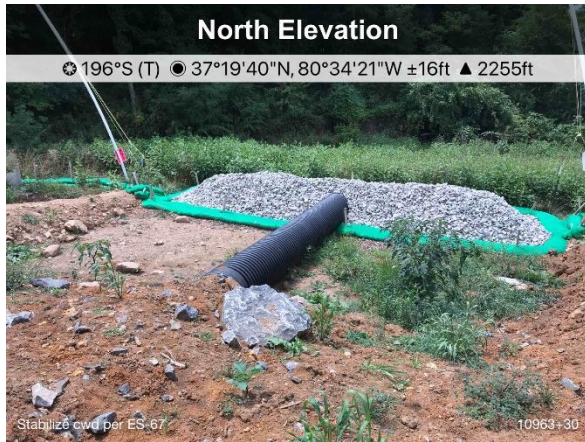
- **Figure 5:** St 10967+35 CWD level spreader requires stabilization per ES 67

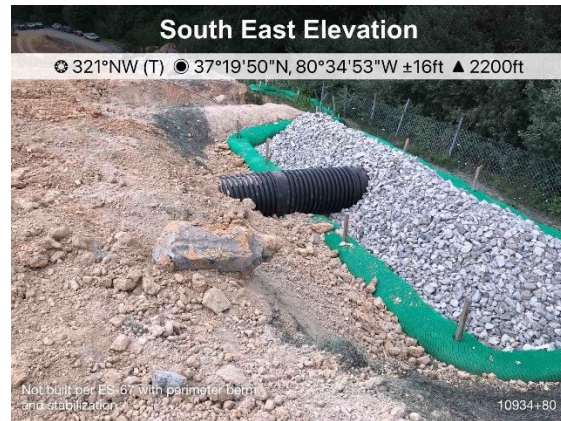
- **Figure 6:** St 10934+80 CWD level spreader lacks perimeter berm and stabilization

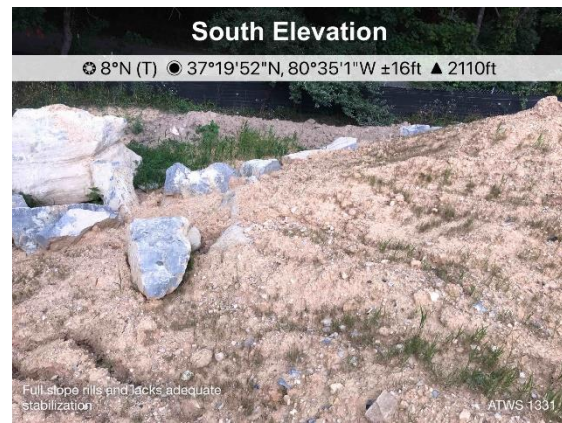
- ATWS 1331 fill slope requires rill repair and re stabilization

- **Figure 7:** ATWS 1331 fill slope requires rill repair and stabilization
