COMPLAINT INVESTIGATION REPORT

Project Name:	Mountain Valley Pipeline	Inspector:	Marshall Willis
Inspection Date:	Thursday, July 15, 2021	Project Contact:	Brian Clauto, Cory Chalmers
Spread H: Franklin County	STA 13188+66 – 13195+79 MVP-FR-292.02	Weather:	Dry

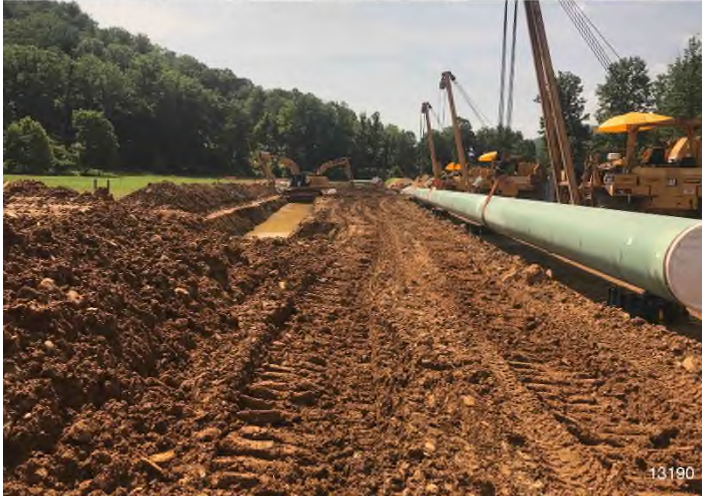
Figure 1: STA 13190+00 – Trench filled with groundwater.

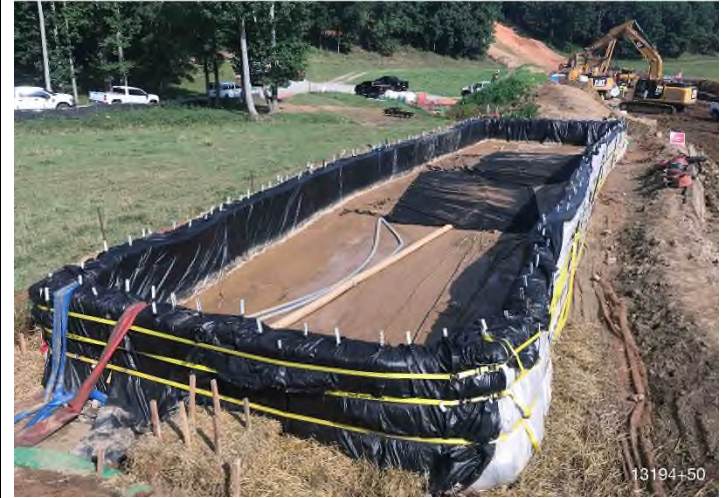
Figure 2: STA 13194+50 – Dewatering structure #1 on west side of the ROW. Pump hoses discharging into sediment bag inside of secondary dewatering structure.

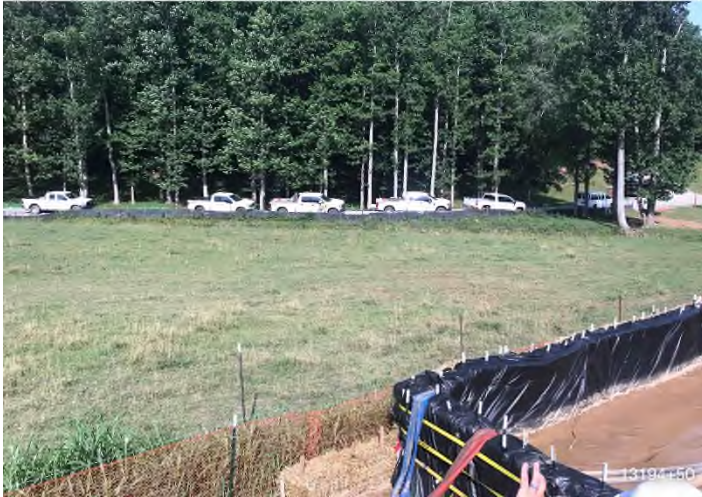
Figure 3: STA 13194+50 – Dewatering structure #1 on west side of the ROW. Discharging onto well vegetated area. No sediment off ROW.

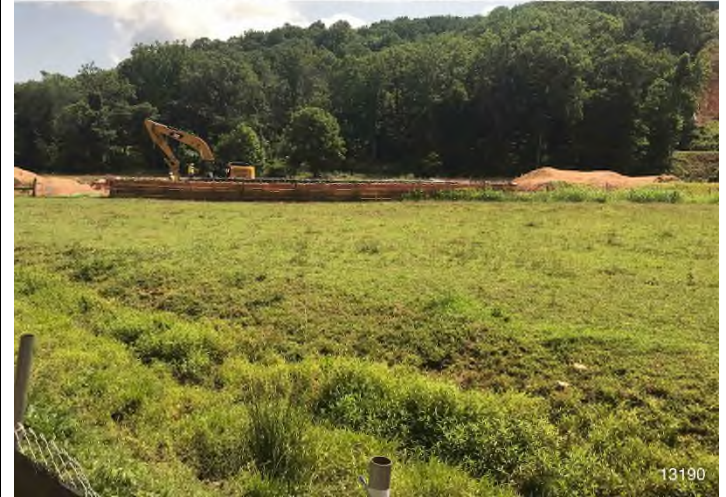
Figure 4: STA 13194+50 – Dewatering structure #1 on west side of the ROW. Discharging onto well vegetated area. No sediment off ROW.

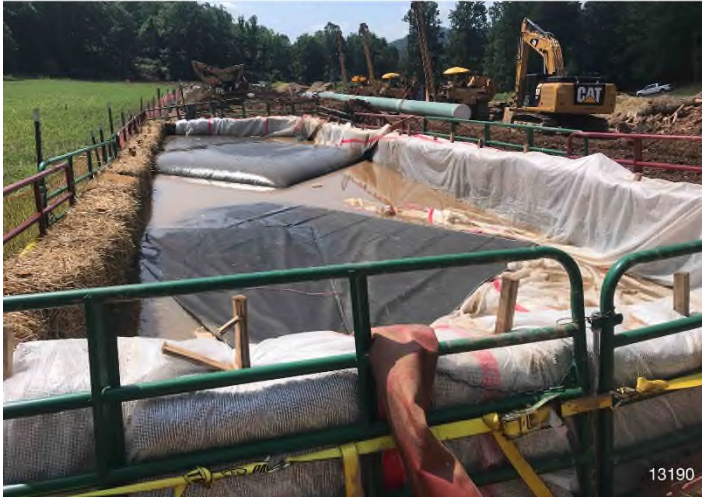
Figure 5: STA 13190+00 – Dewatering structure #2 on east side of the ROW. Pump hoses discharging into sediment bag inside of secondary dewatering structure.

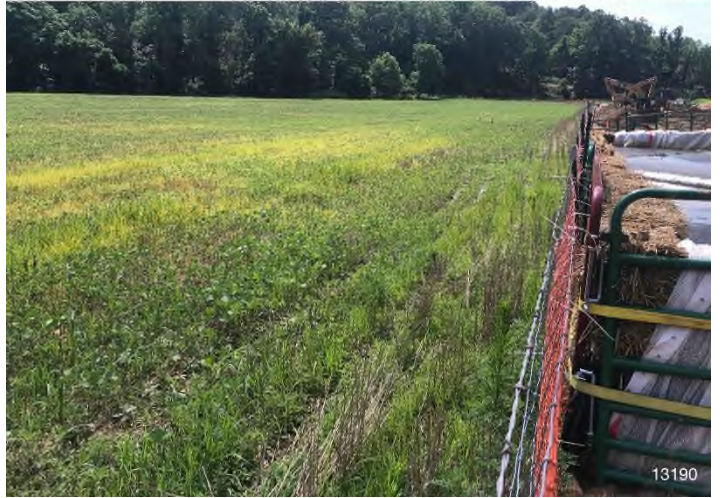
Figure 6: STA 13190+00 – Dewatering structure #2 on east side of the ROW. Discharging onto well vegetated area. No sediment off ROW.
