FIELD INSPECTION REPORT

Project Name:	Mountain Valley Pipeline	Inspector:	Marshall Willis
Inspection Date:	Tuesday, July 13, 2021	Project Contact:	Brian Clauto, Cory Chalmers
Spread G: Giles County	STA 10656+00 – 10670+00 STA 10759+00 – 10798+83 MVP-GI-240	Weather:	Wet

FIELD INSPECTION PHOTO LOG

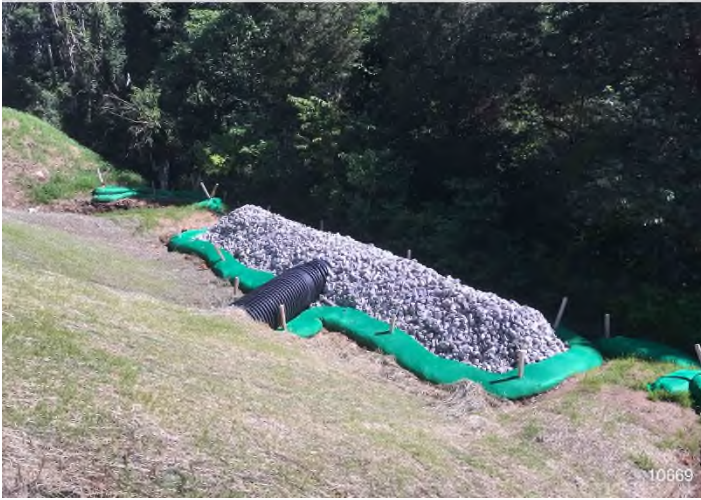
Figure 1: STA 10669+00 – Controls in place and functioning properly.

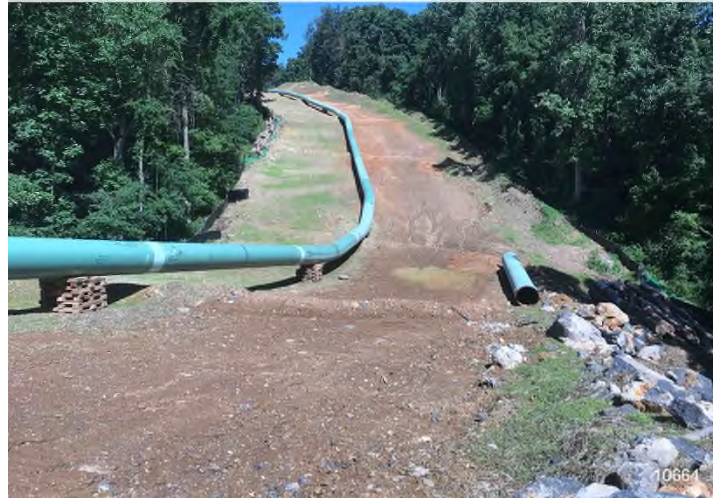
Figure 2: STA 10664+00 – Controls in place and functioning properly.

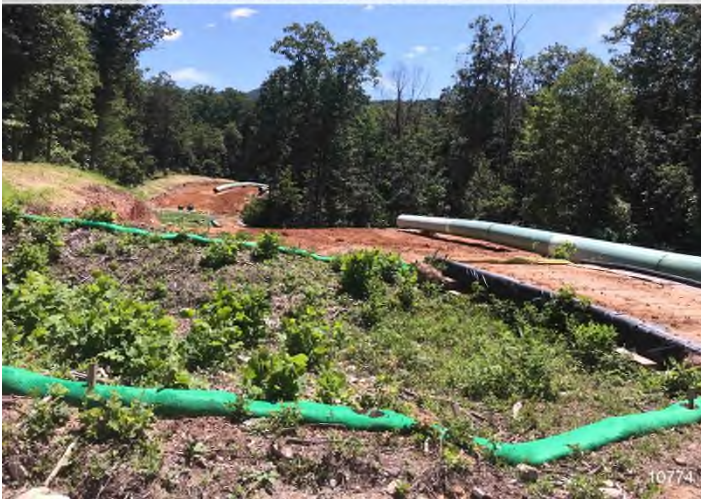
Figure 3: STA 10774+00 – Controls in place and functioning properly.

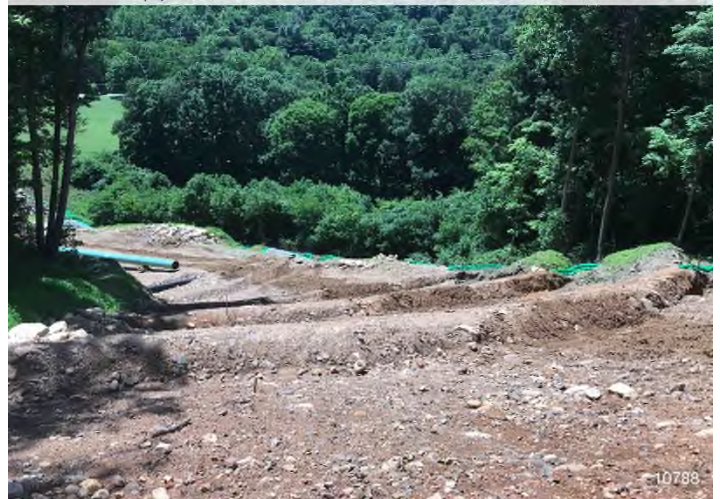
Figure 4: STA 10788+00 – Controls in place and functioning properly.
