FIELD INSPECTION REPORT

Project Name:	Mountain Valley Pipeline	Inspector:	Matthew Grant
Inspection Date:	Tuesday, July 13, 2021	Project Contact:	Brian Clauto
Spread G: Giles	AR GI 240 & 241 ATWS 1335, 816 St 10656+57-10694+99	Weather:	Dry

FIELD INSPECTION PHOTO LOG

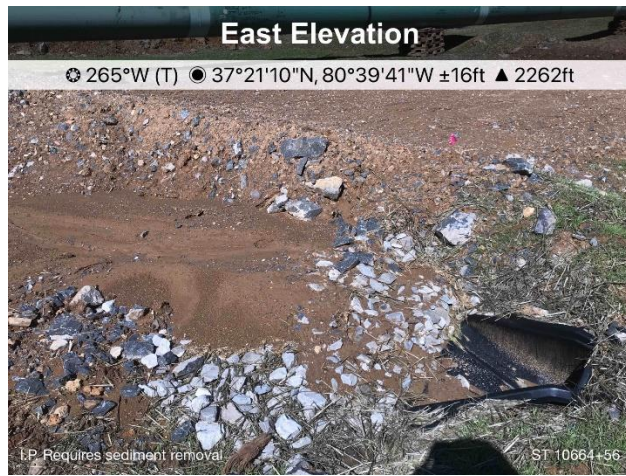
- Figure 1: St10664+56 Inlet protection requires maintenance due to sediment.

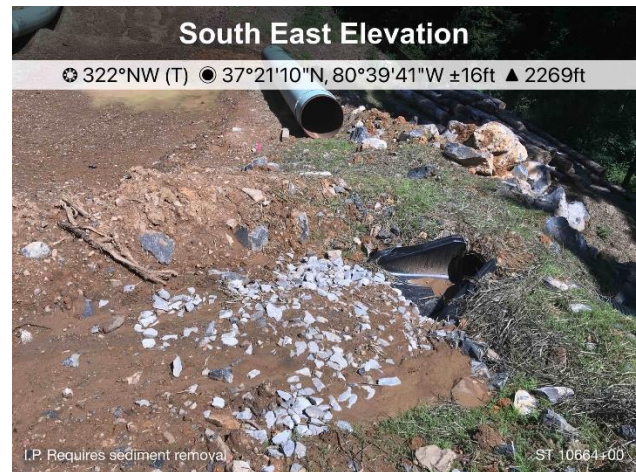
- Figure 2: St10664+00 Inlet protection requires maintenance due to sediment.

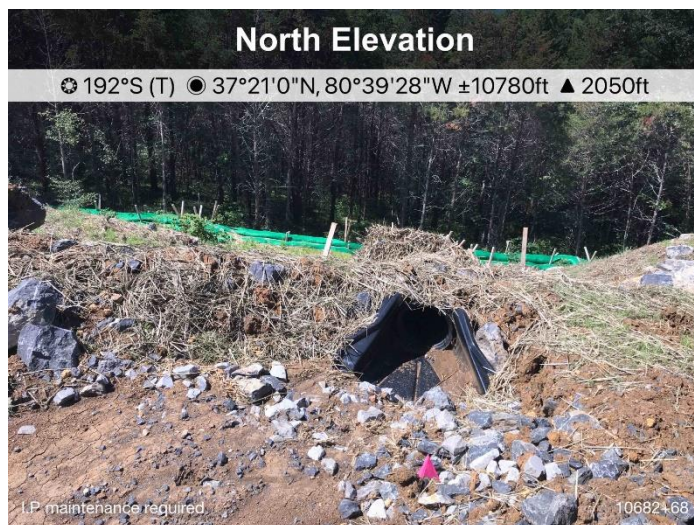
- Figure 3: St10682+68 Inlet protection requires maintenance due to sediment.

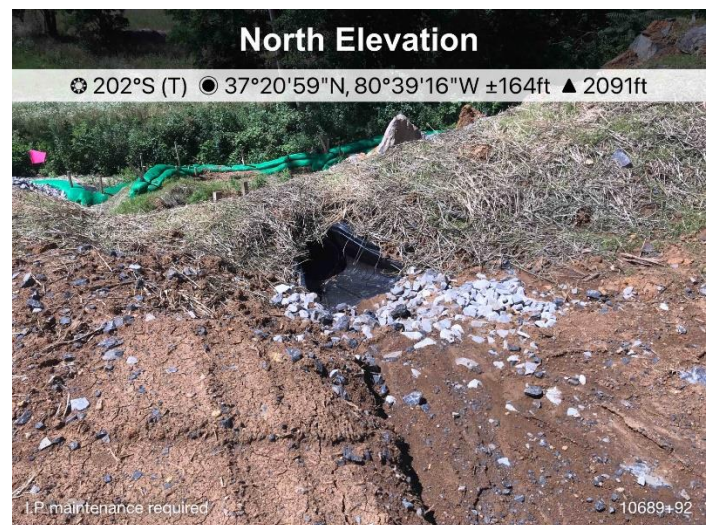
- Figure 4: St10689+92 Inlet protection requires maintenance due to sediment.

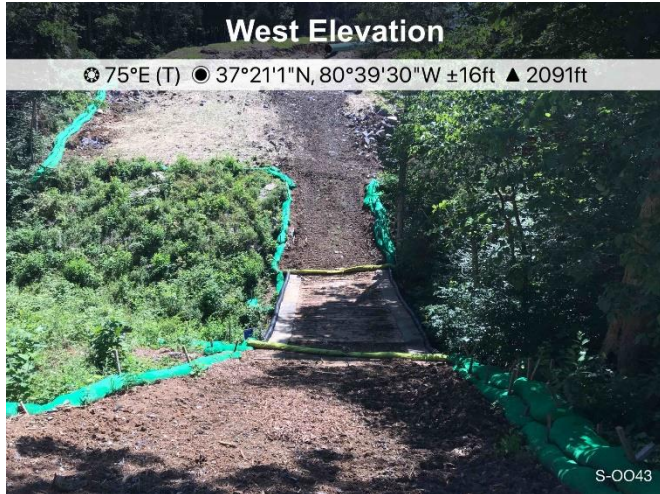
- Comments: Inspected the following resources: S-0043
- ECD's were in place and functioning above the designated crossing.

Figure 5: Designated crossing S-0043, ECD's are in place.

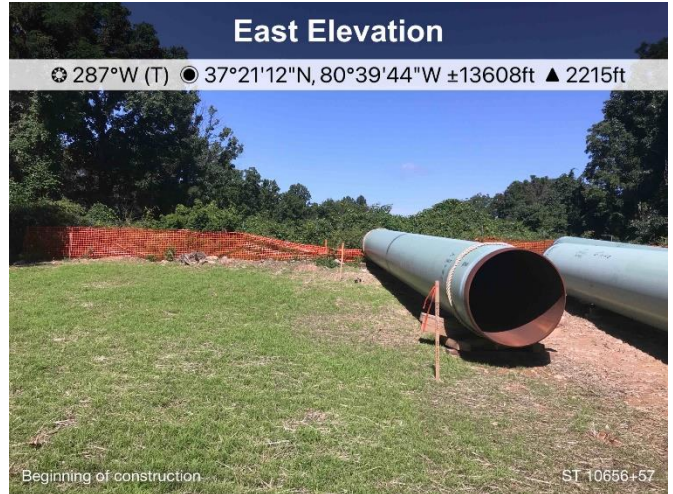
Figure 6 St10656+75 area is temporarily stabilized

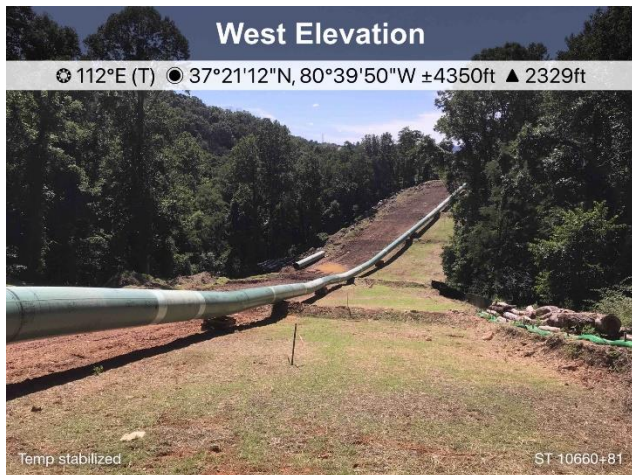
Figure 7: St10660+81 area is temporarily stabilized

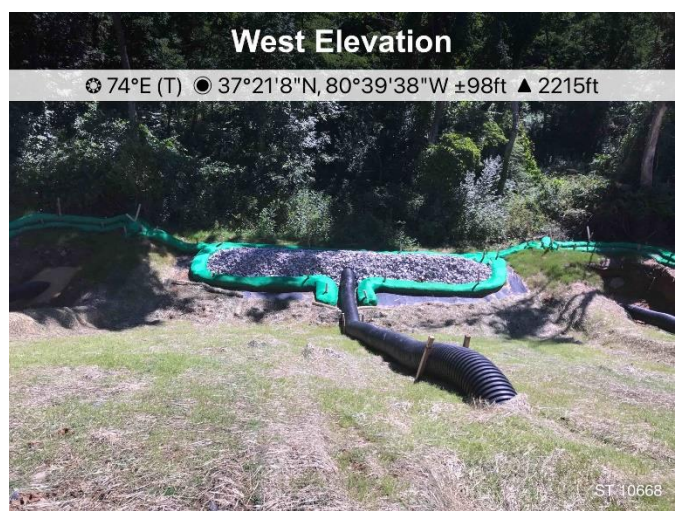
Figure 8: ECD has been installed at St10669
