## FIELD INSPECTION REPORT

<b>Project Name:</b>	Mountain Valley Pipeline	<b>Inspector:</b>	Marshall Willis
<b>Inspection Date:</b>	Monday, July 12, 2021	<b>Project Contact:</b>	Brian Clauto, Cory Chalmers
<b>Spread G: Giles County</b>	STA 10708+10 – 10760+00 MVP-GI-241.01	<b>Weather:</b>	Wet

## FIELD INSPECTION PHOTO LOG

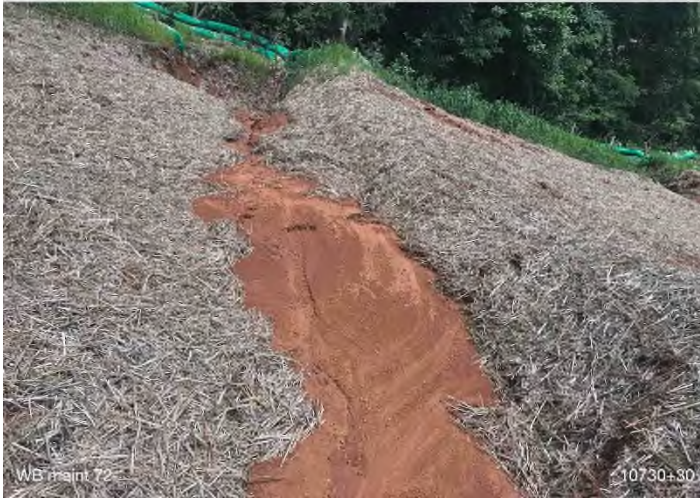
- STA 10730+30: Waterbar maintenance needed. Sediment accumulation in throat.
- STA 10732+00: Inlet protection maintenance needed.
- STA 10739+50 to 10741+00: Inlet protection maintenance needed.

**Figure 1: STA 10730+30** – Waterbar maintenance needed.

**Recommended Corrective Action:** Maintain and install all controls per the approved PSS&S.

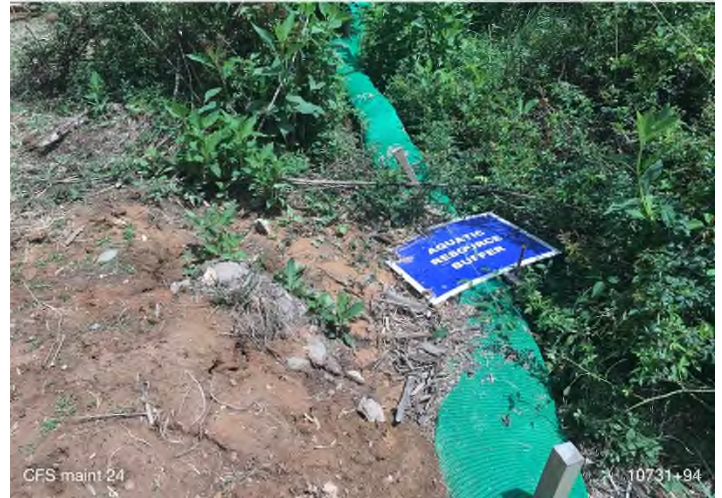
- STA 10731+94: CFS maintenance needed.
- STA 10755+40: Waterbar does not extend full length of ROW.
- STA 10756+00: Waterbar does not extend full length of ROW.

**Figure 2: STA 10731+94** – CFS maintenance needed.

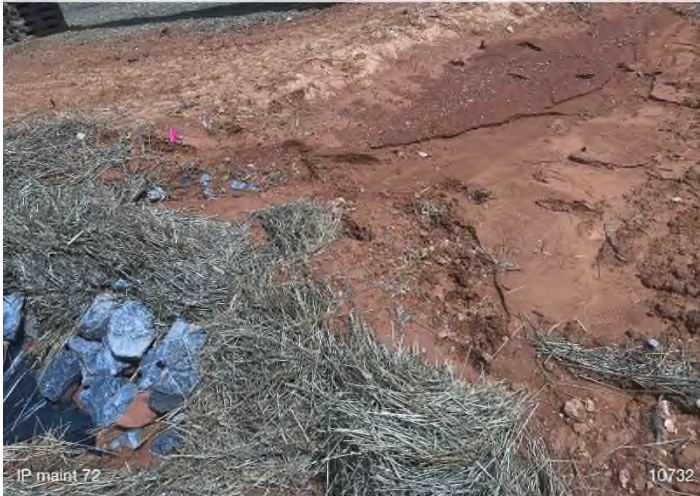
**Figure 3: STA 10732+00** – Inlet protection maintenance needed.

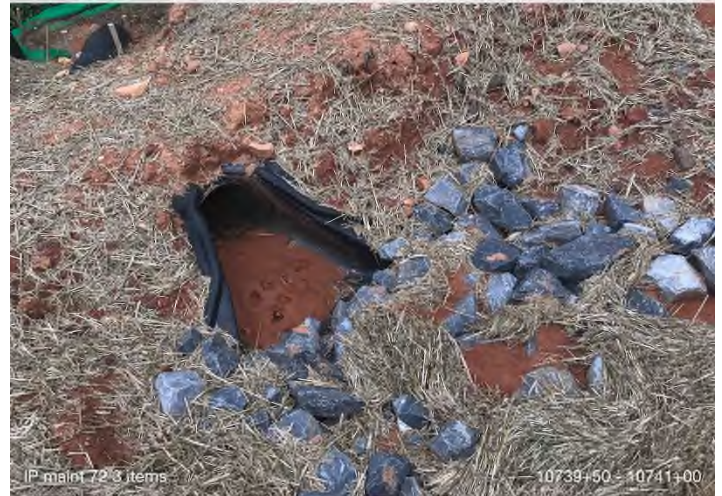
**Figure 4: STA 10739+50 to 10741+00** – Inlet protection maintenance needed.

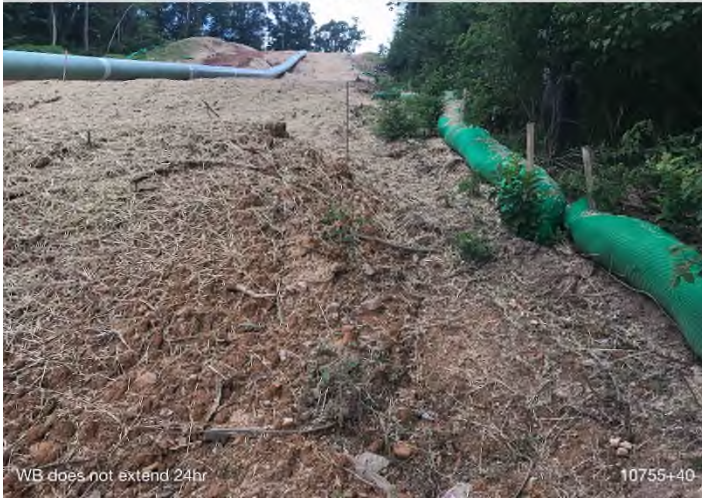
**Figure 7: STA 10755+40** – Waterbar does not extend full length of the ROW.

WB does not extend 24hr

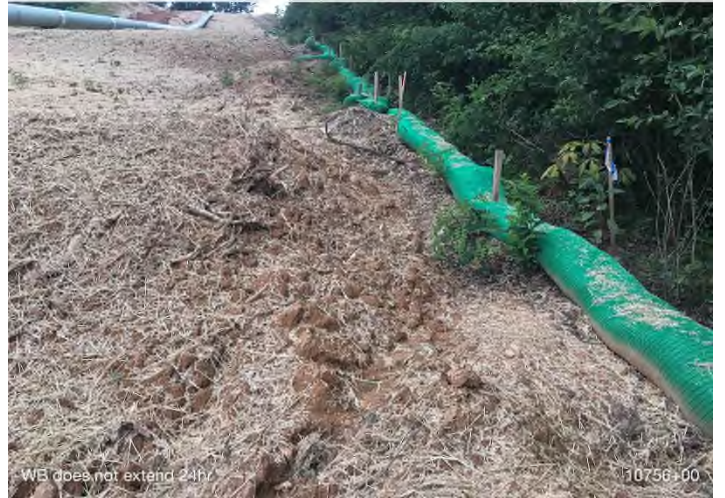
**Figure 6: STA 10756+00** – Waterbar does not extend full length of the ROW.

WB does not extend 24hr
