# FIELD INSPECTION REPORT

<b>Project Name:</b>	Mountain Valley Pipeline	<b>Inspector:</b>	Matthew Grant
<b>Inspection Date:</b>	Monday, July 12, 2021	<b>Project Contact:</b>	Brian Clauto
<b>Spread G: Giles</b>	AR GI 241.01 ATWS 1390, 1391 St 10709+88-10728+87	<b>Weather:</b>	Dry

# FIELD INSPECTION PHOTO LOG

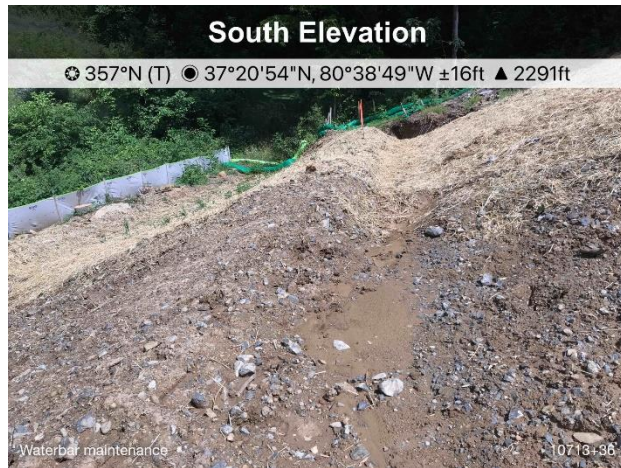
Figure 1: St10713+36 sediment in flow path

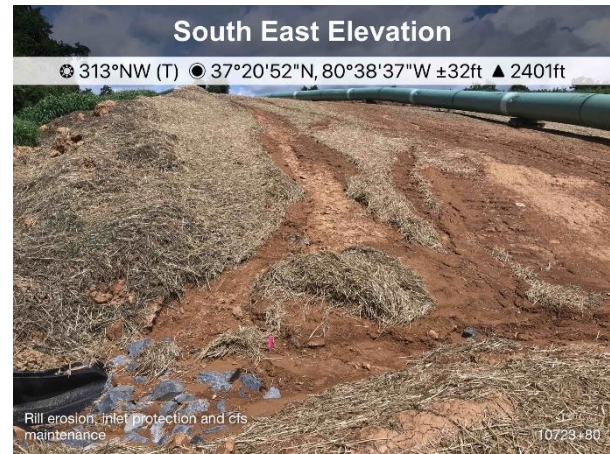
Figure 2: St10723+80 rill erosion and sediment in inlet protection

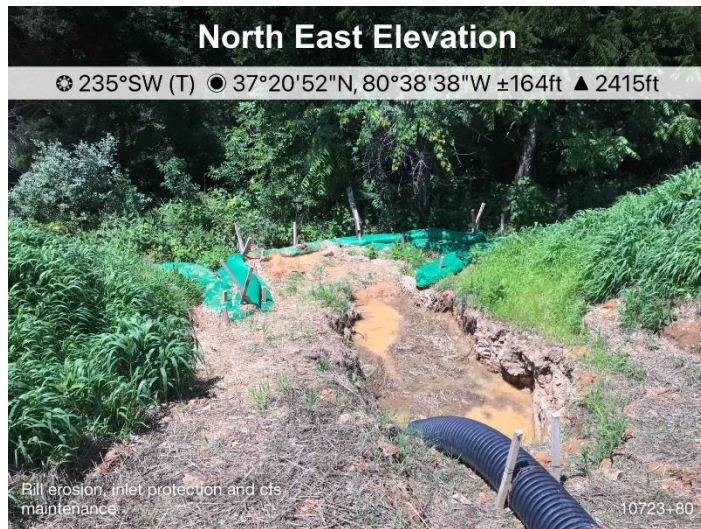
Figure 3: St10723+80 CFS requires sediment removal

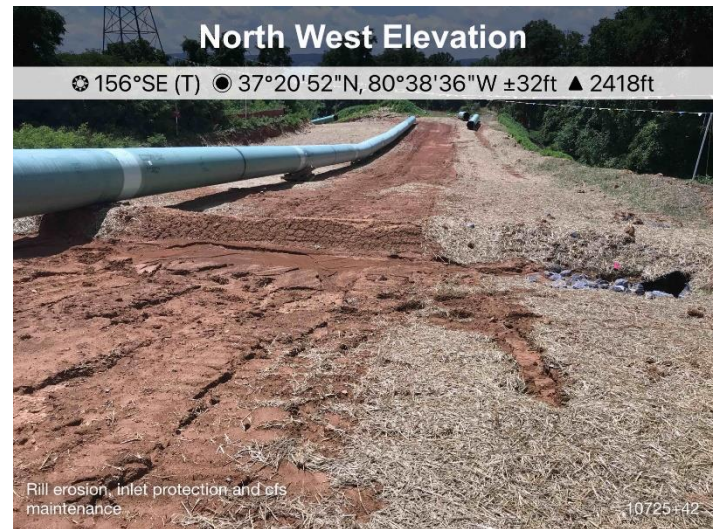
Figure 4: St 10725+42 rill erosion and sediment in inlet protection

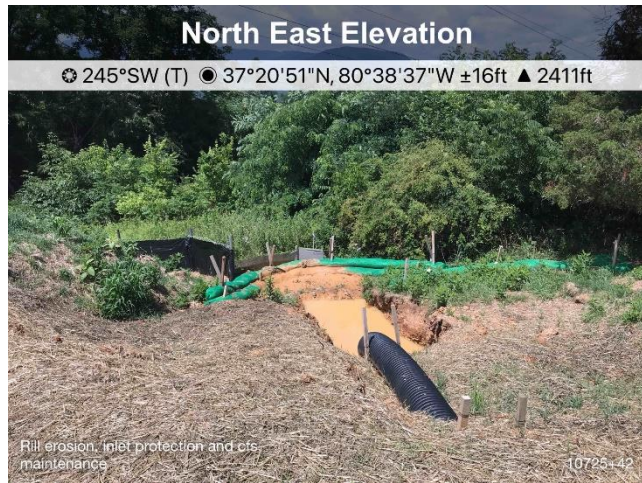
Figure 5: St 10725+42 CFS requires sediment removal

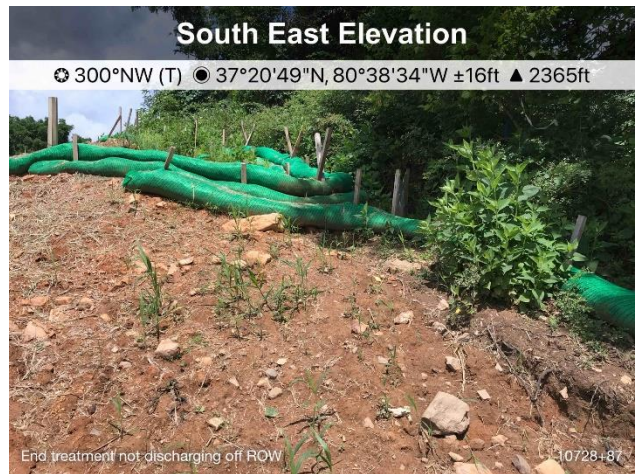
Figure 6: St 10728+87 end treatment is not allowing water off the ROW

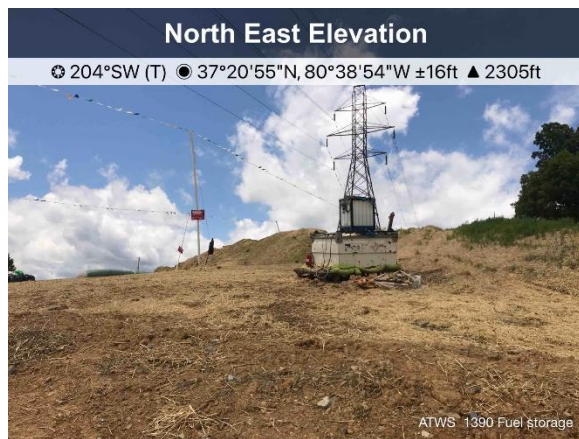
Figure 7: Fuel protected at ATWS 1390

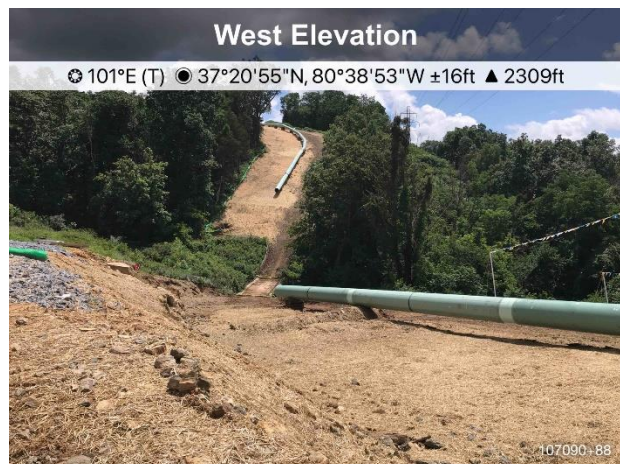
Figure 8: Stabilized area near St10709+88
