## FIELD INSPECTION REPORT

<b>Project Name:</b>	Mountain Valley Pipeline	<b>Inspector:</b>	Marshall Willis
<b>Inspection Date:</b>	Friday, July 9, 2021	<b>Project Contact:</b>	Brian Clauto, Cory Chalmers
<b>Spread G: Montgomery County</b>	STA 11762+50 – 11770+00 STA 12001+72 – 12008+53 MVP-MN-266/266.03/268 MVP-MLV-AR-26	<b>Weather:</b>	Rainy

## FIELD INSPECTION PHOTO LOG

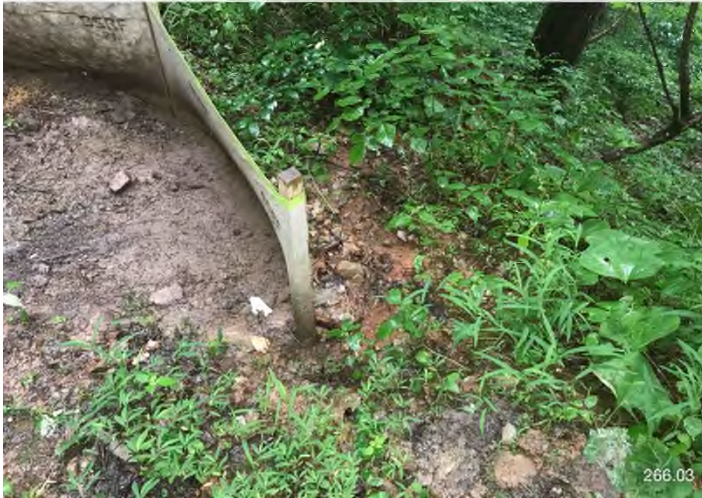
- MVP-MN-266.03: Discharge bypassing P1 and causing minor erosion.

**Figure 1: MVP-MN-266.03** – Discharge bypassing P1 causing minor erosion.

**Recommended Corrective Action:** Maintain and install all controls per the approved PSS&S.

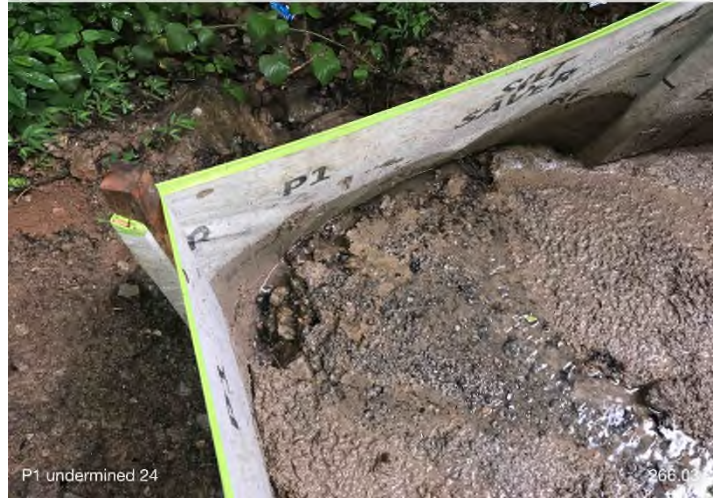
- STA 12004+00: P1 repair needed.
- MVP-MN-266.03: P1 undermined.

**Figure 2: MVP-MN-266.03** – P1 undermined.

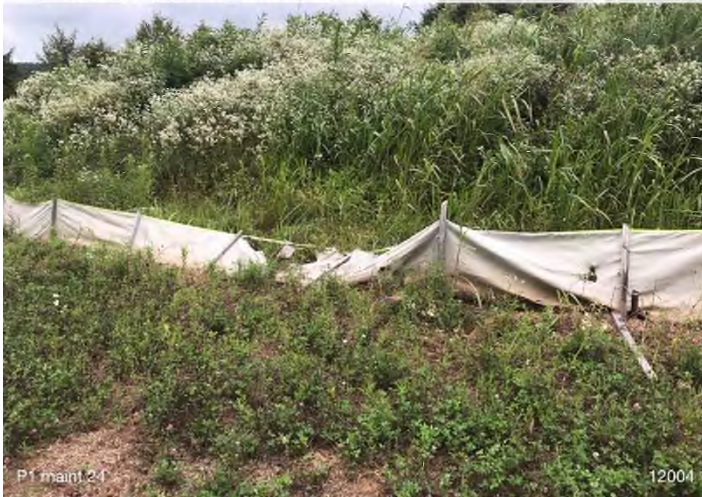
**Figure 3: STA 12004+00** – P1 repair needed.

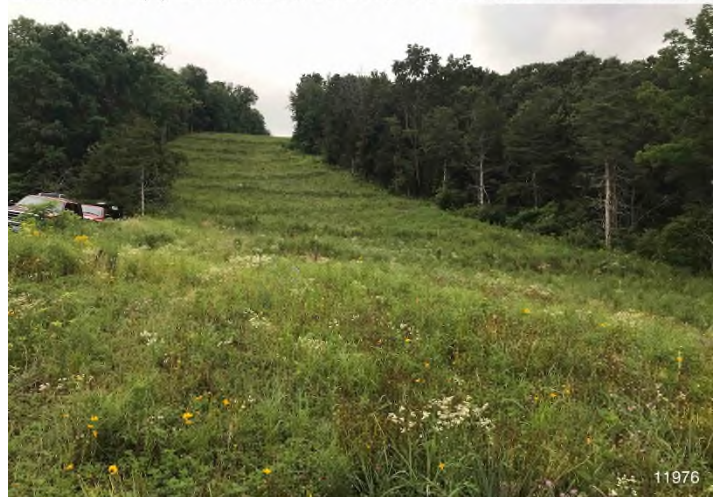
**Figure 4: STA 11976+00** – Controls in place and functioning properly.
