## FIELD INSPECTION REPORT

<b>Project Name:</b>	Mountain Valley Pipeline	<b>Inspector:</b>	Marshall Willis
<b>Inspection Date:</b>	Wednesday, June 30, 2021	<b>Project Contact:</b>	Brian Clauto, Cory Chalmers
<b>Spread G: Craig County Giles County</b>	STA 11540+00 – 11470+00 STA 11327+85 – 11355+00 MVP-GI-256/256.02 MVP-CR-258.02	<b>Weather:</b>	Dry

## FIELD INSPECTION PHOTO LOG

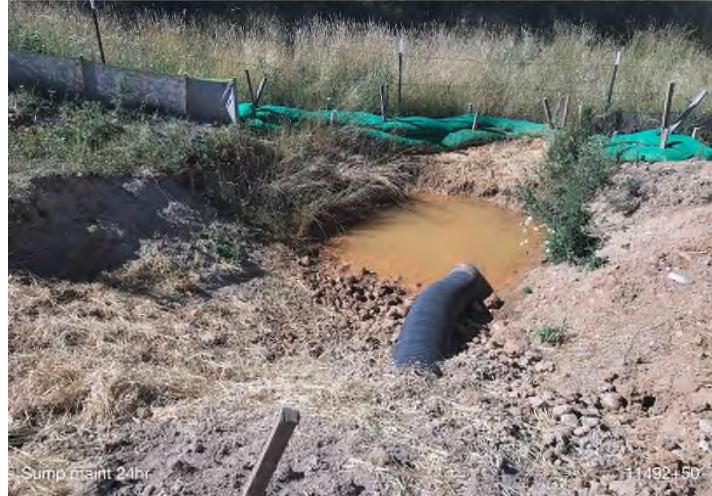
- STA 11492+50: Sump cleanout needed.

**Figure 1: STA 11492+50** – Sump cleanout needed.

**Recommended Corrective Action:** Maintain and install all controls per the approved PSS&S.

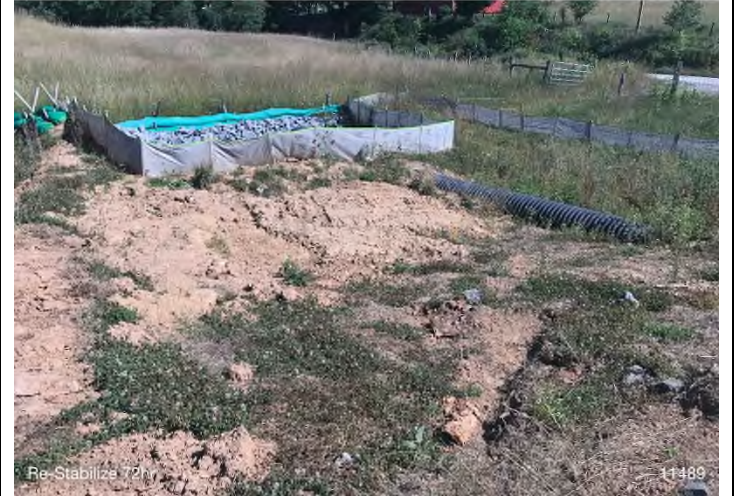
- STA 11489+00: Re-stabilization needed.

**Figure 2: STA 11489+00** – Re-stabilization needed.

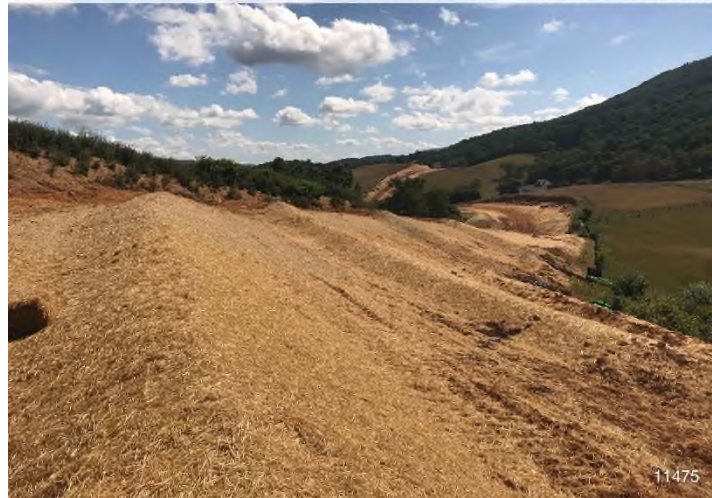
**Figure 3: STA 11475+00** – Controls in place and functioning properly. Area stabilized with straw.

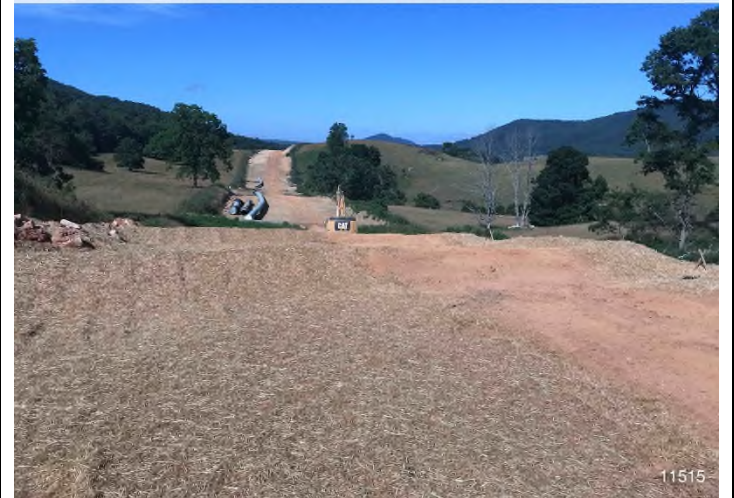
**Figure 4: STA 11515+00** – Controls in place and functioning properly. Area stabilized with straw.
