FIELD INSPECTION REPORT

Project Name:	Mountain Valley Pipeline	Inspector:	Marshall Willis
Inspection Date:	Monday, June 28, 2021	Project Contact:	Brian Clauto, Cory Chalmers
Spread G: Giles County	STA 11084+78 – 11158+12 MVP-GI-245.01 MVP-GI-249	Weather:	Dry

FIELD INSPECTION PHOTO LOG

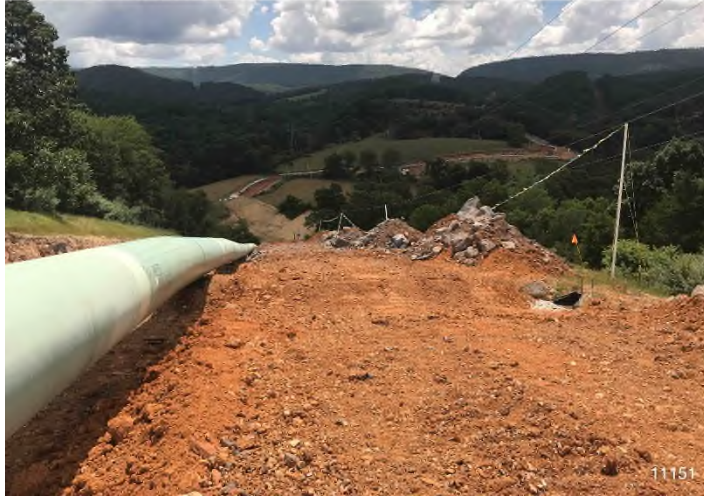
Figure 1: STA 11151+00 – Controls in place and functioning properly.
 BRG: 103°E (T) LAT: 37.312516 LON: -80.518535 ±16ft ALT: 2029ft

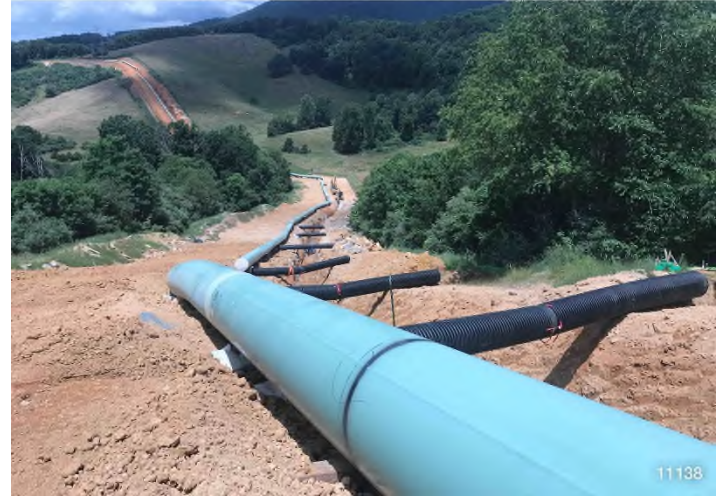
Figure 2: STA 11138+00 – Controls in place and functioning properly.
 BRG: 285°W (T) LAT: 37.312907 LON: -80.518180 ±15492ft ALT: 2143ft

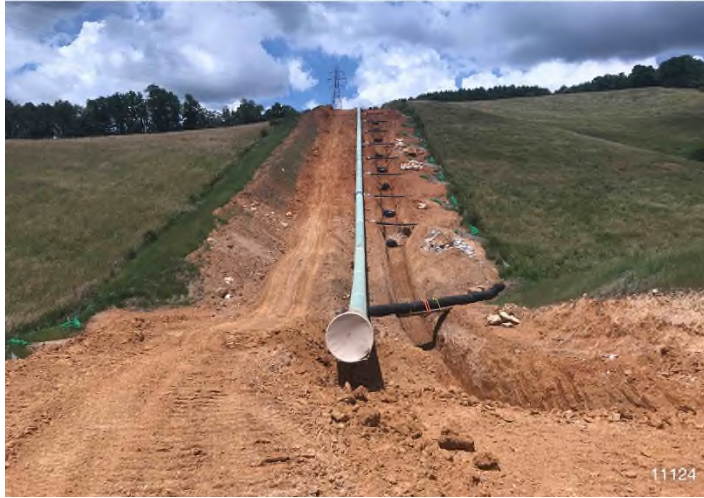
Figure 3: STA 11124+00 – Controls in place and functioning properly.
 BRG: 279°W (T) LAT: 37.315474 LON: -80.526587 ±16ft ALT: 1946ft

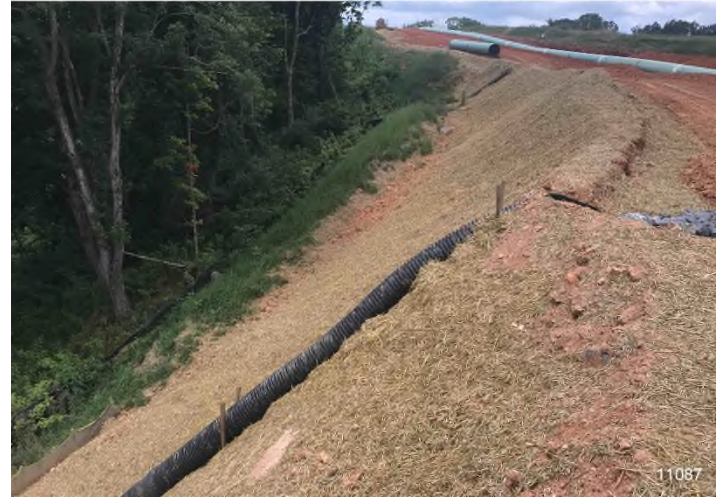
Figure 4: STA 11087+00 – Controls in place and functioning properly.
 BRG: 263°W (T) LAT: 37.315434 LON: -80.538351 ±16ft ALT: 2171ft
