FIELD INSPECTION REPORT

Project Name:	Mountain Valley Pipeline	Inspector:	Marshall Willis
Inspection Date:	Tuesday, August 24, 2021	Project Contact:	Brian Clauto, Cory Chalmers
Spread G: Giles County	STA 10695+00 – 10710+00 STA 10820+00 – 10802+66 MVP-GI-241.01/.02/.03	Weather:	Dry

FIELD INSPECTION PHOTO LOG

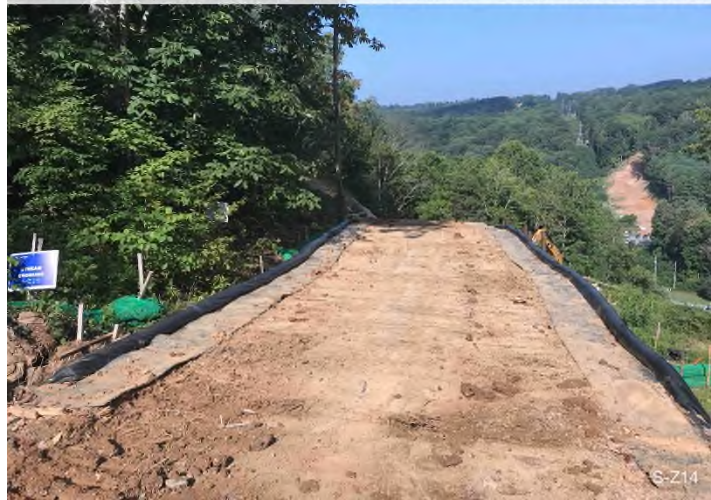
Figure 1: Stream S-Z14 – Controls in place and functioning properly.
 BRG: 281°W (T) LAT: 37.336314 LON: -80.677131 ±25695ft ALT: 2361ft

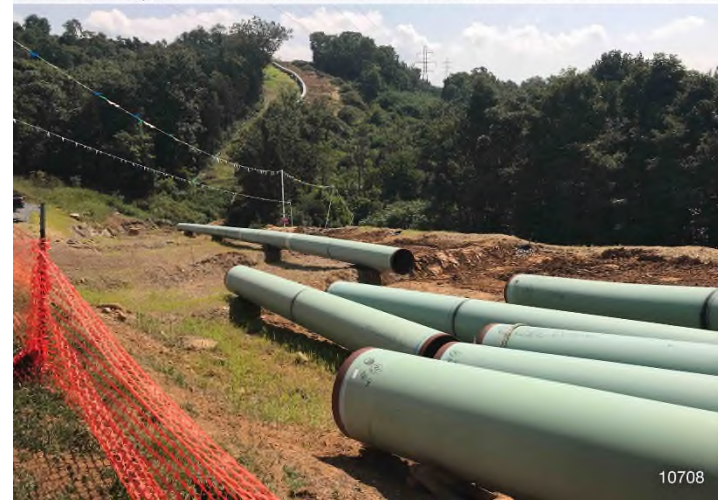
Figure 2: STA 10708+00 – Controls in place and functioning properly.
 BRG: 94°E (T) LAT: 37.348477 LON: -80.648721 ±32ft ALT: 2207ft

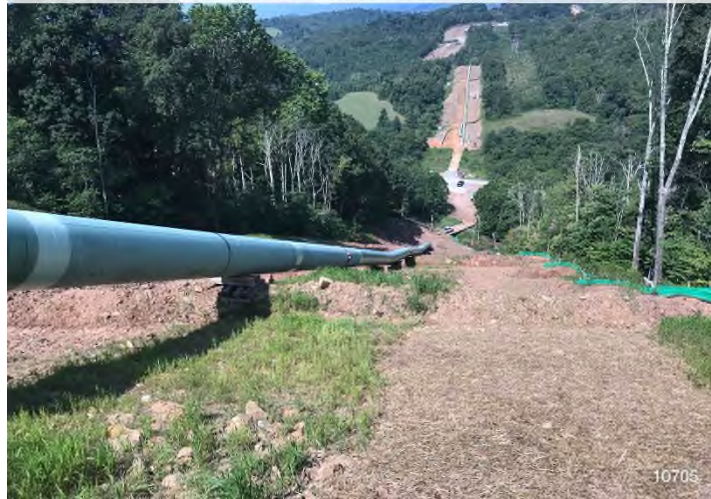
Figure 3: STA 10705+00 – Controls in place and functioning properly.
 BRG: 270°W (T) LAT: 37.339618 LON: -80.660111 ±19573ft ALT: 2332ft

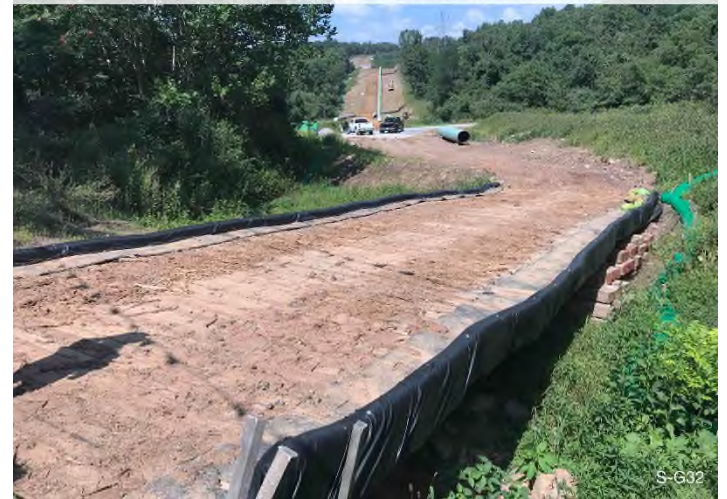
Figure 4: Stream S-G32 – Controls in place and functioning properly.
 BRG: 298°NW (T) LAT: 37.344473 LON: -80.663359 ±7417ft ALT: 2129ft
