Project Name:	Mountain Valley Pipeline	Inspector:	Matthew Grant		
Inspection Date:	Tuesday, August 24, 2021	Project Contact:	Brian Clauto		
Spread G: Giles	St 10819- 10804 ATWS 464 AR 241.03, 241.02	Weather:	Dry

FIELD INSPECTION PHOTO LOG

Project Name: Mountain Valley Pipeline

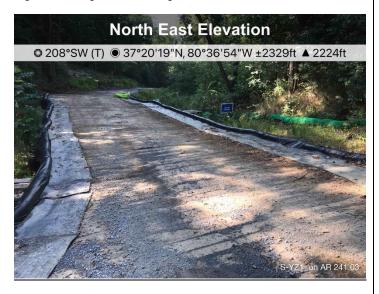
Figure 3: Designated crossing S-YZ1

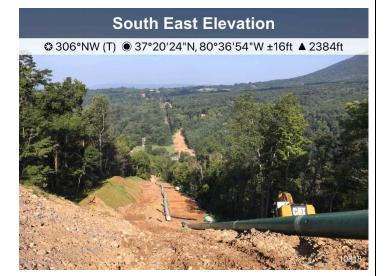
Figure 4: St 10818 ECD ongoing maintenance
