FIELD INSPECTION REPORT

| Project Name: | Mountain Valley Pipeline | Inspector: | Marshall Willis |
| Spread G: Giles County | STA 10859+34 – 10930+00 | Weather: | Dry |

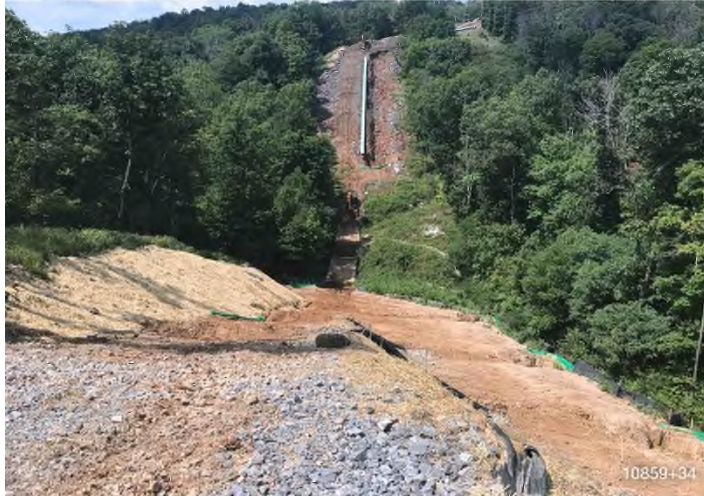
Figure 1: STA 10859+34 – Controls in place and functioning properly.
 BRG: 310°NW (T) LAT: 37.337414 LON: -80.604308 ±16ft ALT: 2326ft

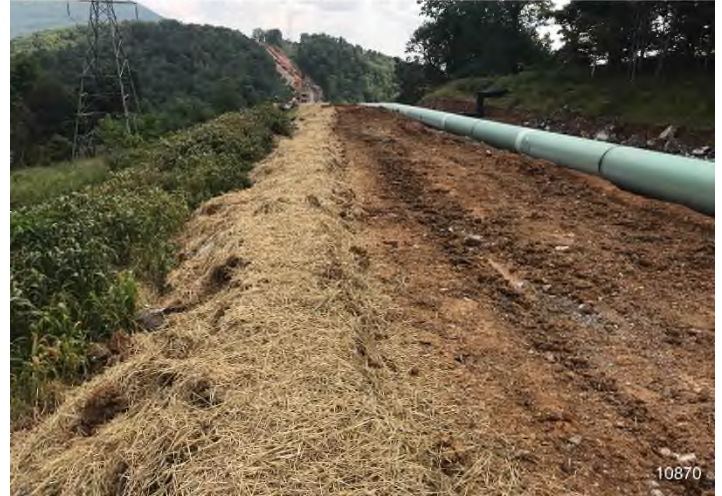
Figure 2: STA 10870+00 – Controls in place and functioning properly.
 BRG: 114°SE (T) LAT: 37.336352 LON: -80.601044 ±32ft ALT: 2448ft

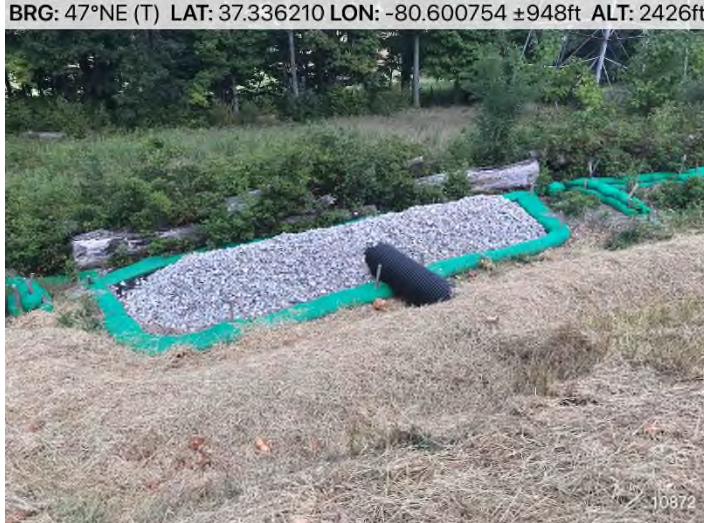
Figure 3: STA 10872+00 – Controls in place and functioning properly.
 BRG: 47°NE (T) LAT: 37.336210 LON: -80.600754 ±948ft ALT: 2426ft

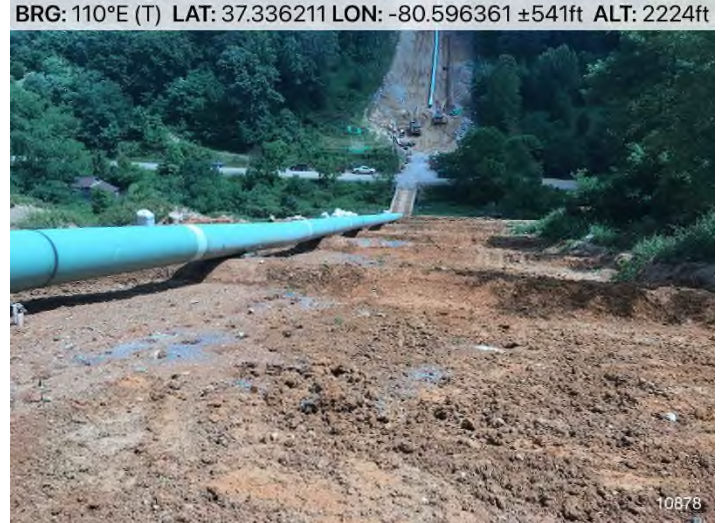
Figure 4: STA 10878+00 – Controls in place and functioning properly.
 BRG: 110°E (T) LAT: 37.336211 LON: -80.596361 ±541ft ALT: 2224ft
