# FIELD INSPECTION REPORT

<b>Project Name:</b>	Mountain Valley Pipeline	<b>Inspector:</b>	Matthew Grant
<b>Inspection Date:</b>	Monday, August 23, 2021	<b>Project Contact:</b>	Brian Clauto
<b>Spread G: Giles</b>	St 10883+60-10930 ATWS 1331, 470, 1333	<b>Weather:</b>	Dry

# FIELD INSPECTION PHOTO LOG

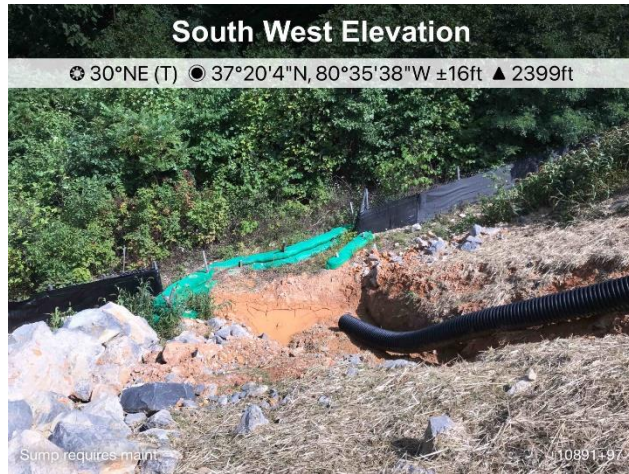
Figure 1: St 10891+97 sump requires maintenance

**Recommended Corrective Action:** Maintain and install all controls per the approved PSS&S.

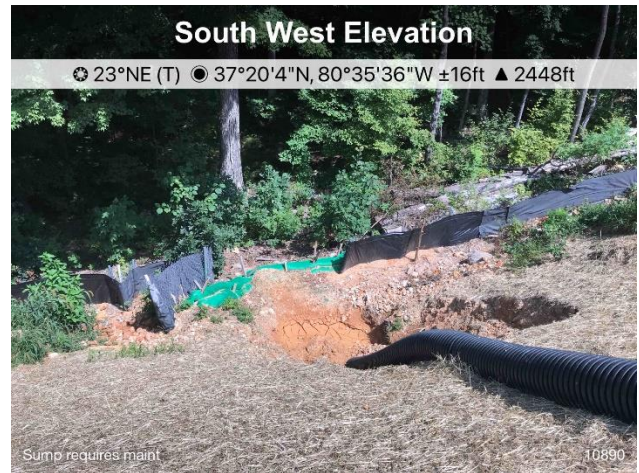
Figure 2: St 10890 sump requires maintenance

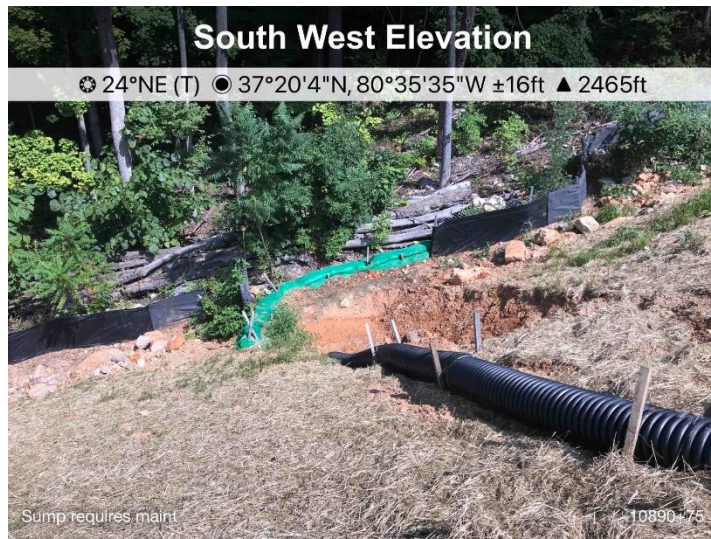
Figure 3: St 10890+75 sump requires maintenance

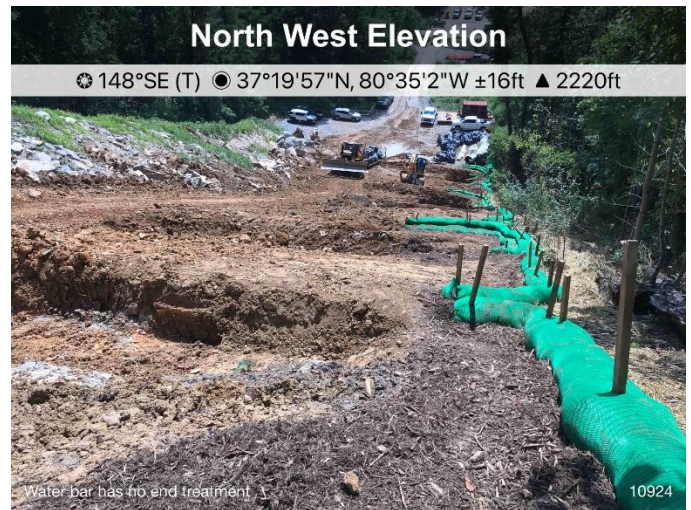
Figure 4: St 10924 waterbar has no end treatment

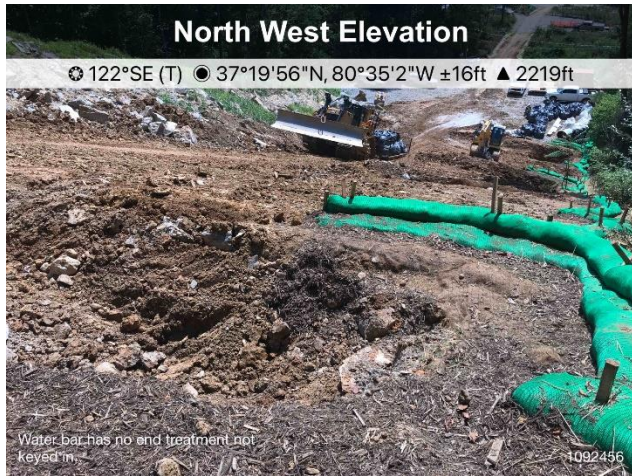
▪ **Figure 5:** St 10924{+56 water bar end treatment not keyed in

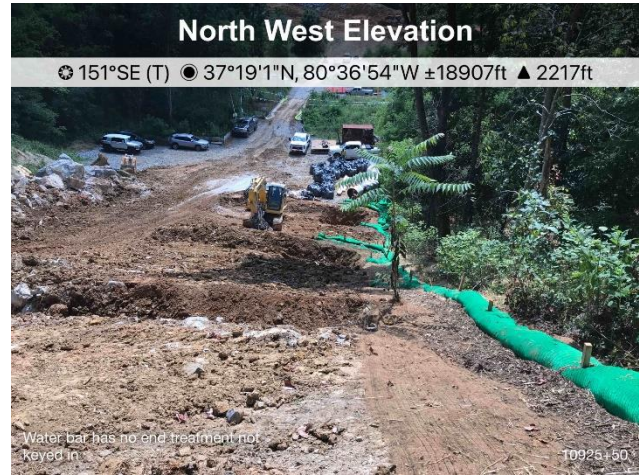
▪ **Figure 6:** St 10925+50 water bar has no end treatment
