FIELD INSPECTION REPORT

Project Name:	Mountain Valley Pipeline	Inspector:	Marshall Willis
Inspection Date:	Monday, August 16, 2021	Project Contact:	Brian Clauto, Cory Chalmers
Spread G: Giles County	STA 11298+08 – 11356+18 MVP-GI-253.02 MVP-GI-256	Weather:	Rainy

FIELD INSPECTION PHOTO LOG

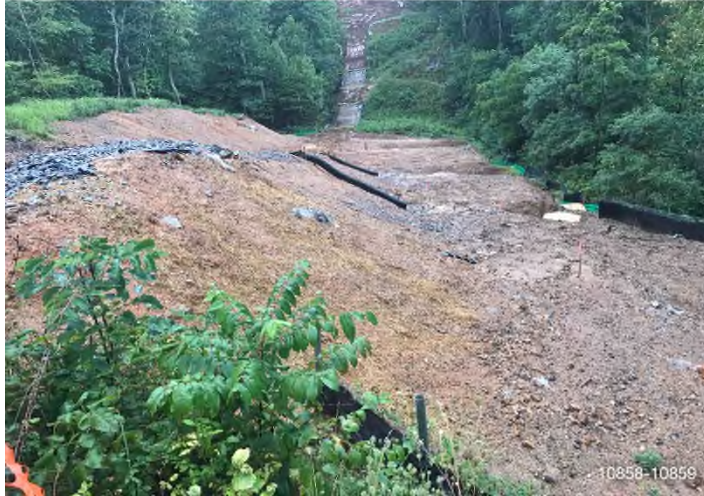
- STA 10858+00 to 10859+00: Stabilize fill slope.
- STA 10857+00 to 10859+00: Stabilize fill slope.

Figure 1: STA 10858+00 to 10859+00 – Stabilize fill slope.

Recommended Corrective Action: Maintain and install all controls per the approved PSS&S.

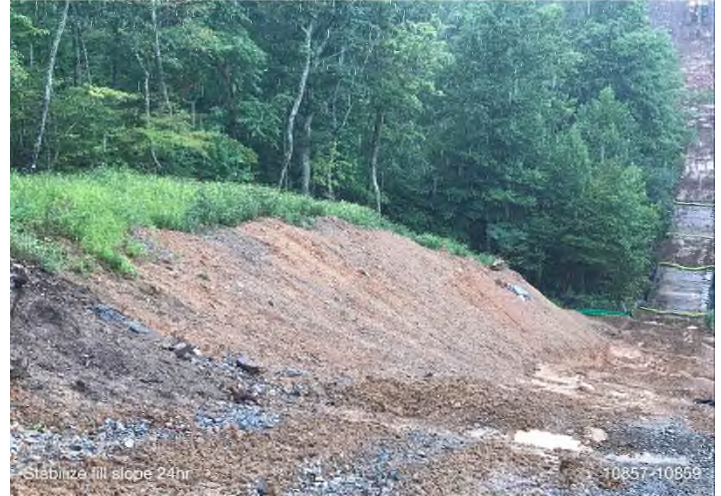
Figure 2: STA 10857+00 to 10859+00 – Stabilize fill slope.

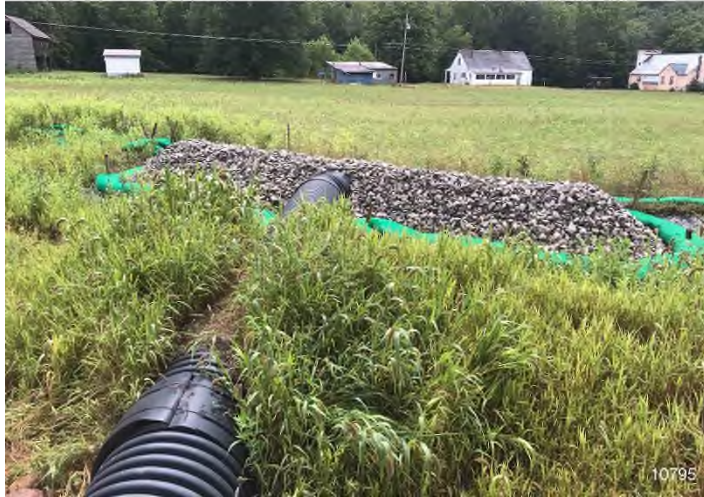
Figure 3: STA 10795+00 – Controls in place and functioning properly.

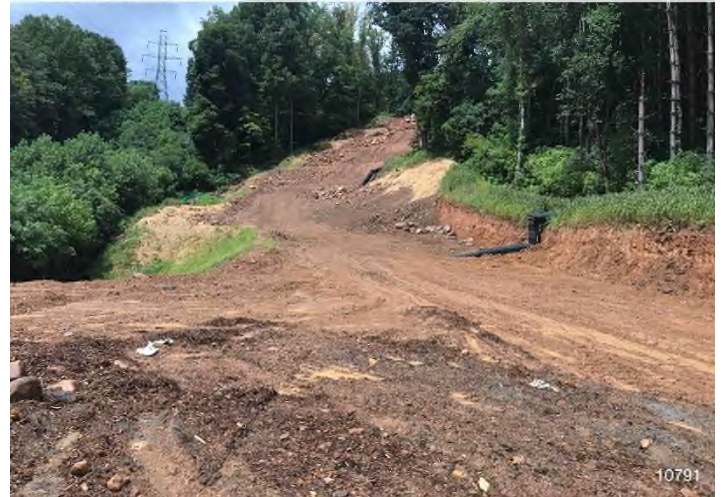
Figure 4: STA 10791+00 – Controls in place and functioning properly.
