## FIELD INSPECTION REPORT

<b>Project Name:</b>	Mountain Valley Pipeline	<b>Inspector:</b>	Marshall Willis
<b>Inspection Date:</b>	Friday, September 10, 2021	<b>Project Contact:</b>	Brian Clauto, Cory Chalmers
<b>Spread G: Craig County Montgomery County</b>	STA 11596+00 – 11619+00 STA 11978+54 – 11988+96 MVP-MN-258.04 MVP-MN-266	<b>Weather:</b>	Dry

## FIELD INSPECTION PHOTO LOG

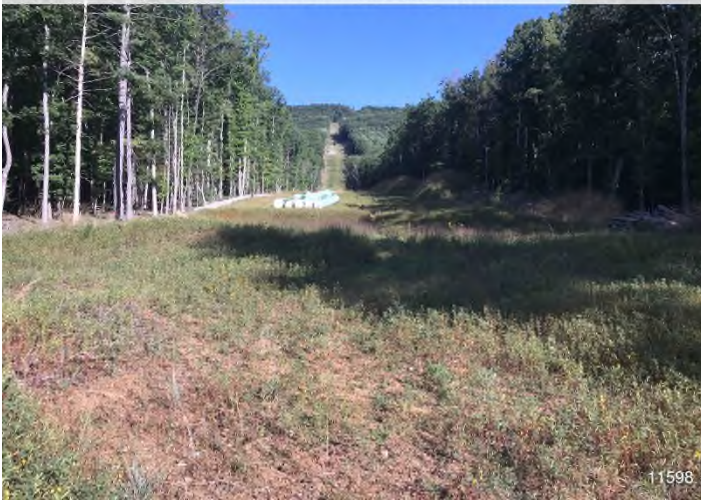
**Figure 1: STA 11598+00** – Controls in place and functioning properly.

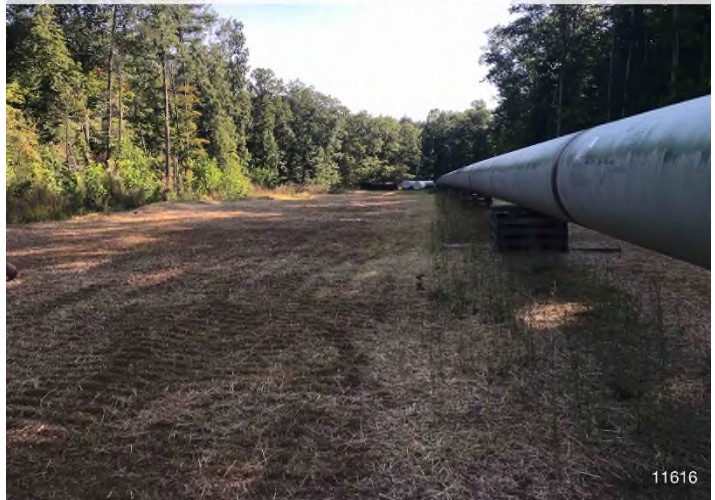
**Figure 2: STA 11616+00** – Controls in place and functioning properly. Area stabilized with straw.

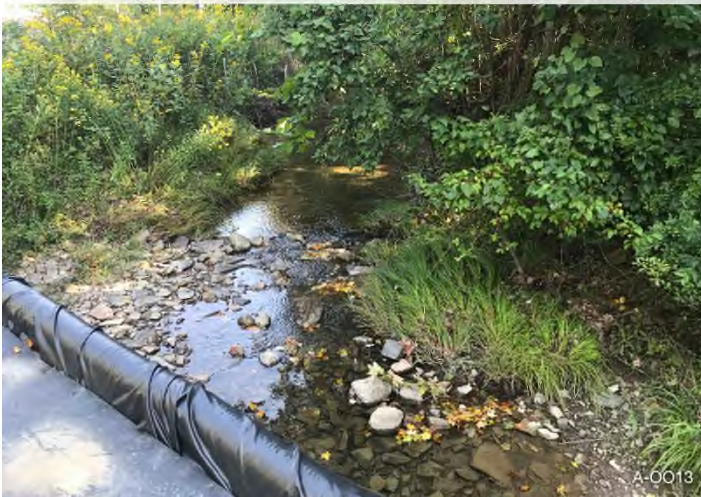
**Figure 3: Stream S-RR13** – Controls in place and functioning properly along Craig Creek.

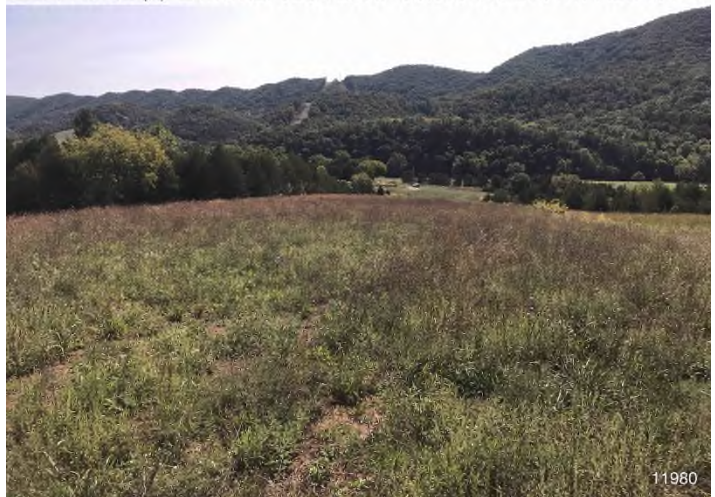
**Figure 4: STA 11960+00** – Controls in place and functioning properly.
