FIELD INSPECTION REPORT

Project Name:	Mountain Valley Pipeline	Inspector:	Marshall Willis
Inspection Date:	Wednesday, September 8, 2021	Project Contact:	Brian Clauto, Cory Chalmers
Spread G: Giles County Craig County	STA 11353+21 – 11526+00 MVP-CR-258.02 MVP-GI-256.02	Weather:	Dry

FIELD INSPECTION PHOTO LOG

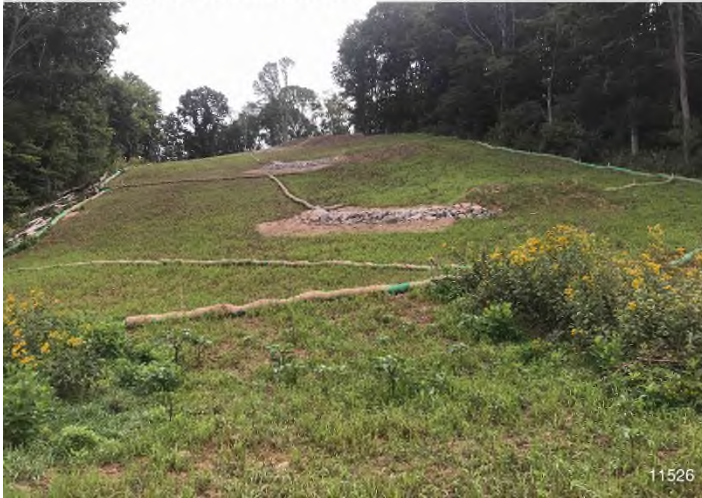
11526

Figure 1: STA 11526+00 – Controls in place and functioning properly.

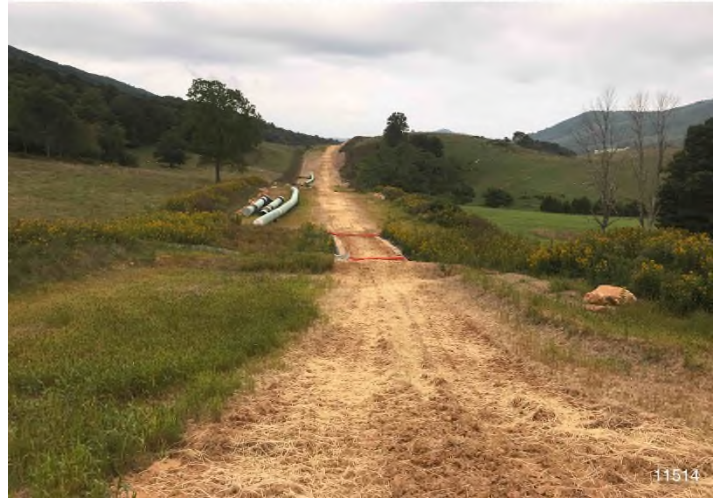
11514

Figure 2: STA 11514+00 – Controls in place and functioning properly.

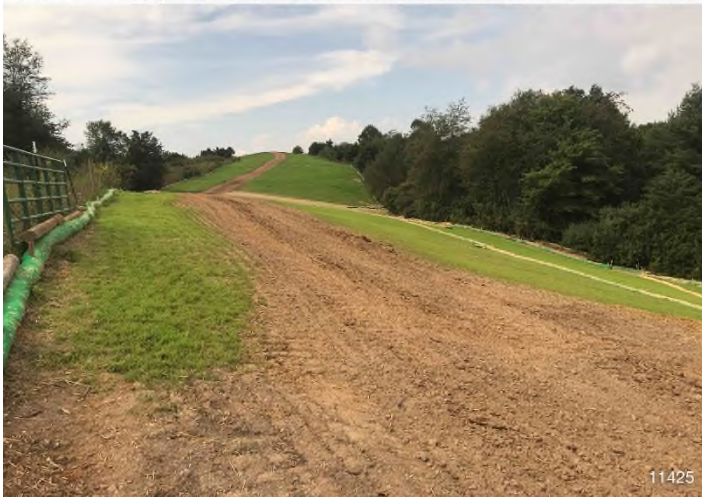
11425

Figure 3: STA 11425+00 – Controls in place and functioning properly.

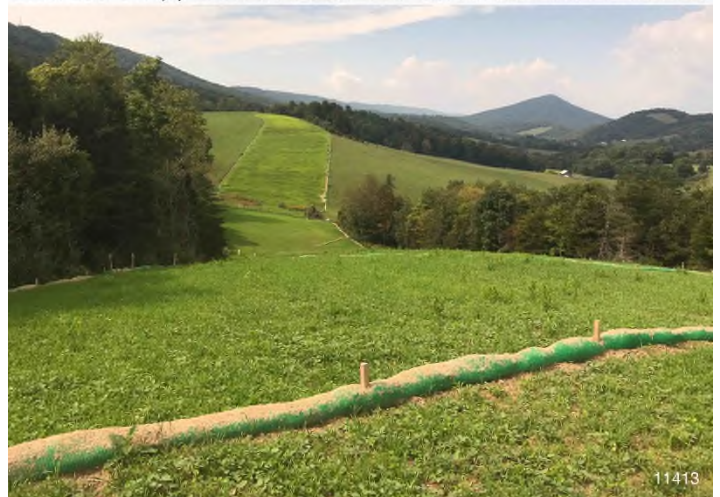
11413

Figure 4: STA 11413+00 – Controls in place and functioning properly.
