FIELD INSPECTION REPORT

Project Name:	Mountain Valley Pipeline	Inspector:	Matthew Grant
Inspection Date:	Wednesday, September 8, 2021	Project Contact:	Brian Clauto
Spread G: Craig	St 11353-11471	Weather:	Dry

FIELD INSPECTION PHOTO LOG

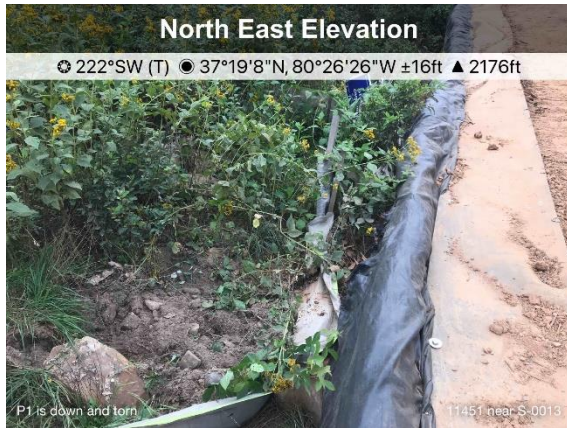
- St 11451 P1 is down and torn
- St 11444- 11445 areas of rill erosion and lacks stabilization

Figure 1: P1 is down and torn at near St 11451.

Recommended Corrective Action: Maintain and install all controls per the approved PSS&S.

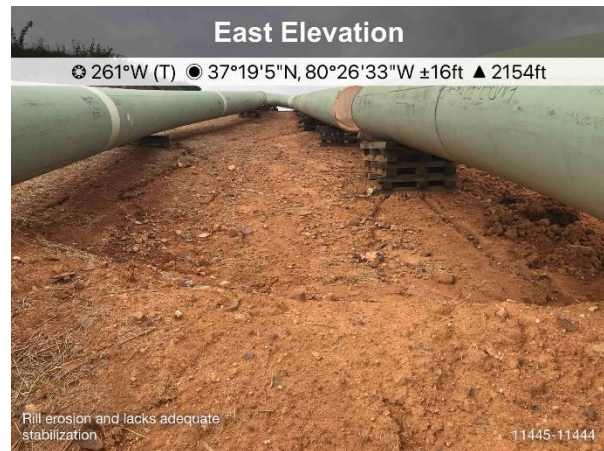
Figure 2: St 11444-11445 lacks stabilization and rill erosion has occurred.

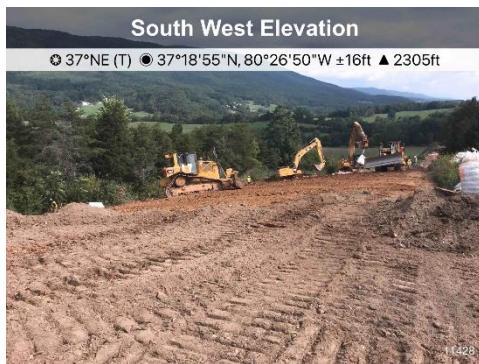
Figure 3: St 11428 on going grading activities and permanent stabilization.

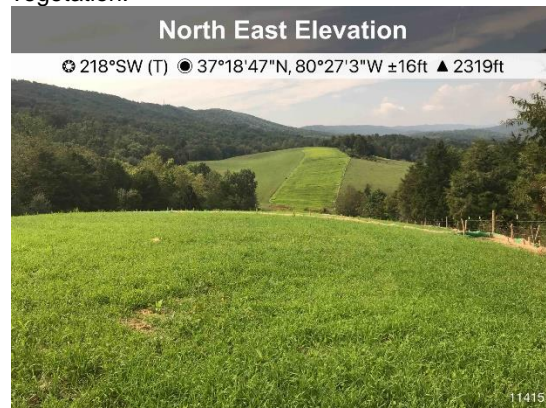
Figure 4: St 11415 area has been stabilized with permanent vegetation.
