FIELD INSPECTION REPORT

Project Name:	Mountain Valley Pipeline	Inspector:	Marshall Willis
Inspection Date:	Thursday, September 2, 2021	Project Contact:	Brian Clauto, Cory Chalmers
Spread G: Giles County	STA 10819+00 – 10859+24 MVP-GI-241.03	Weather:	Wet

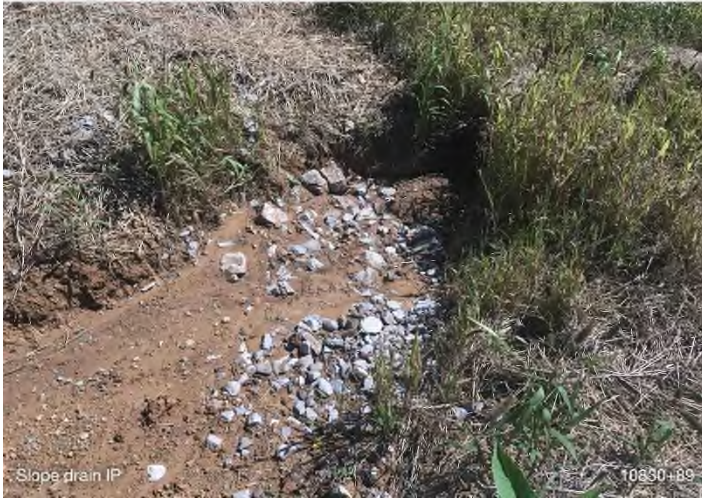
- STA 10830+89: Slope drain inlet protection maintenance needed.
- STA 10831+29: Slope drain inlet protection maintenance needed.

Figure 1: STA 10830+89 – Inlet protection maintenance needed.

Recommended Corrective Action: Maintain and install all controls per the approved PSS&S.

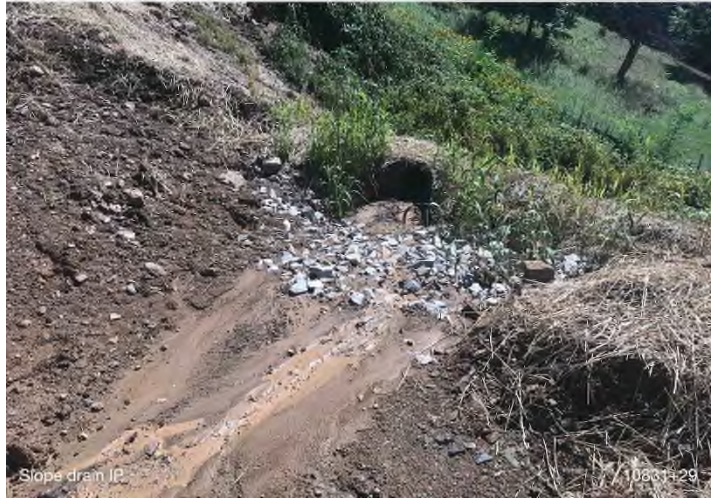
Figure 2: STA 10831+29 – Inlet protection maintenance needed.

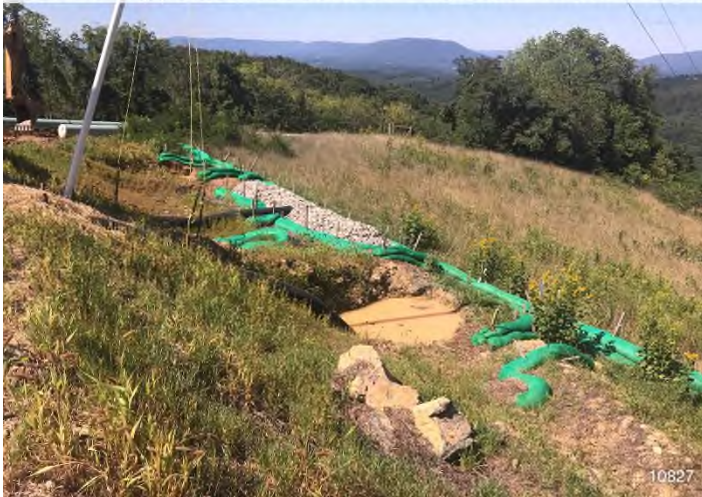
Figure 3: STA 10827+00 – Controls in place and functioning properly.

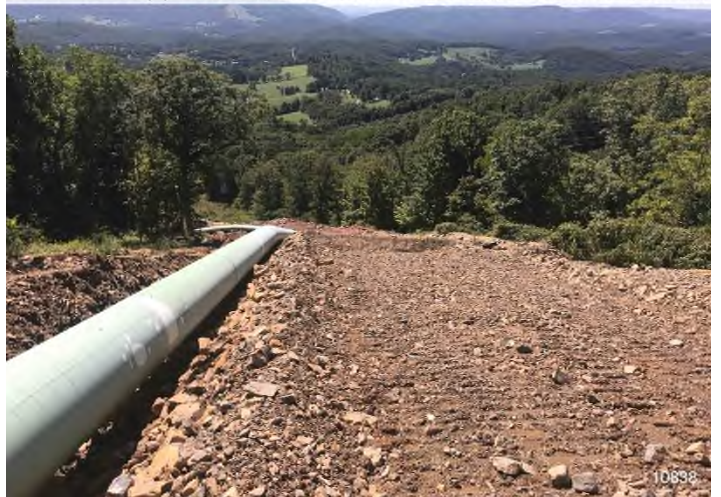
Figure 4: STA 10838+00 – Controls in place and functioning properly.
