Project Name:	Mountain Valley Pipeline	Inspector:	Matthew Grant		
Inspection Date:	Monday, October 18, 2021	Project Contact:	Brian Clauto		
Spread G: Giles	AR 251.01 10859-10930 11230-11255 ATWS1360, 1332, 1347, 1331, 471	Weather:	Dry

FIELD INSPECTION PHOTO LOG

Project Name: Mountain Valley Pipeline

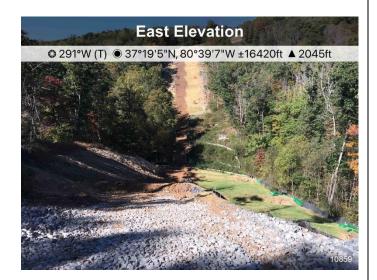
Figure 1: St 10859 ECD's are in place and area has been stabilized.

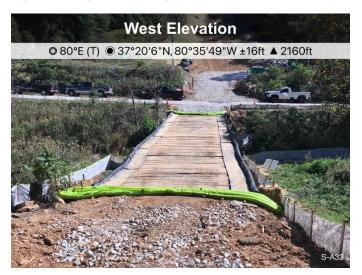
Figure 2: Designated crossing S-A32, ECD's are in place.
