## FIELD INSPECTION REPORT

<b>Project Name:</b>	Mountain Valley Pipeline	<b>Inspector:</b>	Marshall Willis
<b>Inspection Date:</b>	Wednesday, October 13, 2021	<b>Project Contact:</b>	Brian Clauto, Cory Chalmers
<b>Spread G: Montgomery County</b>	STA 11669+00 – 11768+00 MVP-MLV-AR-26	<b>Weather:</b>	Wet

## FIELD INSPECTION PHOTO LOG

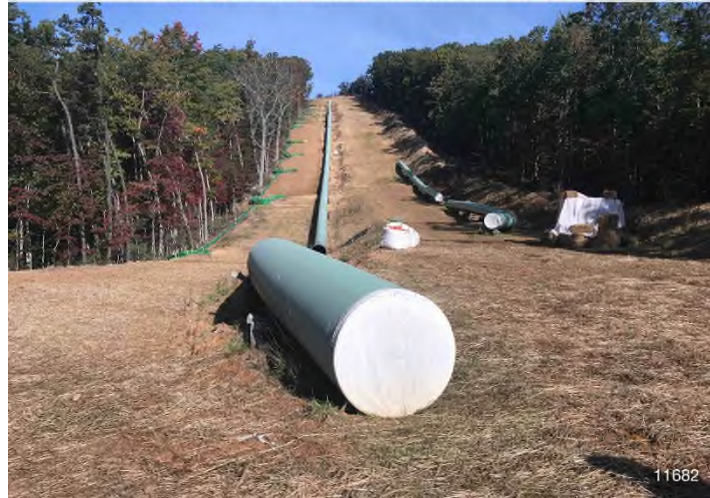
**Figure 1: STA 11682+00** – Controls in place and functioning properly. Area stabilized with straw.  
 BRG: 332°NW (T) LAT: 37.300374 LON: -80.392584 ±16ft ALT: 2576ft

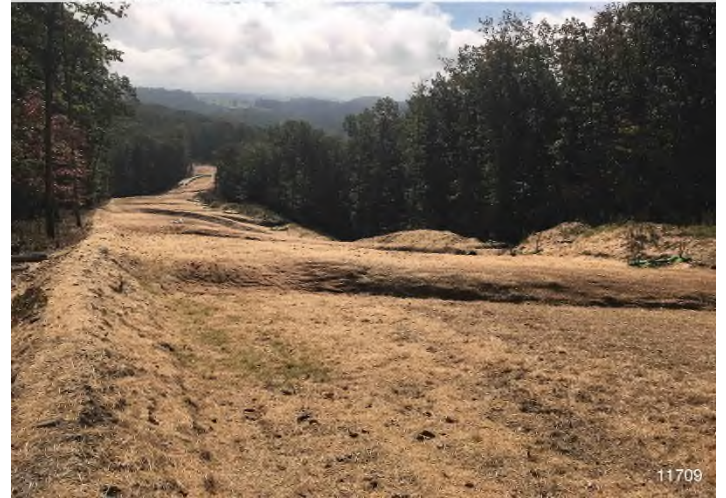
**Figure 2: STA 11709+00** – Controls in place and functioning properly. Area stabilized with straw.  
 BRG: 111°E (T) LAT: 37.296546 LON: -80.384996 ±32ft ALT: 2379ft

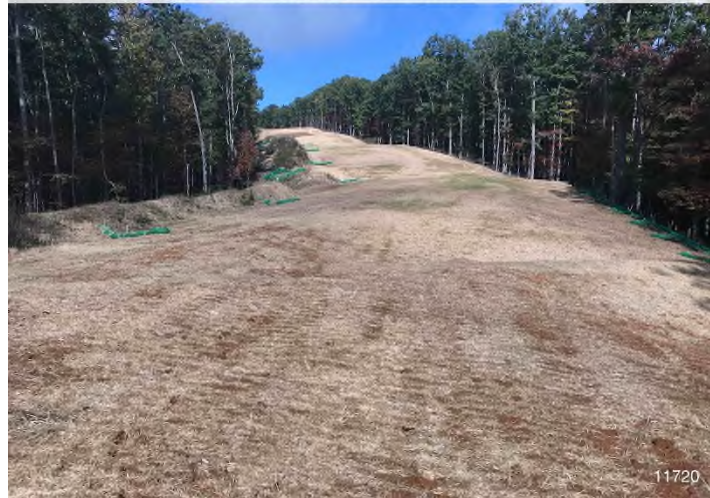
**Figure 3: STA 11720+00** – Controls in place and functioning properly. Area stabilized with straw.  
 BRG: 318°NW (T) LAT: 37.295088 LON: -80.381955 ±98ft ALT: 2250ft

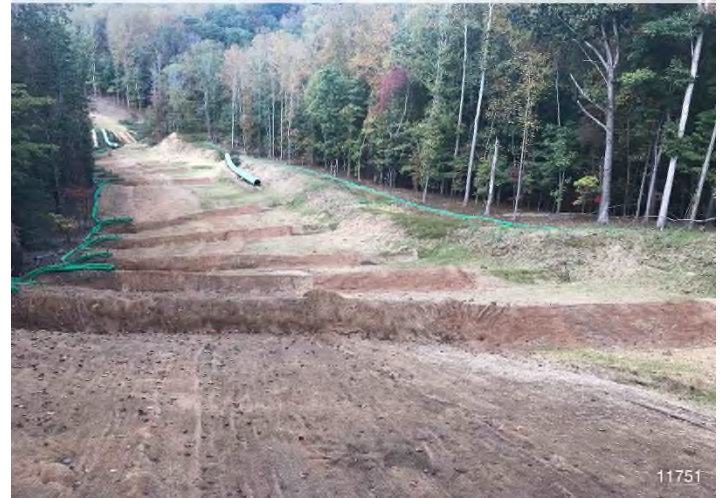
**Figure 4: STA 11751+00** – Controls in place and functioning properly. Area stabilized with straw.  
 BRG: 288°W (T) LAT: 37.288736 LON: -80.373423 ±16092ft ALT: 2037ft
