FIELD INSPECTION REPORT

| Project Name: | Mountain Valley Pipeline | Inspector: | Marshall Willis |
| Spread G: Giles County | STA 11158+37 – 11230+00 MVP-MLV-AR-25 MVP-GI-249.01/.03 | Weather: | Wet |

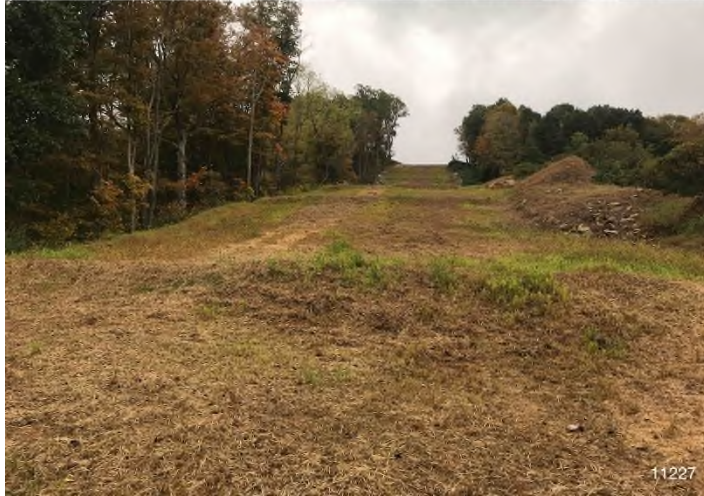
Figure 1: STA 11227+00 – Controls in place and functioning properly.
 BRG: 121°SE (T) LAT: 37.310555 LON: -80.516159 ±33914ft ALT: 1814ft

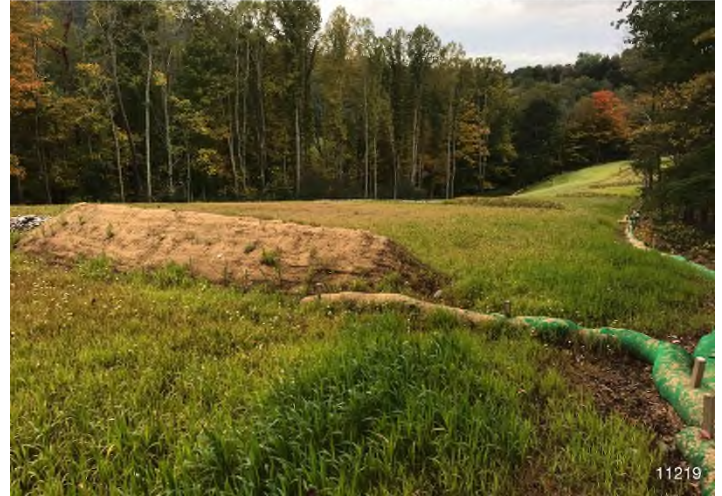
Figure 2: STA 11219+00 – Controls in place and functioning properly.
 BRG: 273°W (T) LAT: 37.301544 LON: -80.504047 ±16ft ALT: 2069ft

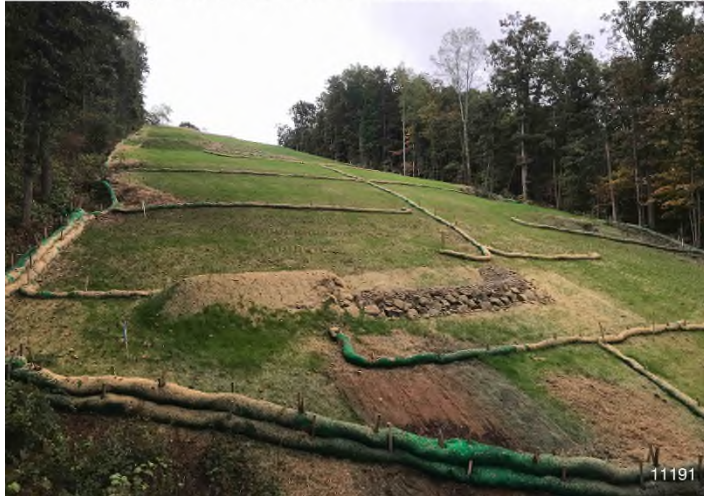
Figure 3: STA 11191+00 – Controls in place and functioning properly.
 BRG: 111°E (T) LAT: 37.306601 LON: -80.509923 ±98ft ALT: 1720ft

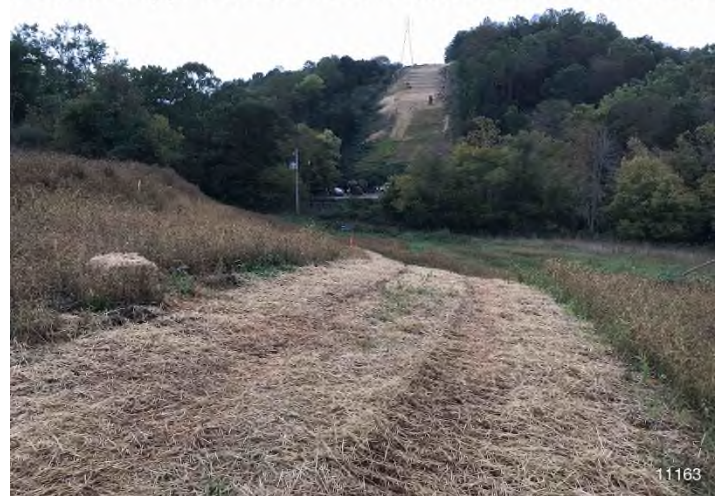
Figure 4: STA 11163+00 – Controls in place and functioning properly.
 BRG: 288°W (T) LAT: 37.311478 LON: -80.514426 ±98ft ALT: 1862ft
