FIELD INSPECTION REPORT

Project Name:	Mountain Valley Pipeline	Inspector:	Marshall Willis
Inspection Date:	Thursday, September 30, 2021	Project Contact:	Brian Clauto, Cory Chalmers
Spread G: Giles County	STA 10819+00 – 10883+56 MVP-GI-241.03	Weather:	Dry

FIELD INSPECTION PHOTO LOG

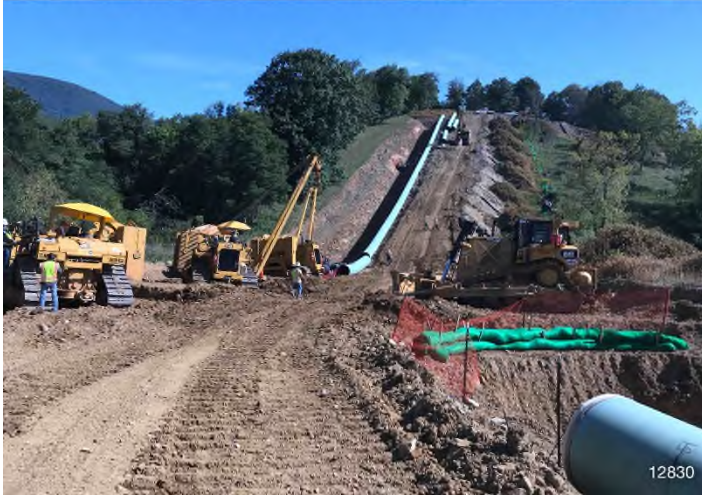
Figure 1: STA 10830+00 – Controls in place and functioning properly.

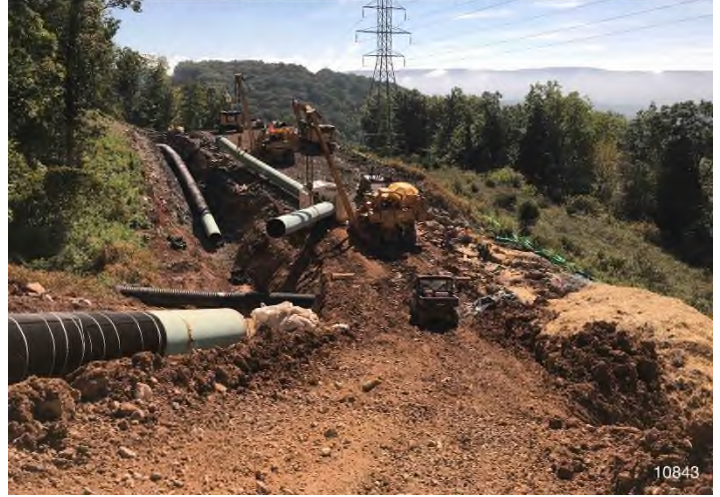
Figure 2: STA 10843+00 – Controls in place and functioning properly.

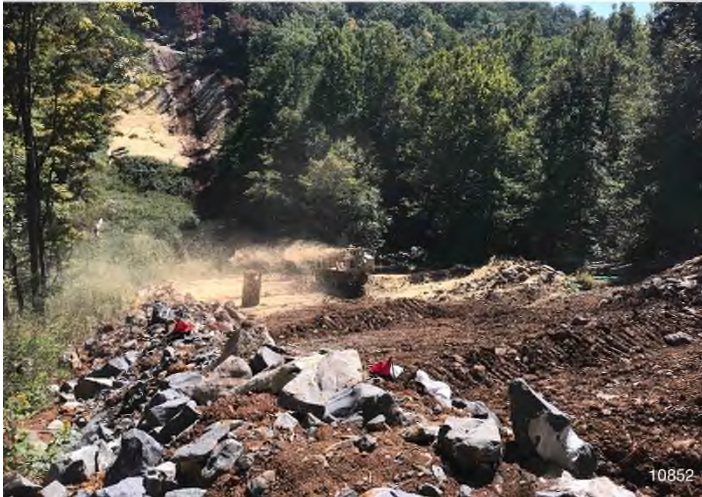
Figure 3: STA 10852+00 – Controls in place and functioning properly.

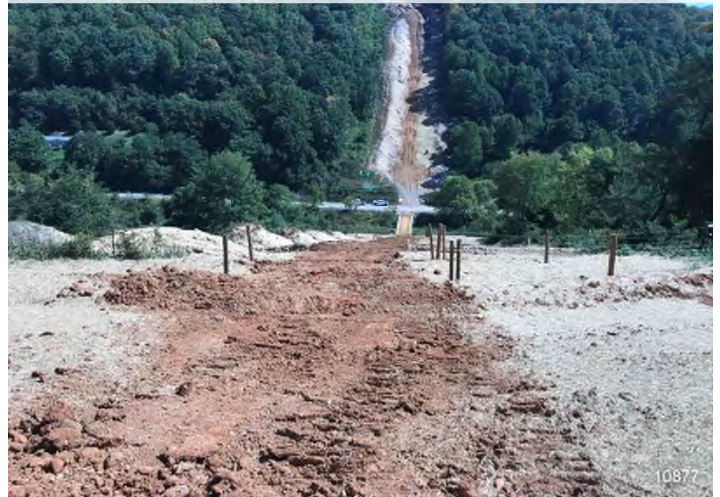
Figure 4: STA 10877+00 – Controls in place and functioning properly.
