FIELD INSPECTION REPORT

Project Name:	Mountain Valley Pipeline	Inspector:	Matthew Grant
Inspection Date:	Monday, September 27, 2021	Project Contact:	Brian Clauto
Spread G: Giles	AR GI 256.02	Weather:	Dry

FIELD INSPECTION PHOTO LOG

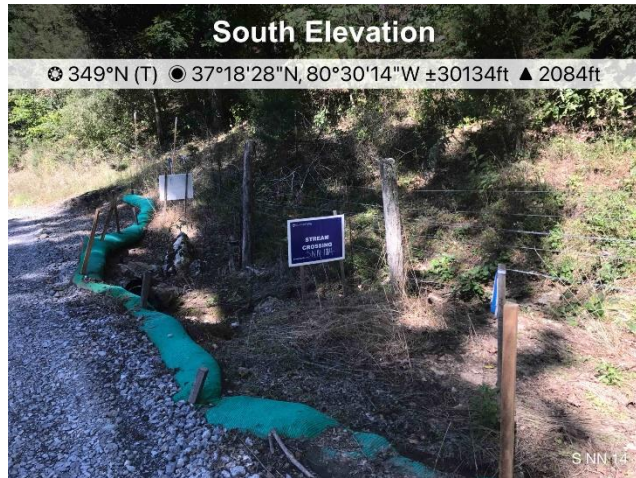
Figure 1: Designated crossing S-NN14

- Comments: Inspected the following resources: S-NN14
- ECD's were in place and functioning above the designated crossing for active construction. Sediment and gravel removal has been completed on S-NN14.

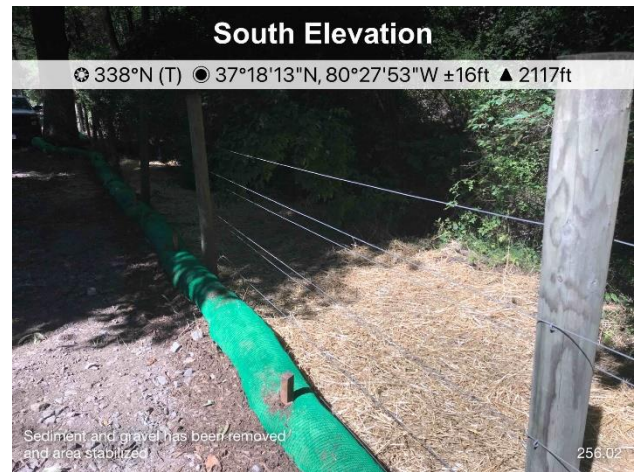
Figure 2: Escaped sediment and gravel has been removed and the area has been stabilized.

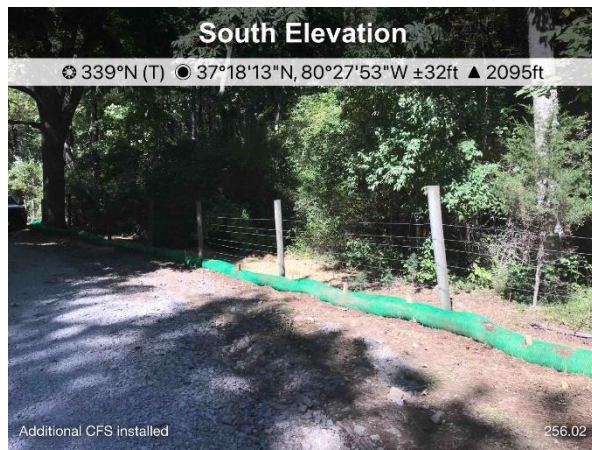
Figure 3: Additional CFS has been installed on portions of AR 256.02.

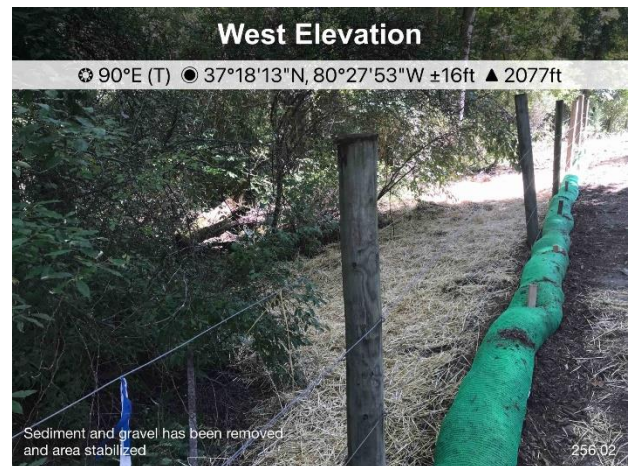
Figure 4: Escaped sediment and gravel has been removed and the area has been stabilized.
