Project Name:	Mountain Valley Pipeline	Inspector:	Matthew Grant		
Inspection Date:	Tuesday, September 21, 2021	Project Contact:	Brian Clauto		
Spread G: Giles	St10883+33, 10859+78, 10759- 10798 ATWS1056, 1334, 469, 466, 1360, 1332, 1333 AR GI 241.02	Weather:	Rainy

FIELD INSPECTION PHOTO LOG

Project Name: Mountain Valley Pipeline Date: Tuesday, September 21, 2021

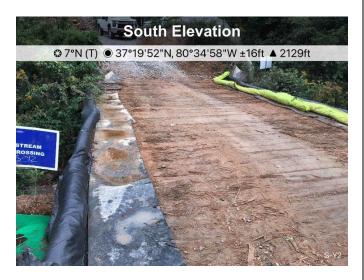
<u>Figure 1</u>: Designated crossing S-Y2, ECD's are in place and functioning for active construction.

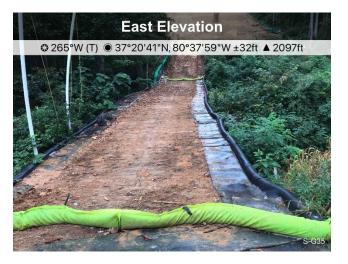
<u>Figure 3</u>: Designated crossing S-G35, ECD's are in place and functioning.

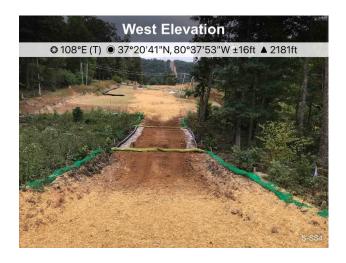
<u>Figure 4</u>: Designated crossing S-S4, ECD's are in place and functioning.
