FIELD INSPECTION REPORT

Project Name:	Mountain Valley Pipeline	Inspector:	Marshall Willis
Inspection Date:	Thursday, September 16, 2021	Project Contact:	Brian Clauto, Cory Chalmers
Spread G: Giles County	STA 11254+88 – 11353+21 MVP-GI-253.02	Weather:	Wet

FIELD INSPECTION PHOTO LOG

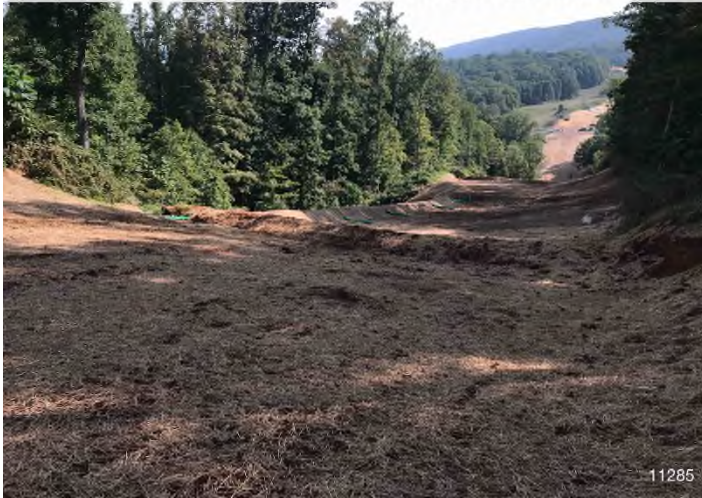
Figure 1: STA 11285+00 – Controls in place and functioning properly. Area stabilized with straw.

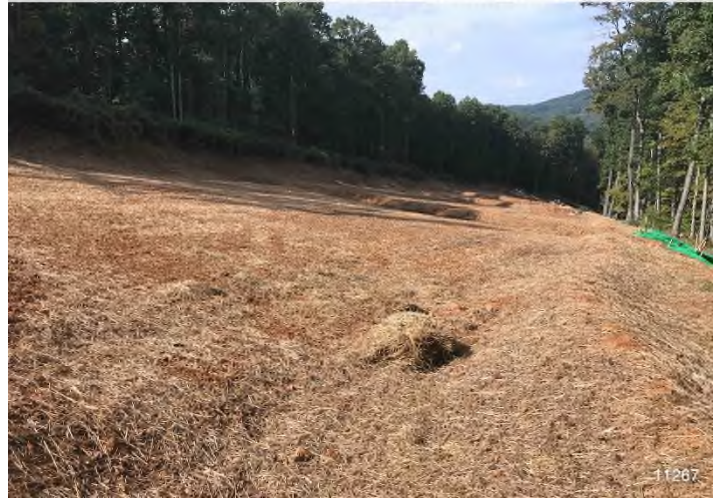
Figure 2: STA 11267+00 – Controls in place and functioning properly. Area stabilized with straw.

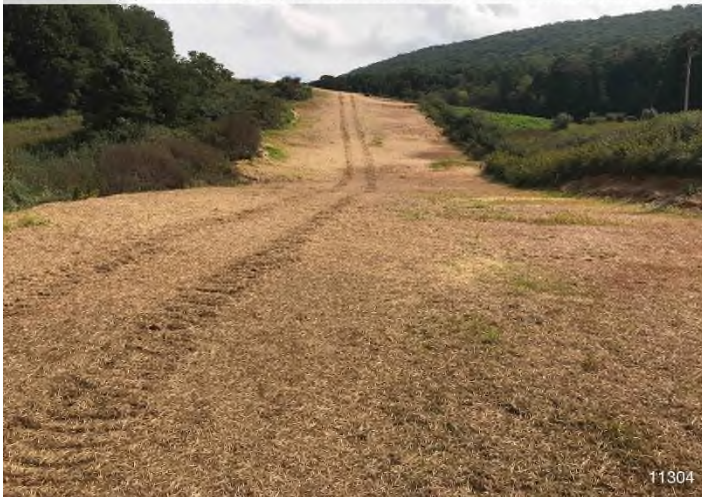
Figure 3: STA 11304+00 – Controls in place and functioning properly. Area stabilized with straw.

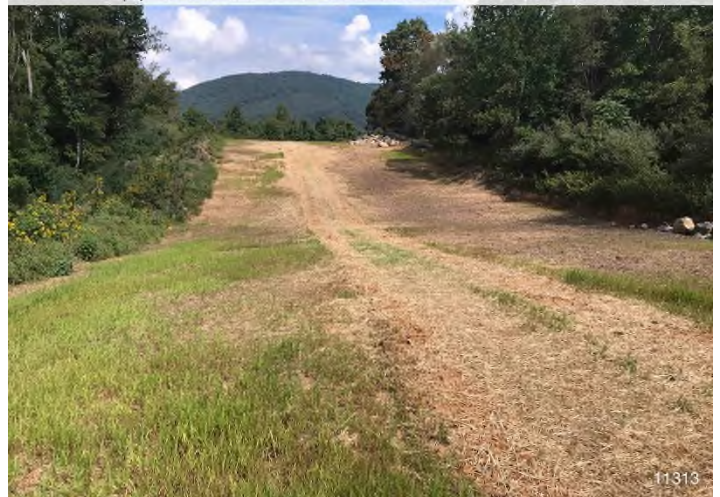
Figure 4: STA 11313+00 – Controls in place and functioning properly. Area stabilized with straw.
