FIELD INSPECTION REPORT

Project Name:	Mountain Valley Pipeline	Inspector:	Marshall Willis
Inspection Date:	Tuesday, September 14, 2021	Project Contact:	Brian Clauto, Cory Chalmers
Spread G: Giles County	STA 11158+37 – 11230+00 MVP-MLV-AR-25 MVP-GI-249.01/.03	Weather:	Dry

FIELD INSPECTION PHOTO LOG

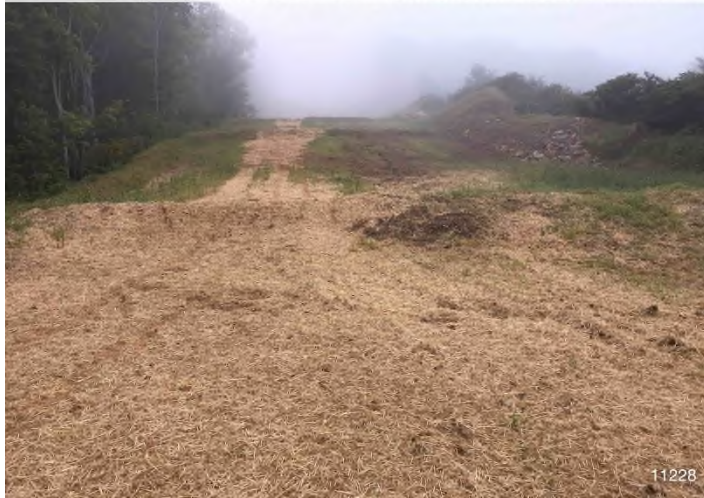
Figure 1: STA 11228+00 – Controls in place and functioning properly.

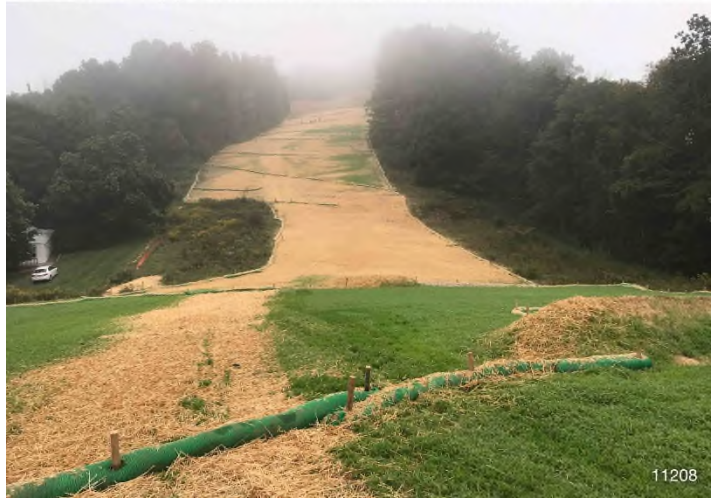
Figure 2: STA 11208+00 – Controls in place and functioning properly.

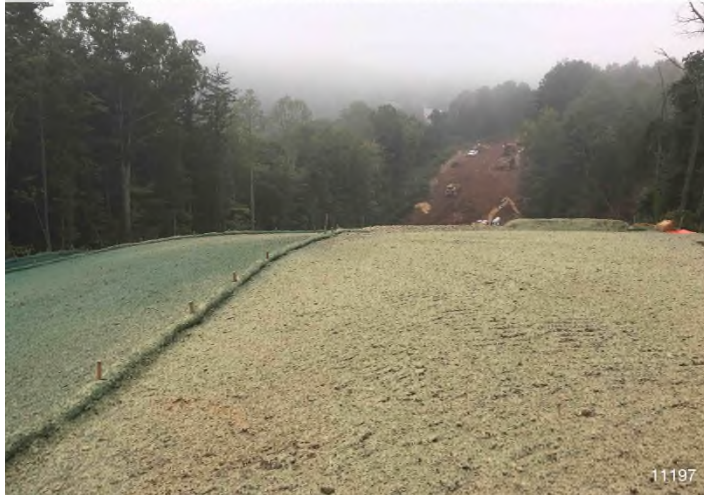
Figure 3: STA 11197+00 – Controls in place and functioning properly.

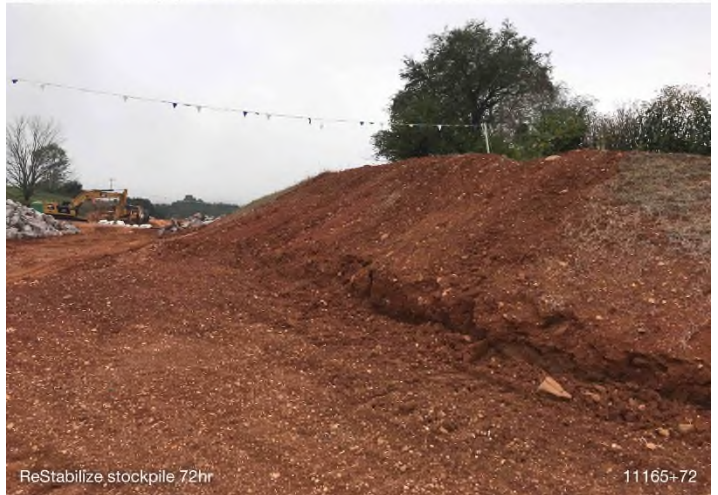
- STA 11165+72: Re-stabilize stockpile.

Figure 4: STA 11165+72 – Re-stabilize stockpile.

Recommended Corrective Action: Maintain and install all controls per the approved PSS&S.

Deadline: Within 72-Hour of Notification
