FIELD INSPECTION REPORT

Project Name:	Mountain Valley Pipeline	Inspector:	Matthew Grant
Inspection Date:	Wednesday, October 27, 2021	Project Contact:	Brian Clauto
Spread G: Giles	AR 249.03, AR258.04 11230-11160 11618+60-11600 ATWS1370A, 1370, 1347, 1464, 1369	Weather:	Dry

FIELD INSPECTION PHOTO LOG

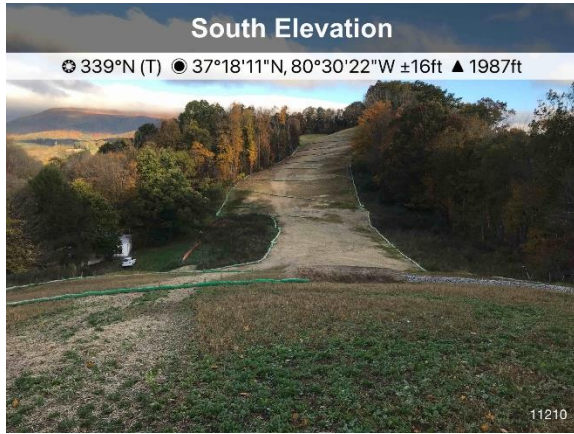
Figure 1: Permanent stabilization and waterbars have been installed near St 11210

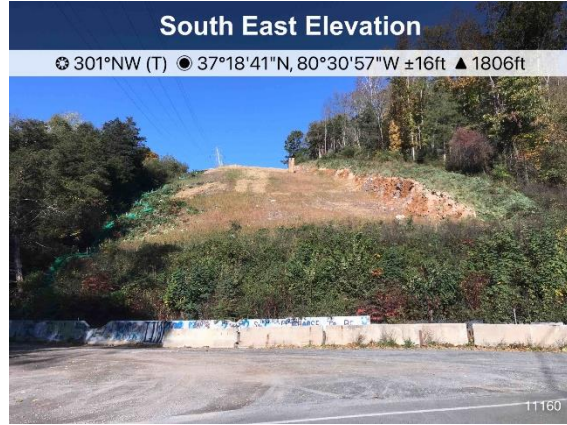
Figure 2: St 11160 Mountain Lake road crossing, ECD's are in place and slope is stabilized.

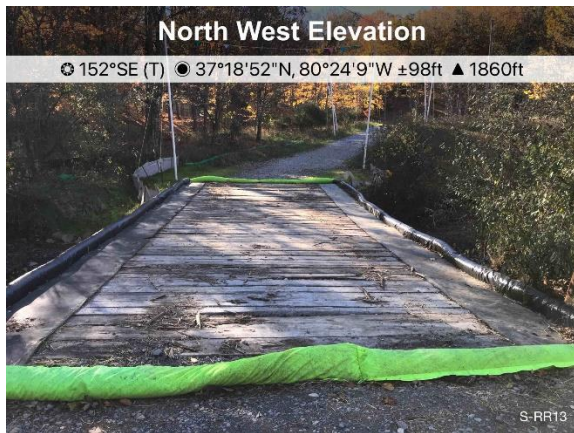
Figure 3: Designated crossing S-RR13, ECD's are in place.

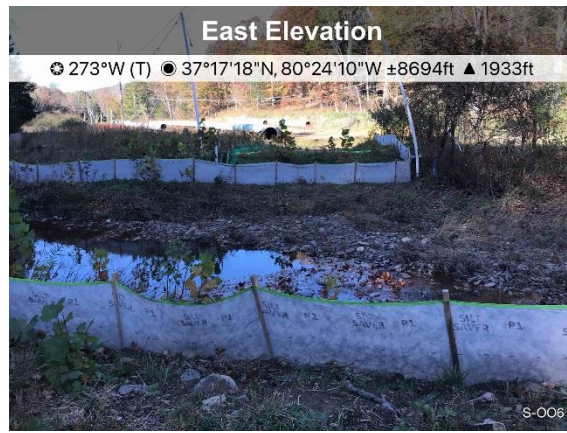
Figure 4: Designated crossing S-006, ECD's are in place.
