## FIELD INSPECTION REPORT

<b>Project Name:</b>	Mountain Valley Pipeline	<b>Inspector:</b>	Marshall Willis
<b>Inspection Date:</b>	Monday, October 18, 2021	<b>Project Contact:</b>	Brian Clauto, Cory Chalmers
<b>Spread G: Giles County</b>	STA 10859+34 – 10929+71	<b>Weather:</b>	Dry

## FIELD INSPECTION PHOTO LOG

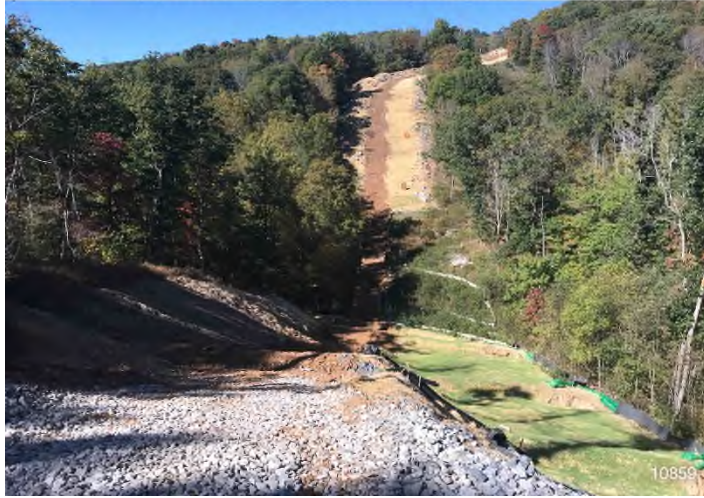
**Figure 1: STA 10859+00** – Controls in place and functioning properly. Area stabilized outside of active travel lane.  
**BRG: 291°W (T) LAT: 37.337672 LON: -80.604354 ±98ft ALT: 2288ft**

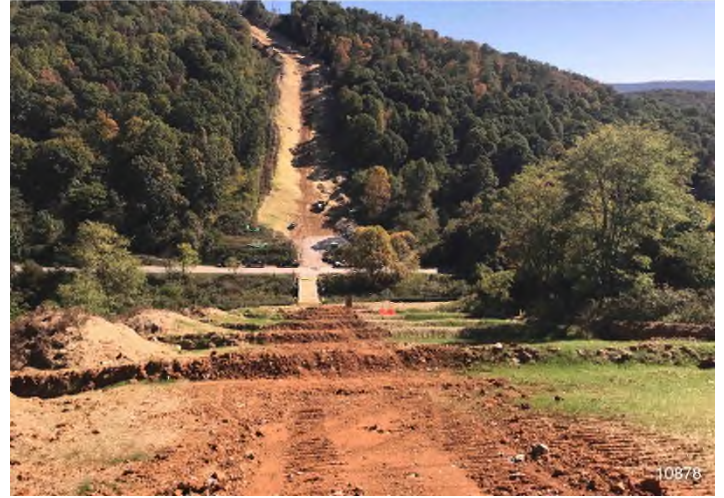
**Figure 2: STA 10878+00** – Controls in place and functioning properly. Area stabilized outside of active travel lane.  
**BRG: 89°E (T) LAT: 37.335681 LON: -80.598313 ±16ft ALT: 2296ft**

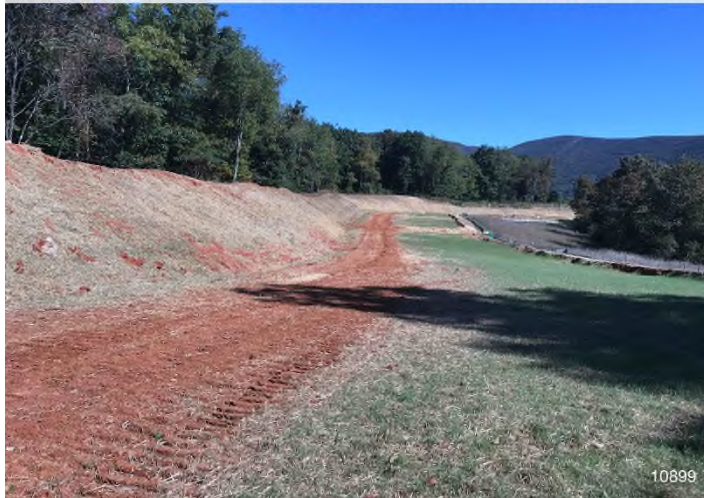
**Figure 3: STA 10899+00** – Controls in place and functioning properly. Area stabilized outside of active travel lane.  
**BRG: 11°N (T) LAT: 37.334599 LON: -80.592117 ±98ft ALT: 2540ft**

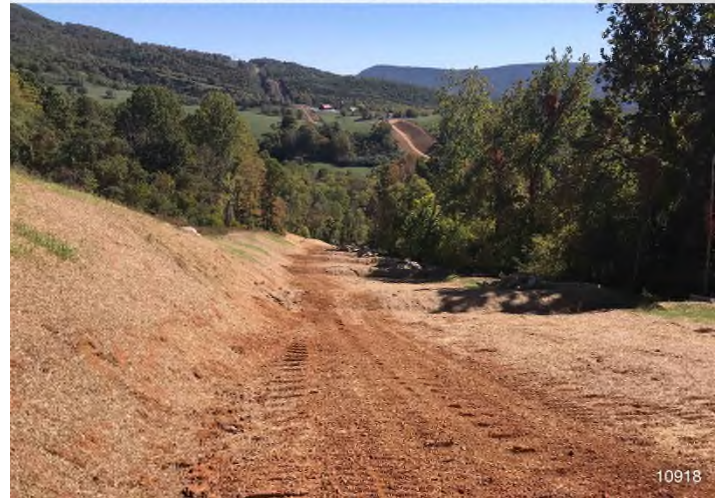
**Figure 4: STA 10918+00** – Controls in place and functioning properly. Area stabilized outside of active travel lane.  
**BRG: 131°SE (T) LAT: 37.332882 LON: -80.584734 ±213ft ALT: 2233ft**
