FIELD INSPECTION REPORT

Project Name:	Mountain Valley Pipeline	Inspector:	Marshall Willis
Inspection Date:	Monday, November 1, 2021	Project Contact:	Brian Clauto, Cory Chalmers
Spread G: Giles County	STA 10674+92 – 10759+05 MVP-GI-241.01/04	Weather:	Dry

FIELD INSPECTION PHOTO LOG

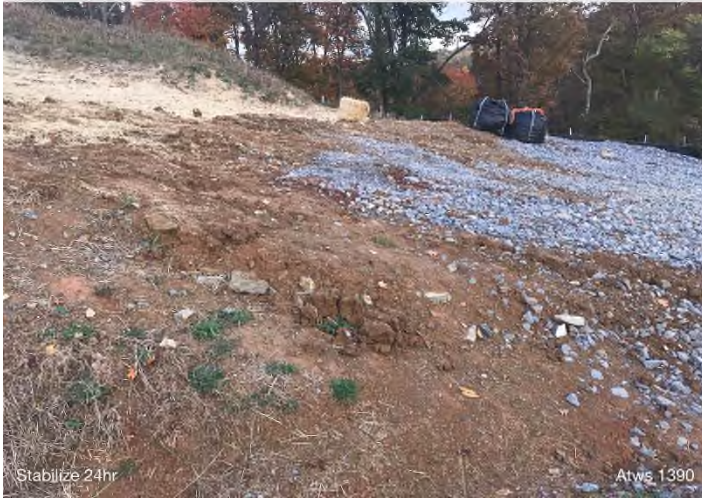
Atws 1390

- ATWS 1390: Stabilization needed.
- STA 10707+25: Stabilization needed.
- STA 10676+15: Stabilization needed.

Figure 1: ATWS 1390 – Stabilization needed.

Stabilize 24hr

Recommended Corrective Action: Maintain and install all controls per the approved PSS&S.

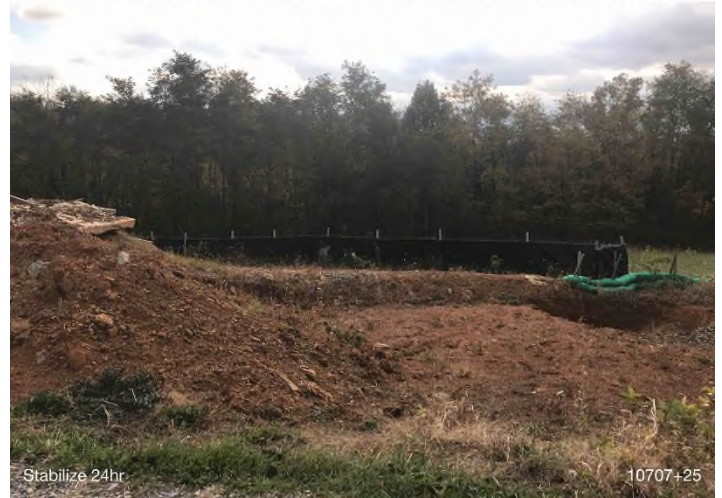
Figure 2: STA 10707+25 – Stabilization needed.

Stabilize 24hr

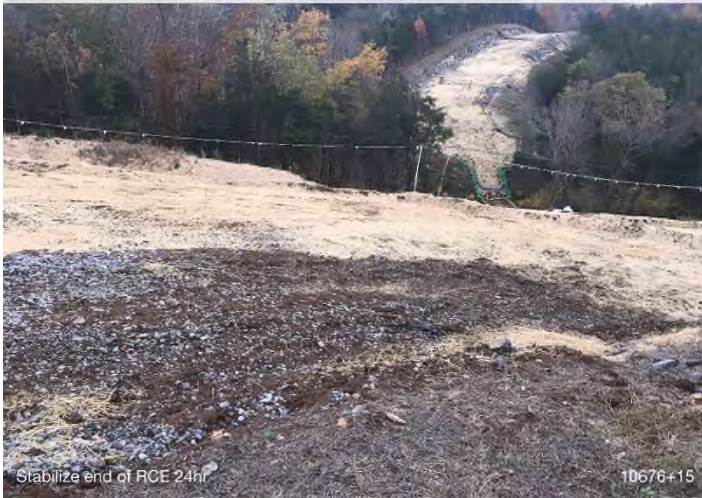
Figure 3: STA 10676+15 –Stabilization needed.

Stabilize end of RCE 24hr

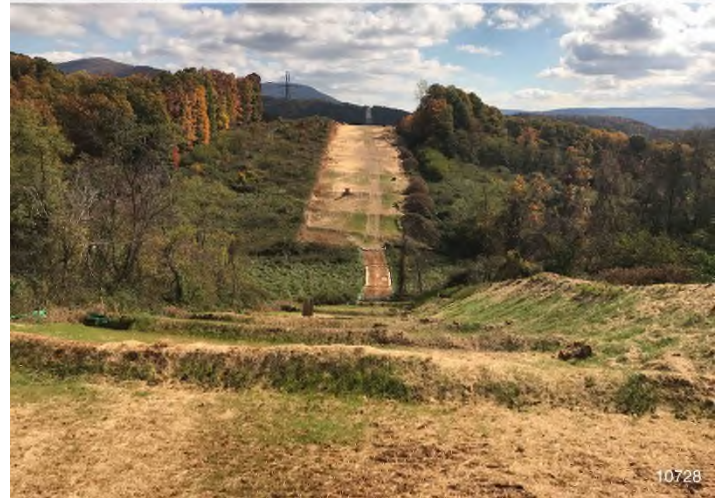
10728

Figure 4: STA 10728+00 – Controls in place and functioning properly. Area stabilized with straw.
