FIELD INSPECTION REPORT

Project Name:	Mountain Valley Pipeline	Inspector:	Marshall Willis
Inspection Date:	Thursday, December 2, 2021	Project Contact:	Brian Clauto, Cory Chalmers
Spread G: Giles County	STA 10656+00 – 10675+13 Laydown Yard 028/029 MVP-GI-240 MVP-GI-238.01	Weather:	Dry

FIELD INSPECTION PHOTO LOG

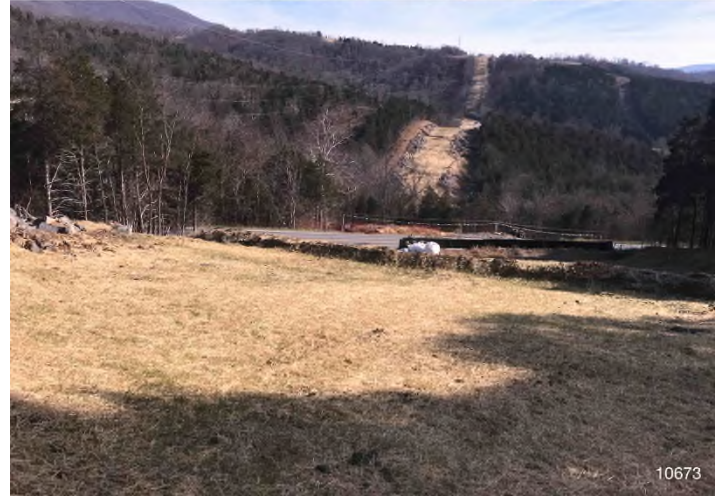
Figure 2: STA 10673+00 – Controls in place and functioning properly. Area stabilized with straw.

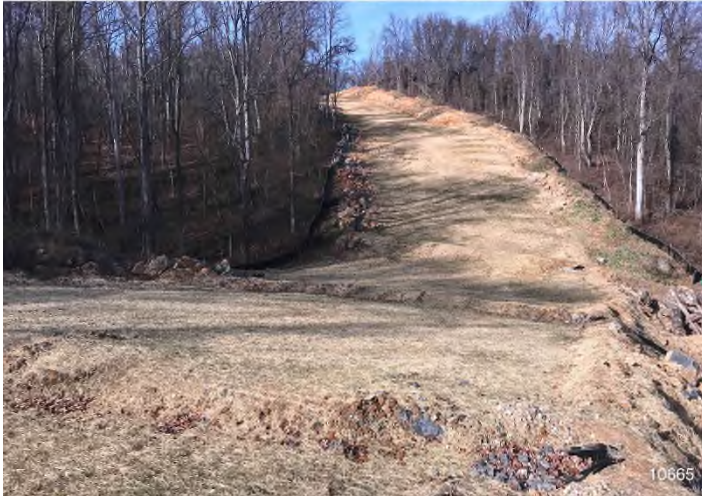
Figure 3: STA 10665+00 – Controls in place and functioning properly. Area stabilized with straw

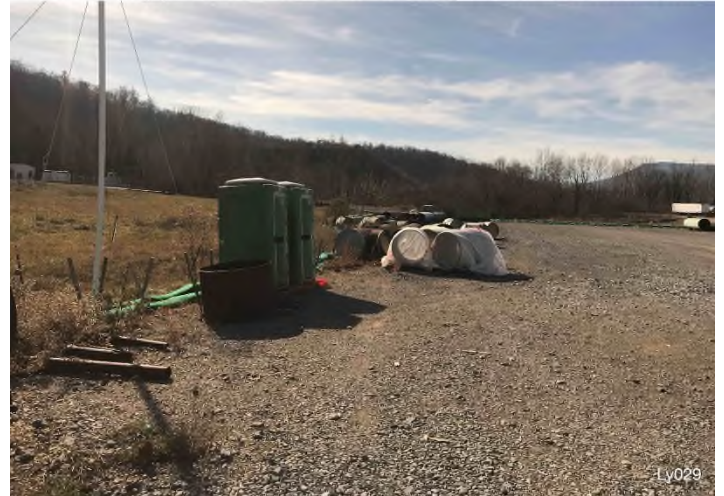
Figure 4: Laydown Yard 029 – Controls in place and functioning properly.
