## COMPLAINT INVESTIGATION REPORT

<b>Project Name:</b>	Mountain Valley Pipeline	<b>Inspector:</b>	Marshall Willis
<b>Inspection Date:</b>	Tuesday, November 30, 2021	<b>Project Contact:</b>	Brian Clauto, Cory Chalmers
<b>Spread H: Roanoke County</b>	STA 12862+00 – 12866+36	<b>Weather:</b>	Dry

## FIELD INSPECTION PHOTO LOG

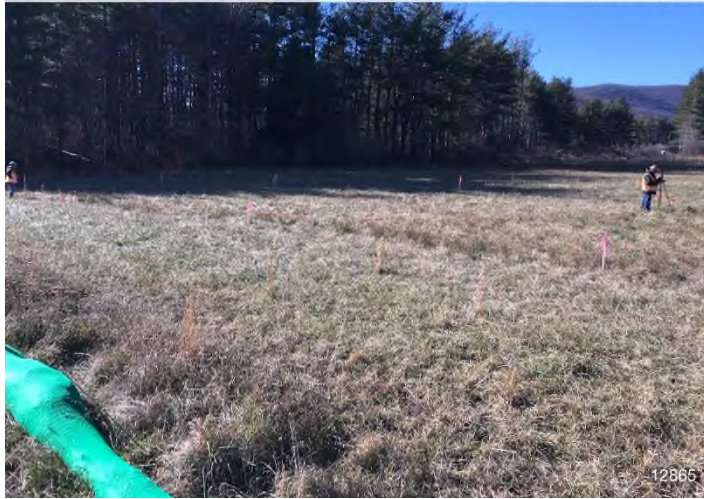
**Figure 1: STA 12865+00** – Looking W towards Wetland W-AB3-PEM-2 from edge of disturbance. Note survey crews re-staking delineation of wetland with pink flags.

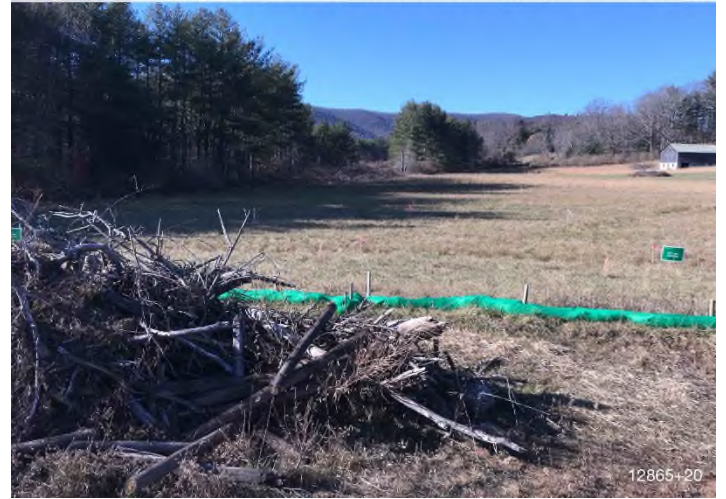
1. The woody debris pile or "fill" pile of concern was located at approximate STA 12865+00.
2. The woody debris pile was located outside of Wetland W-AB3-PEM-2 (STA 12854+57). No impacts were observed to the resource.
3. Survey crews were onsite during the inspection re-staking the wetland delineation for W-AB3-PEM-2.
4. Installed ECDs within the MVP LOD were per the approved plans and appeared to be functioning as designed.

**Figure 2: STA 12865+20** – Looking NW towards Wetland W-AB3-PEM-2. Woody debris stockpile is located within the LOD and outside the boundaries of Wetland W-AB3-PEM-2.

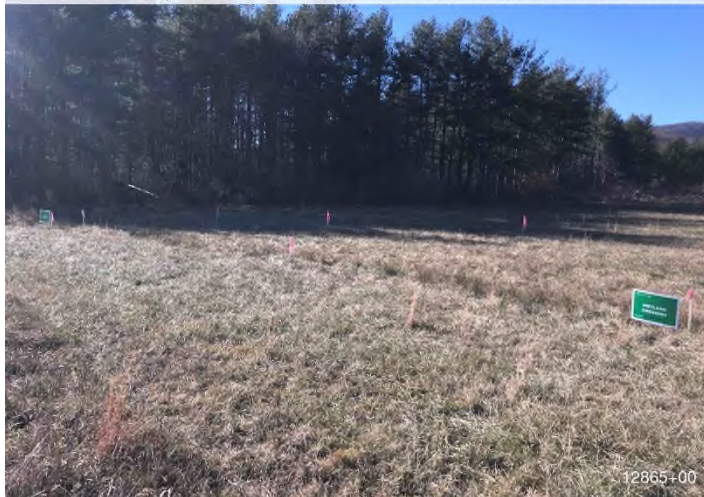
**Figure 3: STA 12865+00** – Looking W towards Wetland W-AB3-PEM-2 from edge of disturbance. No impacts were observed to the resource.

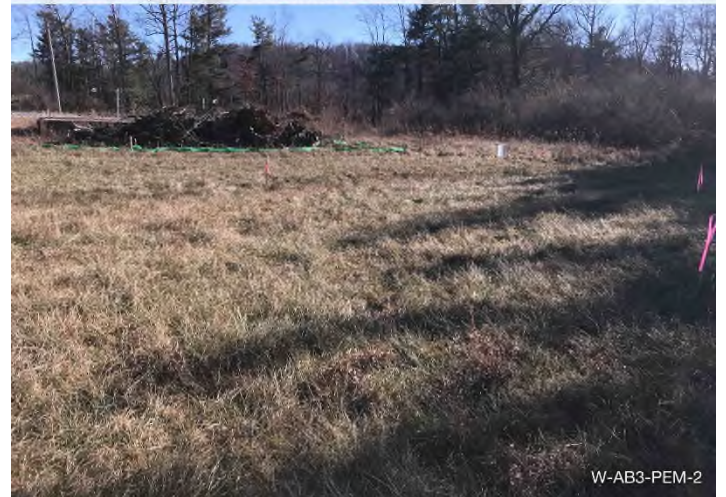
**Figure 4: Wetland W-AB3-PEM-2** – Looking S towards debris pile from Wetland W-AB3-PEM-2. No impacts were observed to the resource.
