FIELD INSPECTION REPORT

Project Name:	Mountain Valley Pipeline	Inspector:	Matthew Grant
Inspection Date:	Wednesday, November 10, 2021	Project Contact:	Brian Clauto
Spread G: Montgomery	St11024-10931 AR 244	Weather:	Dry

FIELD INSPECTION PHOTO LOG

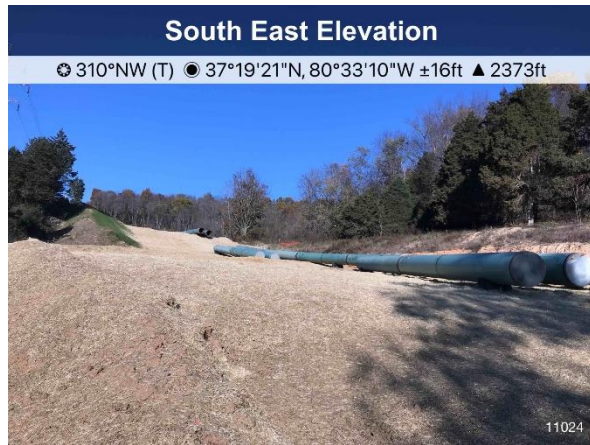
Figure 1: St11024 area is stabilized and ECD's are in place.

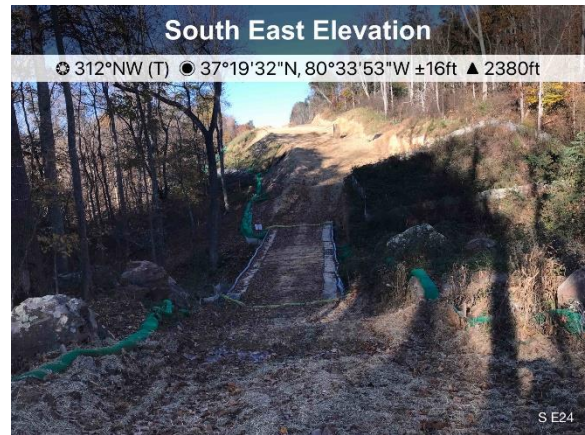
Figure 2: Designated crossing S-E24, ECD's are in place.

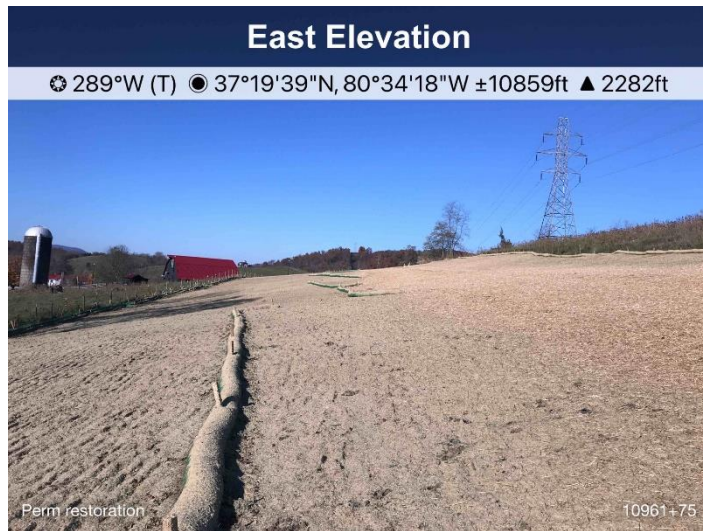
Figure 3: St10961+75 permanent restoration has been applied.

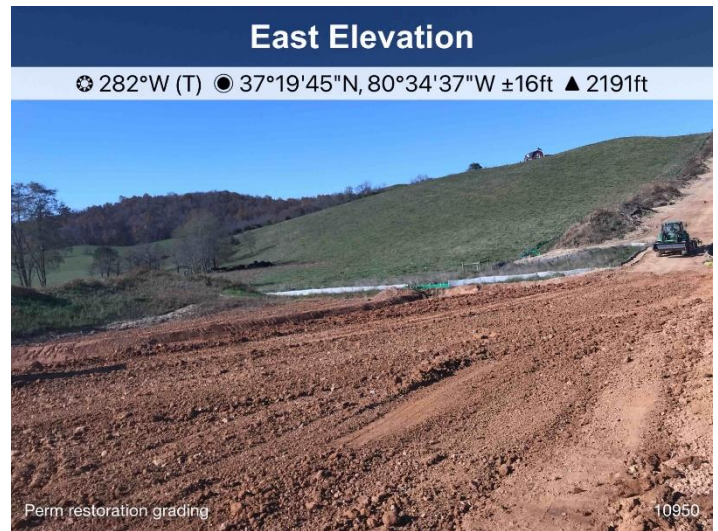
Figure 4: St10950 active restoration grading.
