## FIELD INSPECTION REPORT

<b>Project Name:</b>	Mountain Valley Pipeline	<b>Inspector:</b>	Marshall Willis
<b>Inspection Date:</b>	Monday, November 8, 2021	<b>Project Contact:</b>	Brian Clauto, Cory Chalmers
<b>Spread G: Giles County</b>	STA 11098+00 – 11158+12 MVP-GI-245.02 MVP-GI-249	<b>Weather:</b>	Dry

## FIELD INSPECTION PHOTO LOG

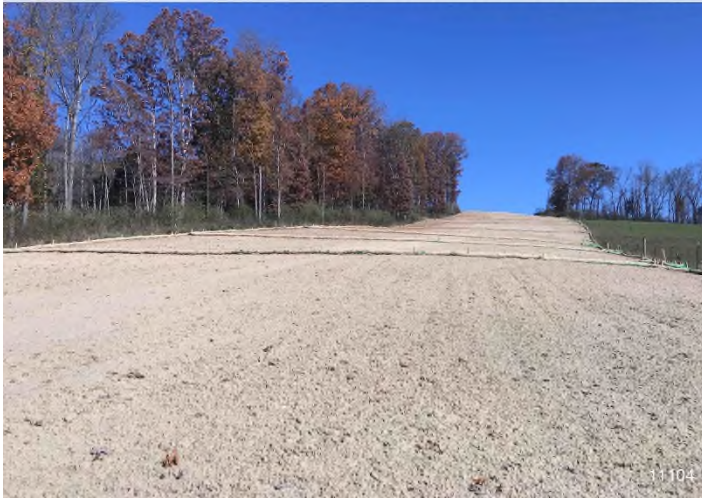
**Figure 1: STA 11104+00** – Controls in place and functioning properly. Area stabilized with straw.

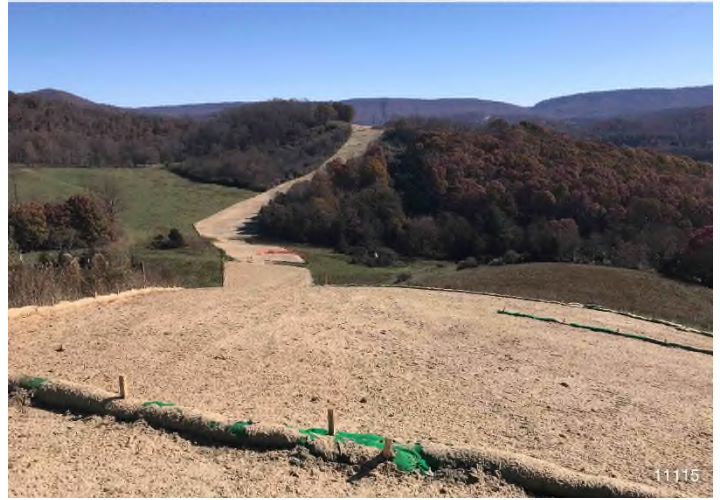
**Figure 2: STA 11115+00** – Controls in place and functioning properly. Area stabilized with straw.

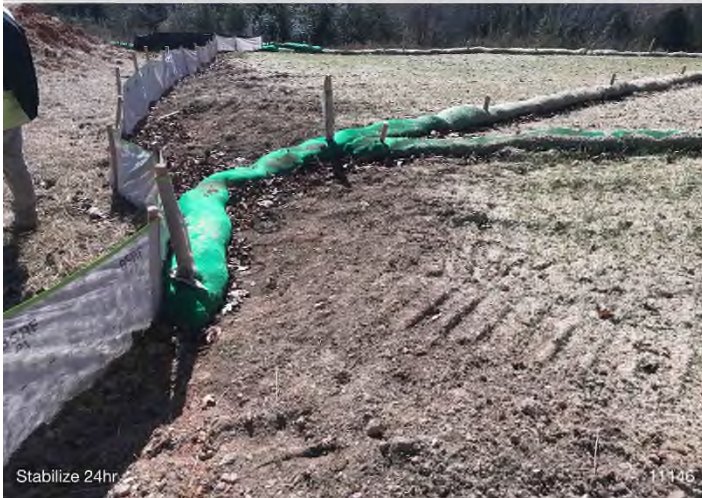
- STA 11146+00: Stabilization needed.

**Figure 3: STA 11146+15** –Stabilization needed.

**Recommended Corrective Action:** Maintain and install all controls per the approved PSS&S.

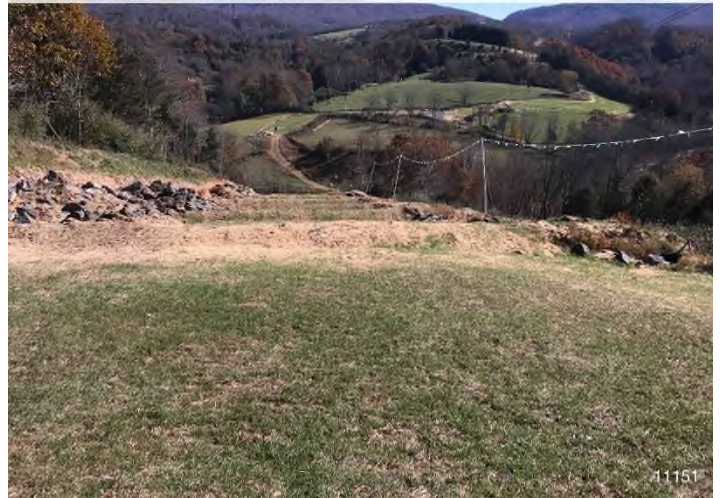
**Figure 4: STA 11151+00** – Controls in place and functioning properly. Area stabilized with straw.
