FIELD INSPECTION REPORT

Project Name:	Mountain Valley Pipeline	Inspector:	Marshall Willis
Inspection Date:	Monday, December 6, 2021	Project Contact:	Brian Clauto, Cory Chalmers
Spread G: Giles County	STA 11254+88 – 11298+29 MVP-GI-253.02	Weather:	Dry

FIELD INSPECTION PHOTO LOG

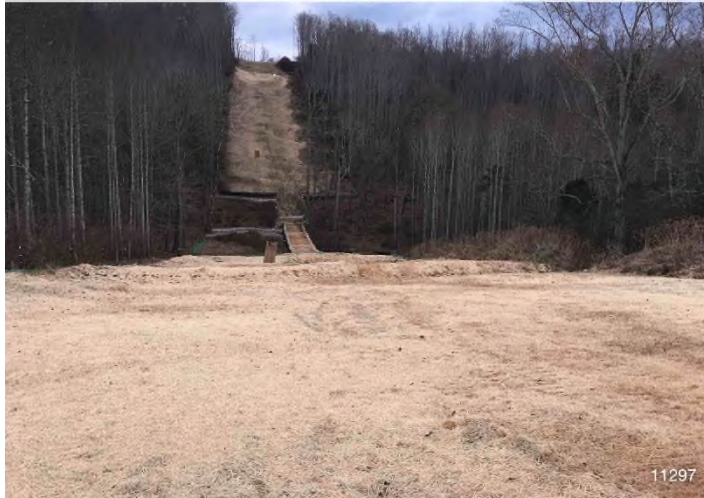
Figure 1: STA 11297+00 – Controls in place and functioning properly. Area stabilized with straw
BRG: 259°W (T) LAT: 37.296326 LON: -80.479501 ±164ft ALT: 1950ft

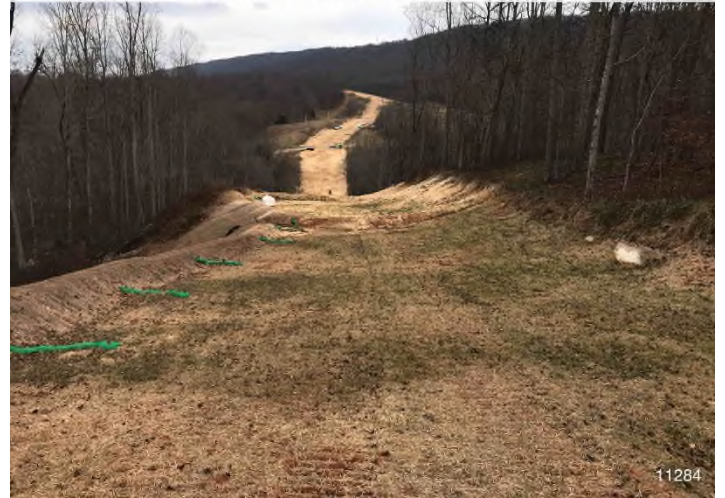
Figure 2: STA 11284+00 – Controls in place and functioning properly. Area stabilized with straw
BRG: 72°E (T) LAT: 37.295938 LON: -80.484098 ±98ft ALT: 2120ft

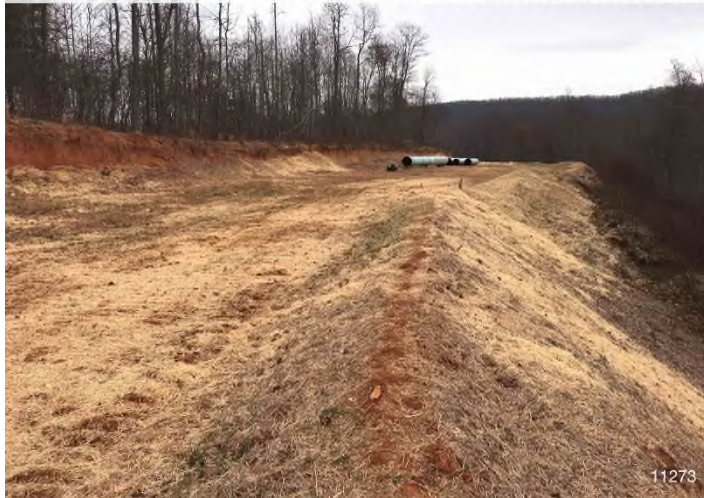
Figure 3: STA 11273+00 – Controls in place and functioning properly. Area stabilized with straw
BRG: 84°E (T) LAT: 37.296367 LON: -80.488366 ±16ft ALT: 2285ft

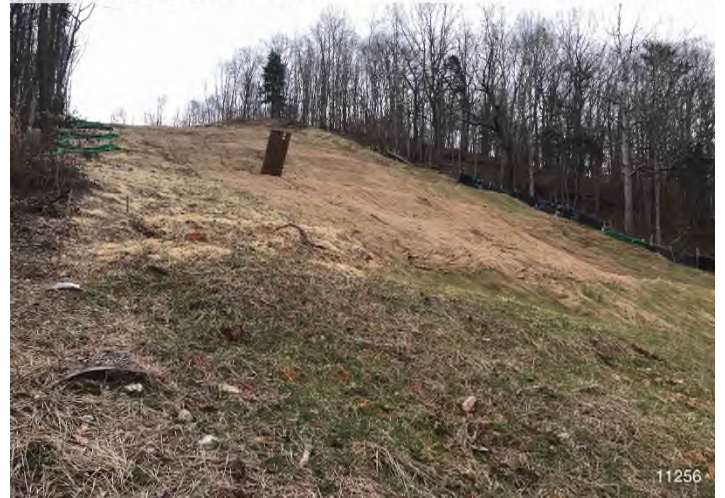
Figure 4: STA 11256+00 – Controls in place and functioning properly. Area stabilized with straw
BRG: 122°SE (T) LAT: 37.296724 LON: -80.493480 ±32ft ALT: 1961ft
