Project Name:	Mountain Valley Pipeline	Inspector:	Matthew Grant		
Inspection Date:	Wednesday, February 9, 2022	Project Contact:	Brian Clauto		
Spread G: Giles	St11025-11064 ATWS 1146, 1145, 1465 AR-GI 244	Weather:	Dry

FIELD INSPECTION PHOTO LOG

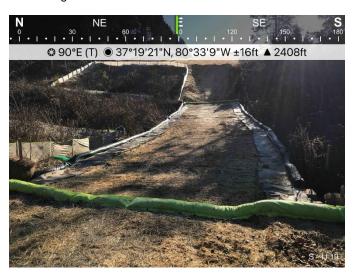
<u>Figure 1</u>: Designated crossing S-IJ19, ESC's are in place and functioning.

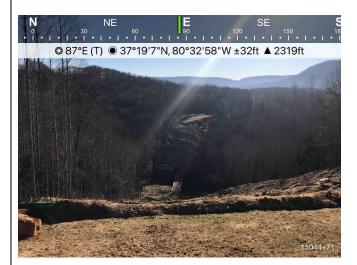
Figure 2: St 11044+71, ESC controls were in place.

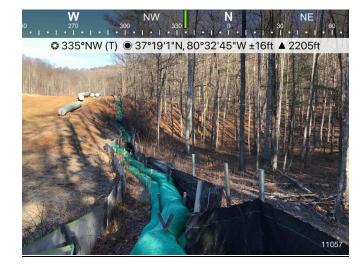
Figure 4: St 11057, ECD's are in place and functioning.
