FIELD INSPECTION REPORT

Project Name:	Mountain Valley Pipeline	Inspector:	Marshall Willis
Inspection Date:	Monday, January 31, 2022	Project Contact:	Brian Clauto, Cory Chalmers
Spread G: Giles County	STA 10656+00 – 10711+00 MVP-GI-240 MVP-GI-241.01/241.04	Weather:	Snow

FIELD INSPECTION PHOTO LOG

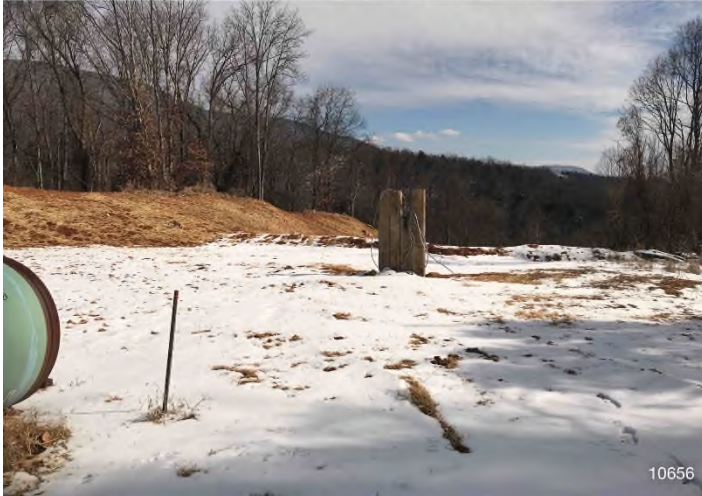
10656

Figure 1: STA 10656+00 – Controls in place and functioning properly.

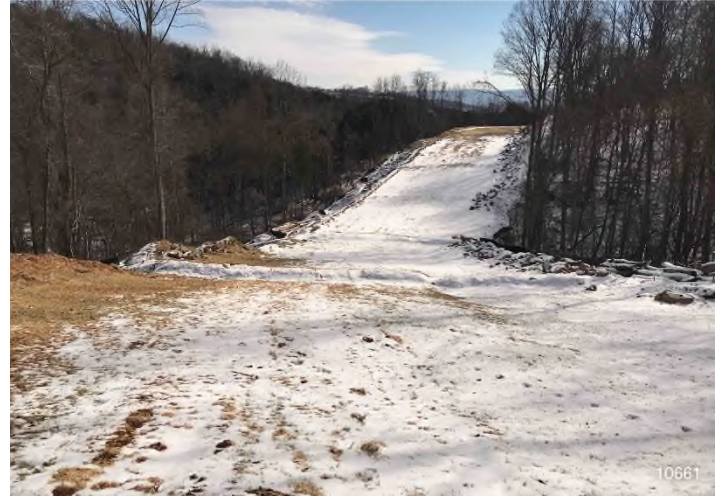
10661

Figure 2: STA 10661+00 – Controls in place and functioning properly.

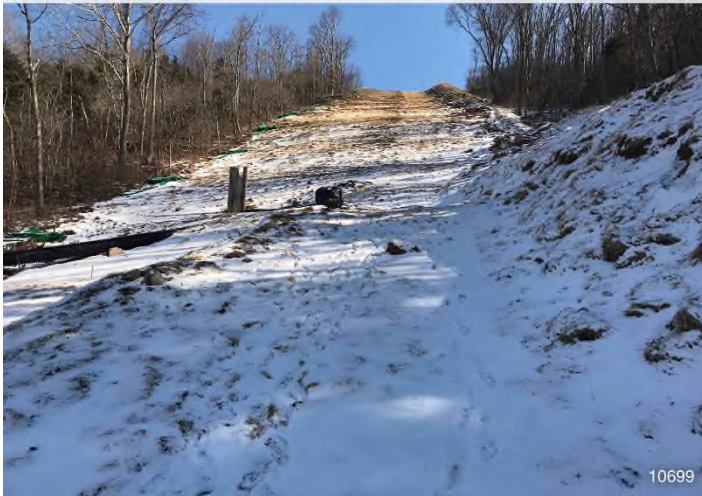
10699

Figure 3: STA 10699+00 – Controls in place and functioning properly.

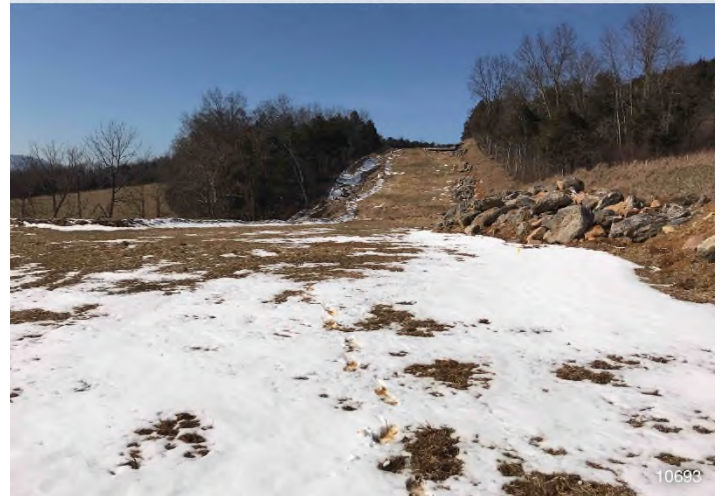
10693

Figure 4: STA 10693+00 – Controls in place and functioning properly.
