Project Name:	Mountain Valley Pipeline	Inspector:	Matthew Grant		
Inspection Date:	Monday, January 31, 2022	Project Contact:	Brian Clauto		
Spread G: Giles	St10710-10696+73 ATWS 1390, 1391 AR-GI 241.01	Weather:	Wet

FIELD INSPECTION PHOTO LOG

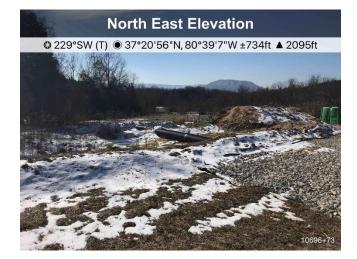
Figure 4: ECD's in place at St 10696+73.
