FIELD INSPECTION REPORT

Project Name:	Mountain Valley Pipeline	Inspector:	Matthew Grant
Inspection Date:	Tuesday, January 25, 2022	Project Contact:	Brian Clauto
Spread G: Giles	St11668+66-11766+03, 11614+73-11607+87 ATWS1057	Weather:	Snow

FIELD INSPECTION PHOTO LOG

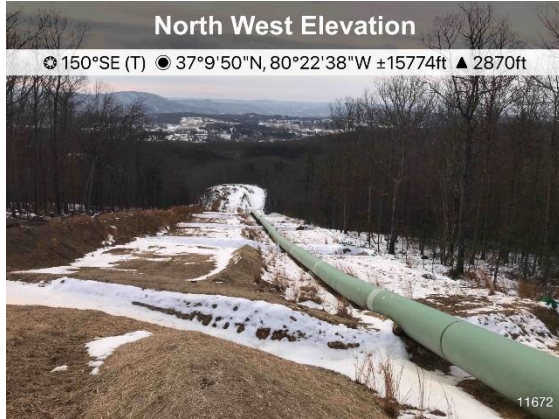
Figure 1: ESC controls were snow covered near St 11672

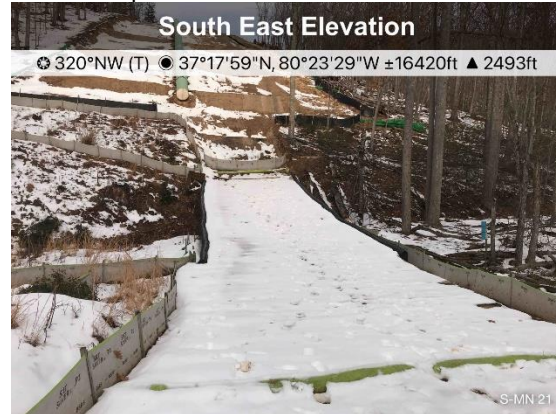
Figure 2: Designated stream crossing S-MN21, ESC controls were in place.

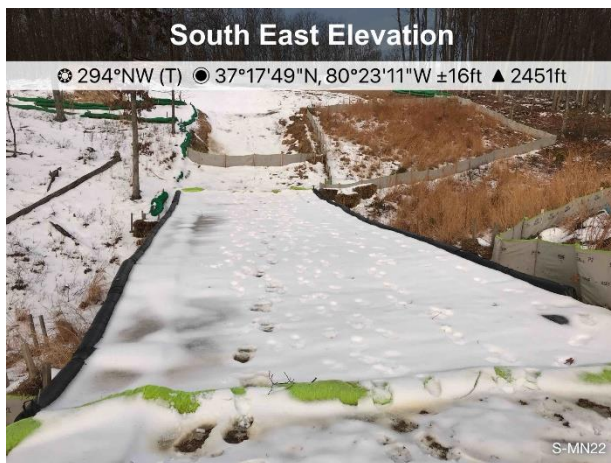
Figure 3: Designated stream crossing S-MN22, ESC controls were in place.

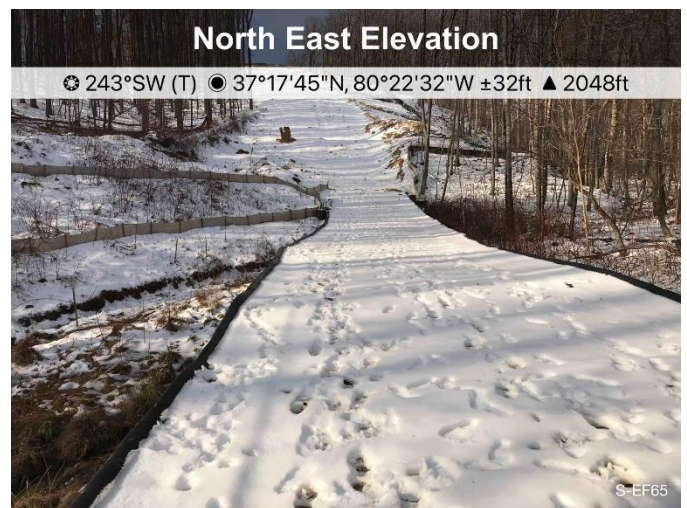
Figure 4: Designated stream crossing S-EF35, ESC controls were in place.
