FIELD INSPECTION REPORT

Project Name:	Mountain Valley Pipeline	Inspector:	Marshall Willis
Inspection Date:	Tuesday, January 11, 2022	Project Contact:	Brian Clauto, Cory Chalmers
Spread G: Giles County	STA 10929+00 – 10972+00 STA 11167+00 – 11227+00 MVP-MLV-AR-25 MVP-GI-249.01 MVP-GI-241.02	Weather:	Dry

FIELD INSPECTION PHOTO LOG

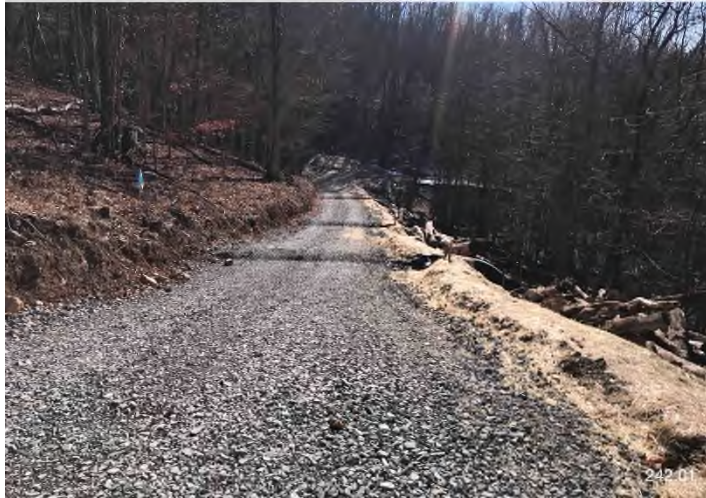
Figure 1: MVP-GI-242.01 – Controls in place and functioning properly along access road.
BRG: 140°SE (T) **LAT:** 37.332773 **LON:** -80.560607 ±16ft **ALT:** 3018ft

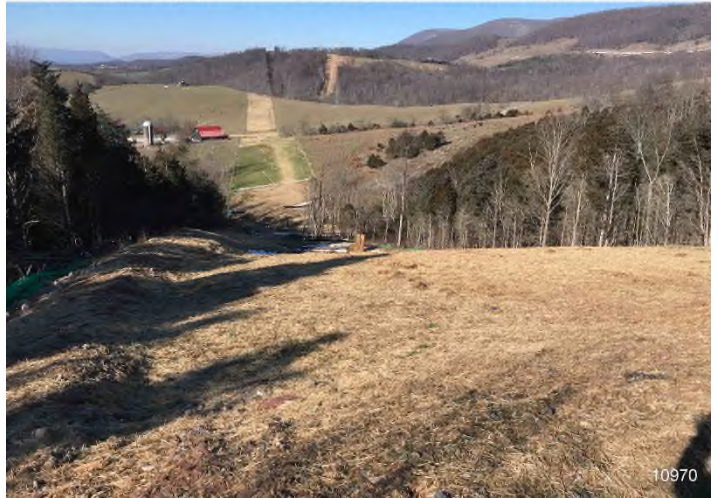
Figure 2: STA 10970+00 – Controls in place and functioning properly. Area stabilized with straw.
BRG: 305°NW (T) **LAT:** 37.327106 **LON:** -80.570319 ±16ft **ALT:** 2452ft

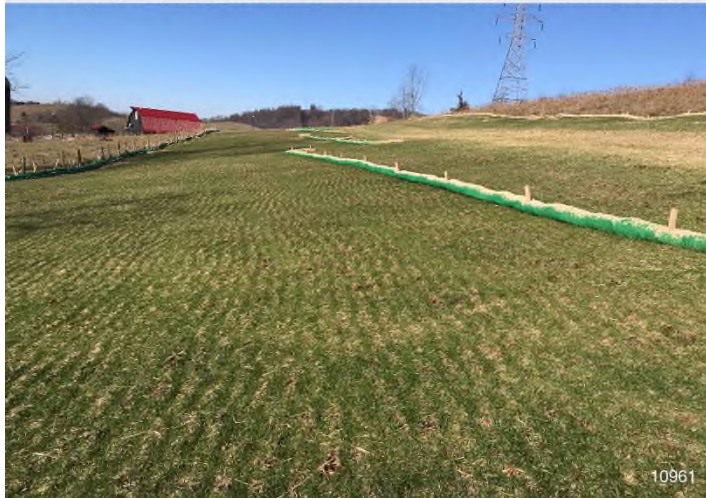
Figure 3: STA 10961+00 – Controls in place and functioning properly.
BRG: 307°NW (T) **LAT:** 37.327940 **LON:** -80.572925 ±16ft **ALT:** 2308ft

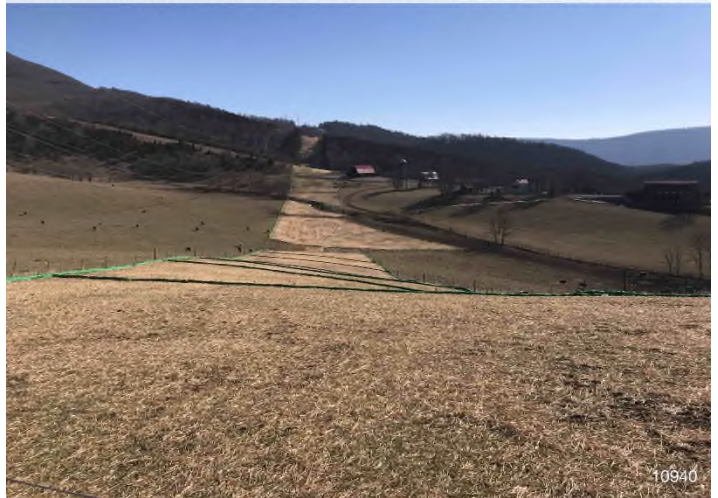
Figure 4: STA 10940+00 – Controls in place and functioning properly. Area stabilized with straw.
BRG: 189°S (T) **LAT:** 37.330028 **LON:** -80.579988 ±16ft **ALT:** 2282ft
