FIELD INSPECTION REPORT

Project Name:	Mountain Valley Pipeline	Inspector:	Marshall Willis
Inspection Date:	Wednesday, February 9, 2022	Project Contact:	Brian Clauto, Cory Chalmers
Spread G: Giles County	STA 11023+80 – 11151+27 MVP-GI-244 MVP-GI-249	Weather:	Wet

FIELD INSPECTION PHOTO LOG

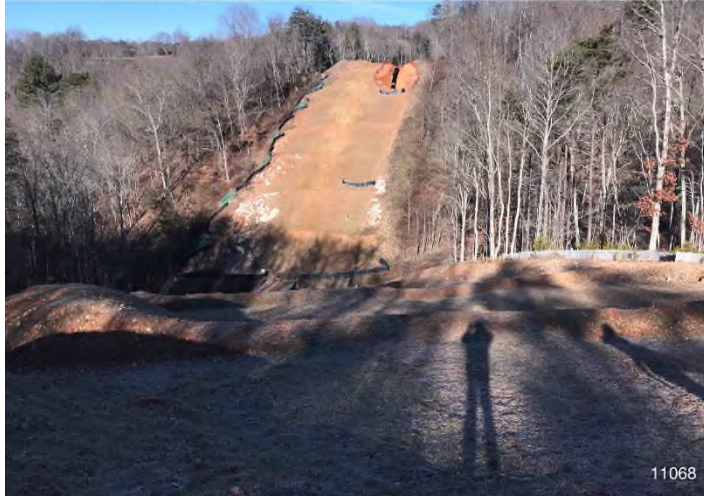
11068

Figure 1: STA 11068+00 – Controls in place and functioning properly.
 BRG: 307°NW (T) LAT: 37.267910 LON: -80.471223 ±16535ft ALT: 2192ft

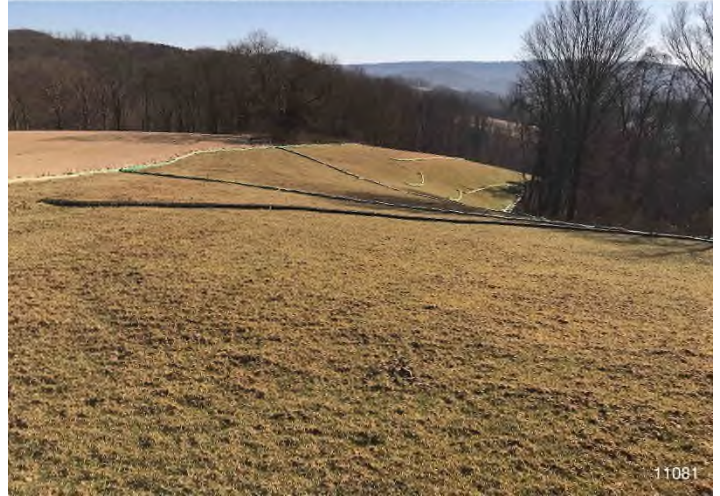
11081

Figure 2: STA 11081+00 – Controls in place and functioning properly.
 BRG: 96°E (T) LAT: 37.316280 LON: -80.543244 ±13795ft ALT: 2238ft

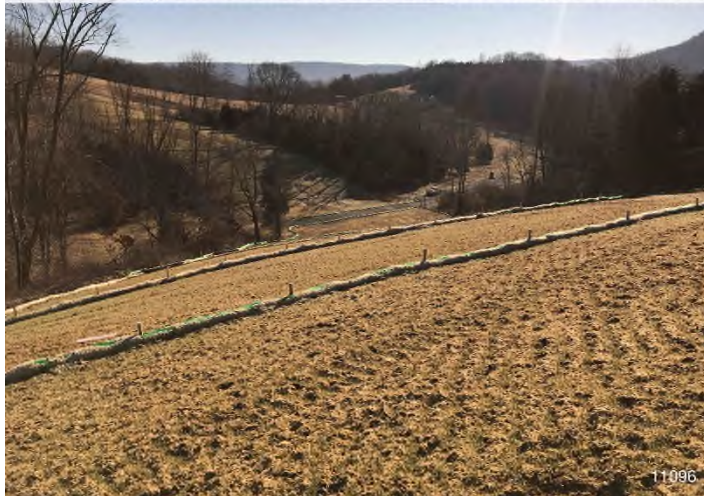
11096

Figure 3: STA 11096+00 – Controls in place and functioning properly.
 BRG: 103°E (T) LAT: 37.313340 LON: -80.535043 ±98ft ALT: 1910ft

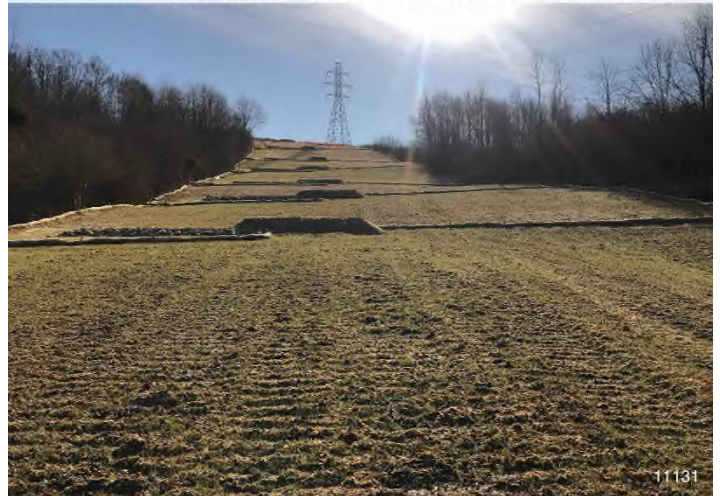
11131

Figure 4: STA 11131+00 – Controls in place and functioning properly.
 BRG: 133°SE (T) LAT: 37.314253 LON: -80.523731 ±164ft ALT: 2050ft
