FIELD INSPECTION REPORT

Project Name:	Mountain Valley Pipeline	Inspector:	Matthew Grant
Inspection Date:	Tuesday, February 22, 2022	Project Contact:	Brian Clauto
Spread G: Giles	St 11521-11533, 10975-10974+96 ATWS 874A, 874 AR-GI242.01, 243.01, 258.02	Weather:	Wet

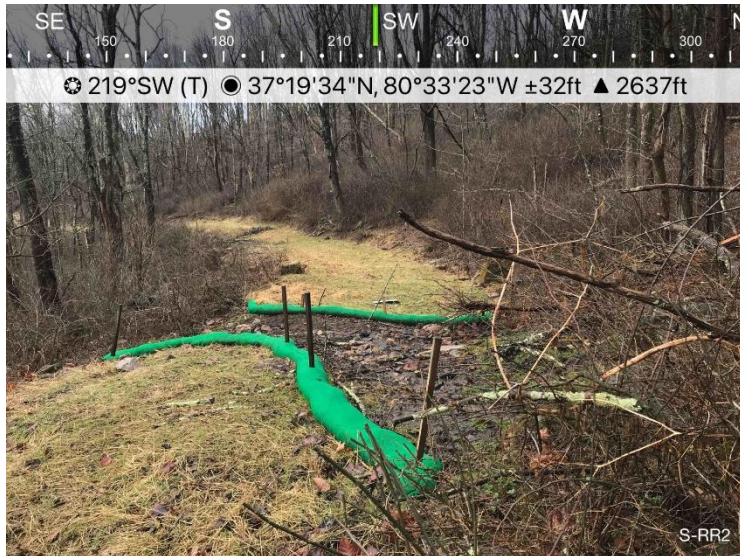
Figure 1: Designated crossing S-RR2, ESC's are in place and functioning.

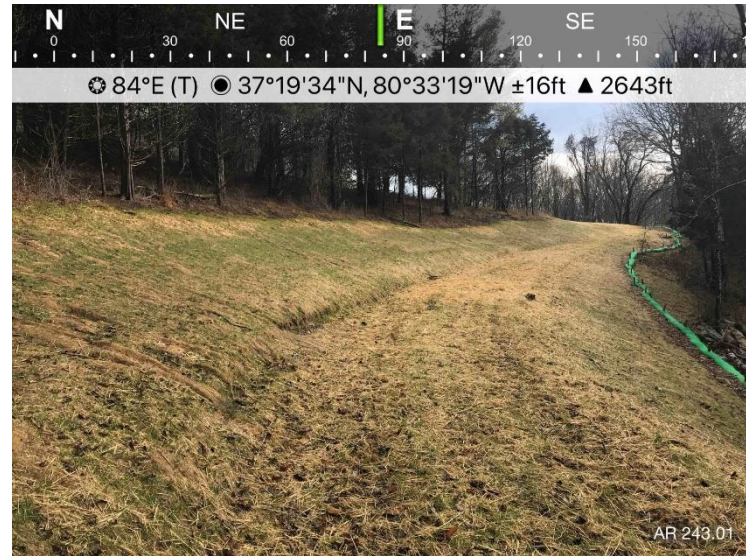
Figure 2: ESC controls were in place on AR 243.01

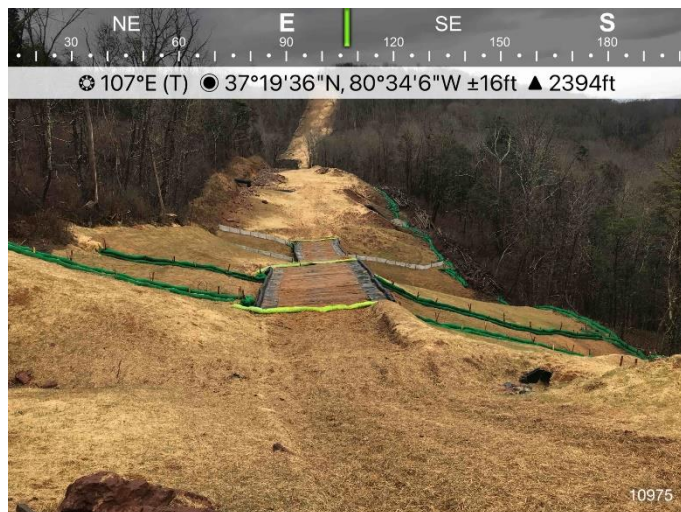
Figure 3: St10975, ECD's are in place and functioning.

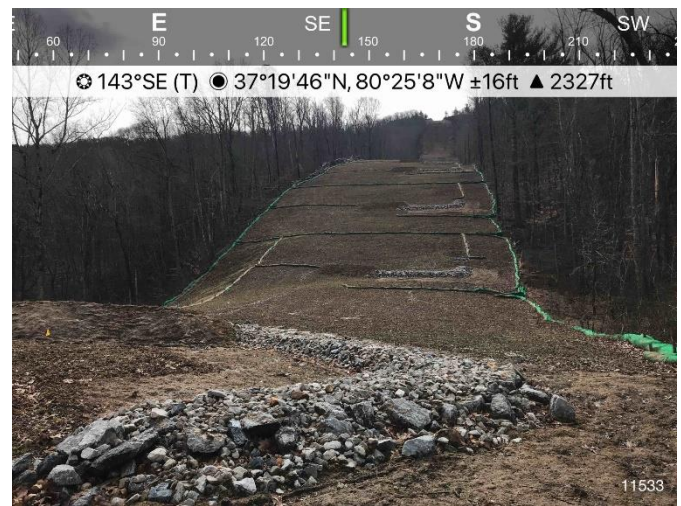
Figure 4: St1 1533, ECD's are in place and functioning.
