FIELD INSPECTION REPORT

Project Name:	Mountain Valley Pipeline	Inspector:	Matthew Grant
Inspection Date:	Tuesday, March 8, 2022	Project Contact:	Brian Clauto
Spread G: Craig	St 11522-11472+43 AR-Cr 258.02	Weather:	Dry

FIELD INSPECTION PHOTO LOG

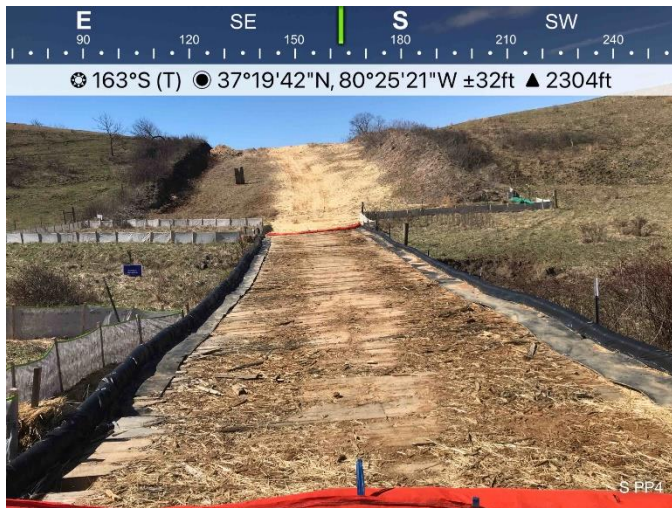
Figure 1: Designated crossing S-PP4, ESC's are in place and functioning.

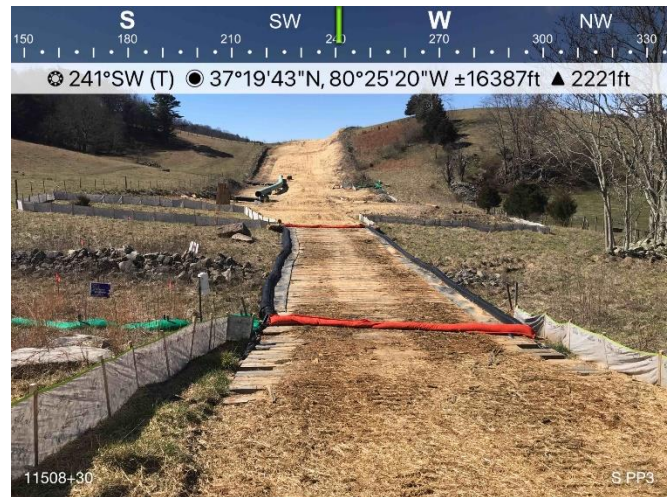
Figure 2: Designated crossing S-PP3, ESC's are in place and functioning.

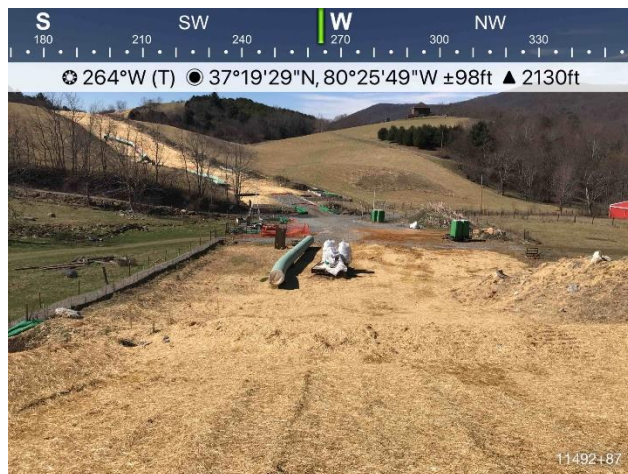
Figure 3: St 11492+87, ECD's are in place and functioning.

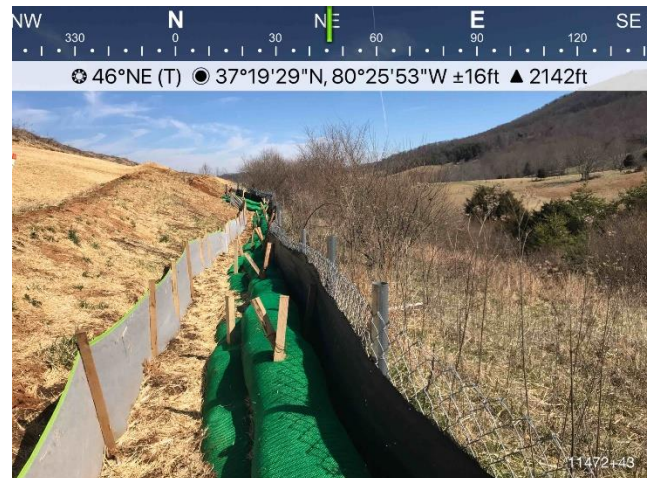
Figure 4: St11472+73, ECD's are in place and functioning.
