FIELD INSPECTION REPORT

Project Name:	Mountain Valley Pipeline	Inspector:	Matthew Grant
Inspection Date:	Tuesday, March 29, 2022	Project Contact:	Brian Clauto
Spread G: Montgomery	St11900-11928 AR-266, 266.03 ATWS 1487	Weather:	Dry

FIELD INSPECTION PHOTO LOG

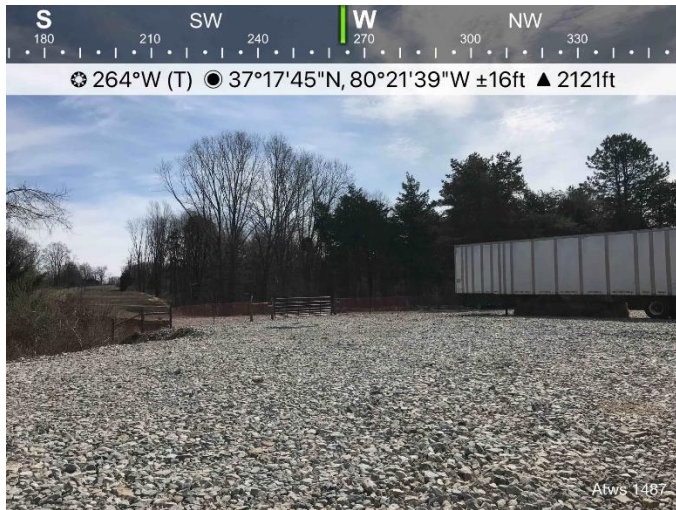
- Figure 1: ATWS 1487 remains dormant and access to ROW locked.

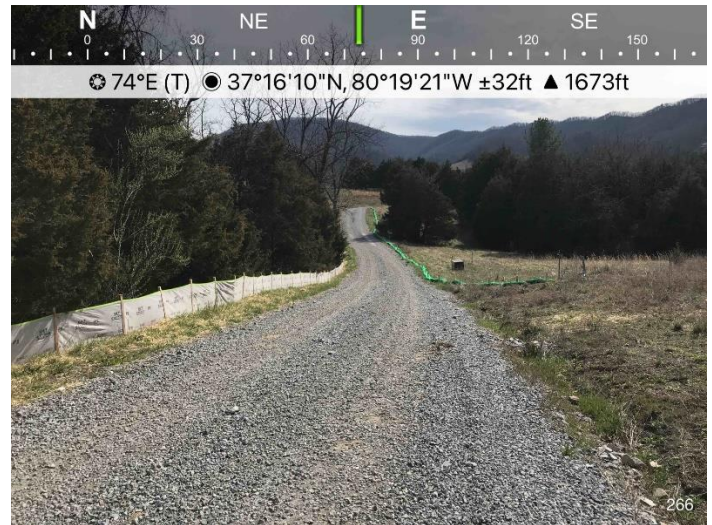
- Figure 2: AR 266 ESC in place and functioning

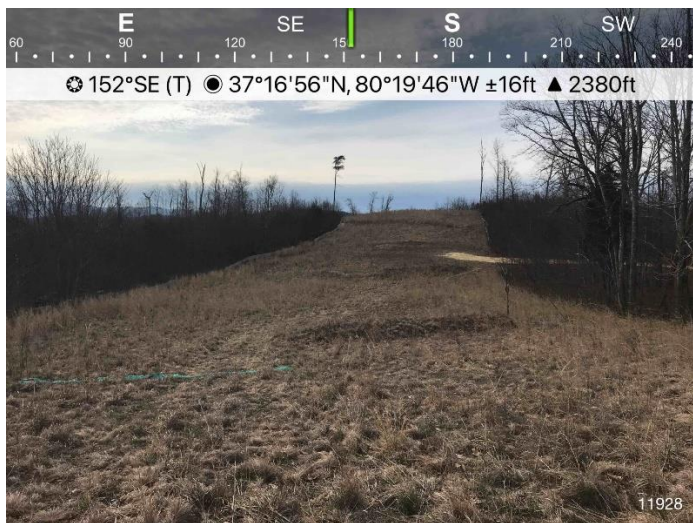
- Figure 3: St 11298, ECD's are in place and functioning.

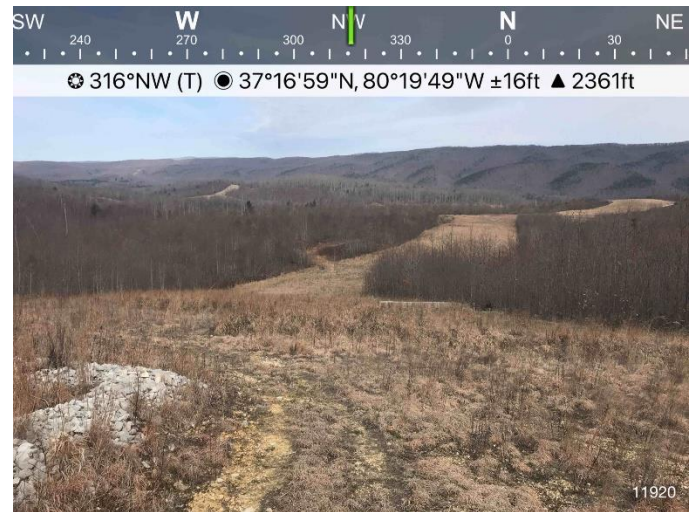
- Figure 4: St11920, ECD's are in place and functioning.
