## FIELD INSPECTION REPORT

<b>Project Name:</b>	Mountain Valley Pipeline	<b>Inspector:</b>	Marshall Willis
<b>Inspection Date:</b>	Tuesday, March 29, 2022	<b>Project Contact:</b>	Brian Clauto, Cory Chalmers
<b>Spread G: Montgomery County</b>	STA 11900+00 – 12007+33 MVP-MN-266/266.03/268	<b>Weather:</b>	Dry

# FIELD INSPECTION PHOTO LOG

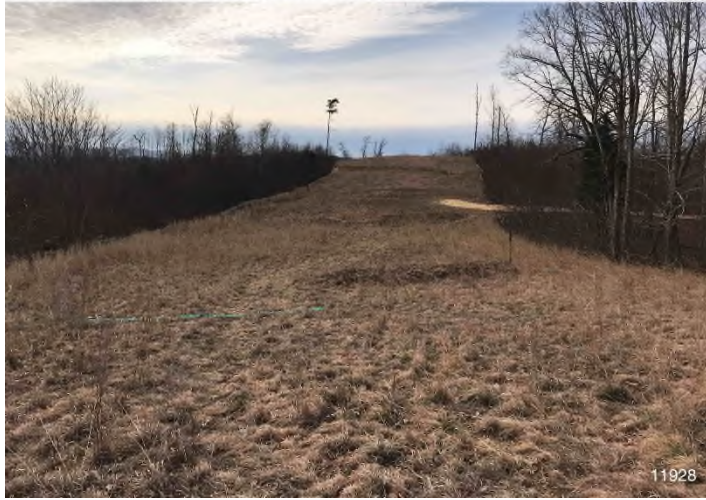
11928

**Figure 1: STA 11928+00** – Controls in place and functioning properly.

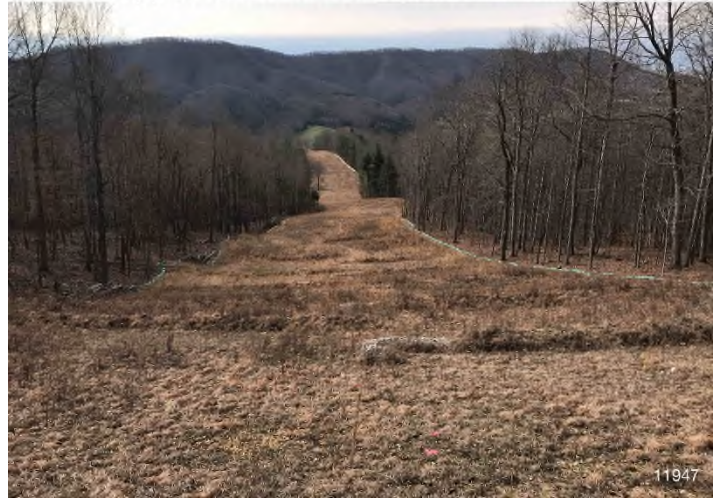
11947

**Figure 2: STA 11947+00** – Controls in place and functioning properly.

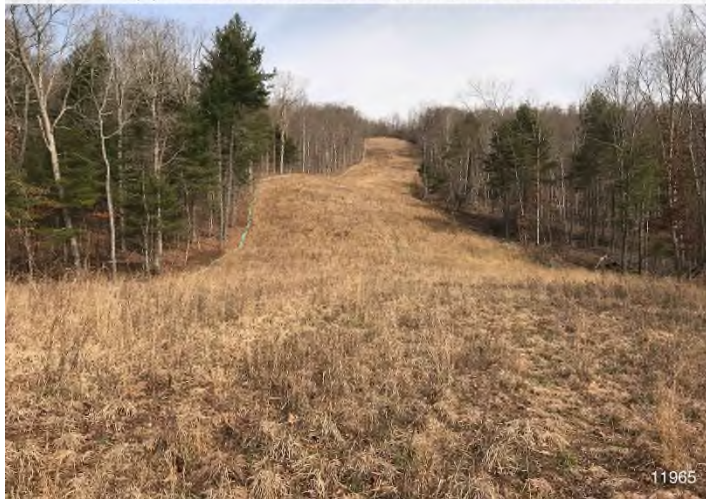
11965

**Figure 3: STA 11965+00** – Controls in place and functioning properly.

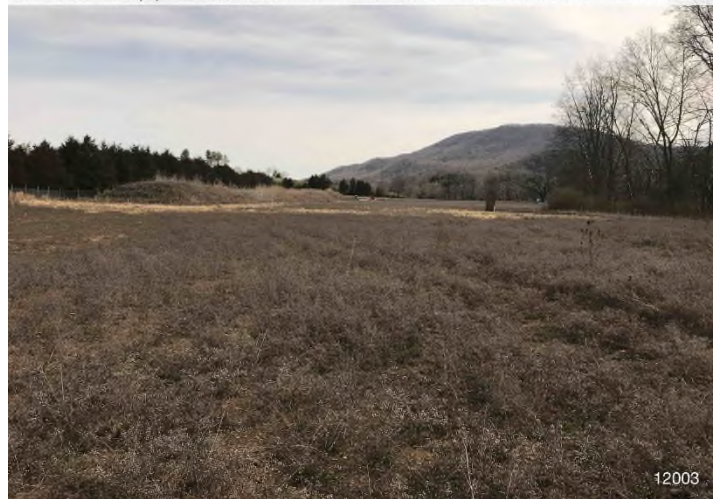
12003

**Figure 4: STA 12003+00** – Controls in place and functioning properly.
